Vehicle: All Technical Service Bulletins Aftermarket Radio May Set DTC'S 72 and 74 In CCM

Number: 93-68-9A

AFTERMARKET RADIO MAY SET DTC'S 72 AND 74 IN CCM

Model and Year: 1990-93 CORVETTE

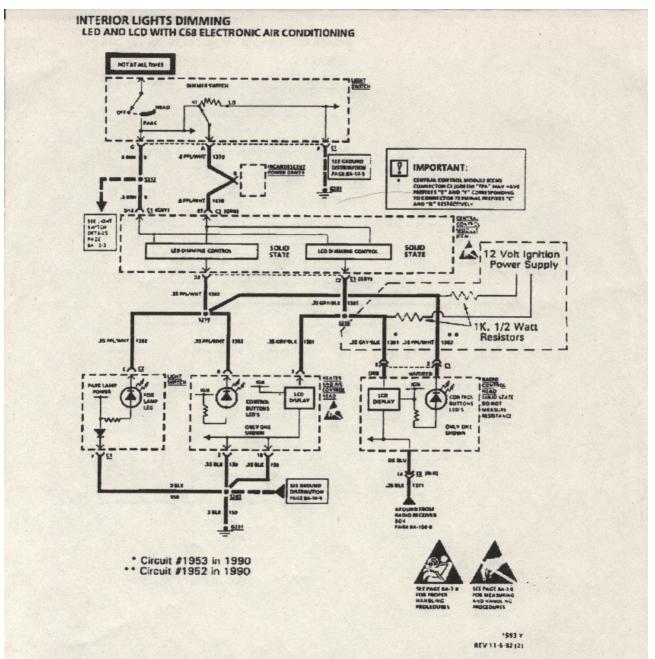
On the 1990-93 Y-car, Diagnostic Trouble Codes (DTC's) 72 and 74 may be set in CCM if an aftermarket radio is installed. "SYS" will be displayed in the LCD section of the cluster, and the DTC's will be displayed when the diagnostic mode is entered.

With an aftermarket radio installed, DTC's 72 and 74 are likely to be set because the LCD and LED dimming lines to the radio have gone to an open circuit, because these inputs do not exist in an aftermarket radio.

- Disconnect negative battery cable.
- Remove the radio control head, following the directions in the Service Manual, Section 8C. This will allow access to the radio control head wiring.

- 3. Add 1K ohm, 1/2 watt resistors as shown in the illustration. The resistors are available from a local electronics supply store, such as "Radio Shack. The resistors should be connected to a 12 volt ignition-switched circuit. For 1991 to 1993, there is an auxiliary power pickup in the console. For 1990, ignition circuit number 300 should be used. See Section 8A for wiring details.
- 4. Reinstall the radio, then reconnect negative battery cable. Clear the CCM DTC's as shown in Section 8D, and verify proper operation.
