Broken headlight-bezel attaching tabs: a “workable repair”?.

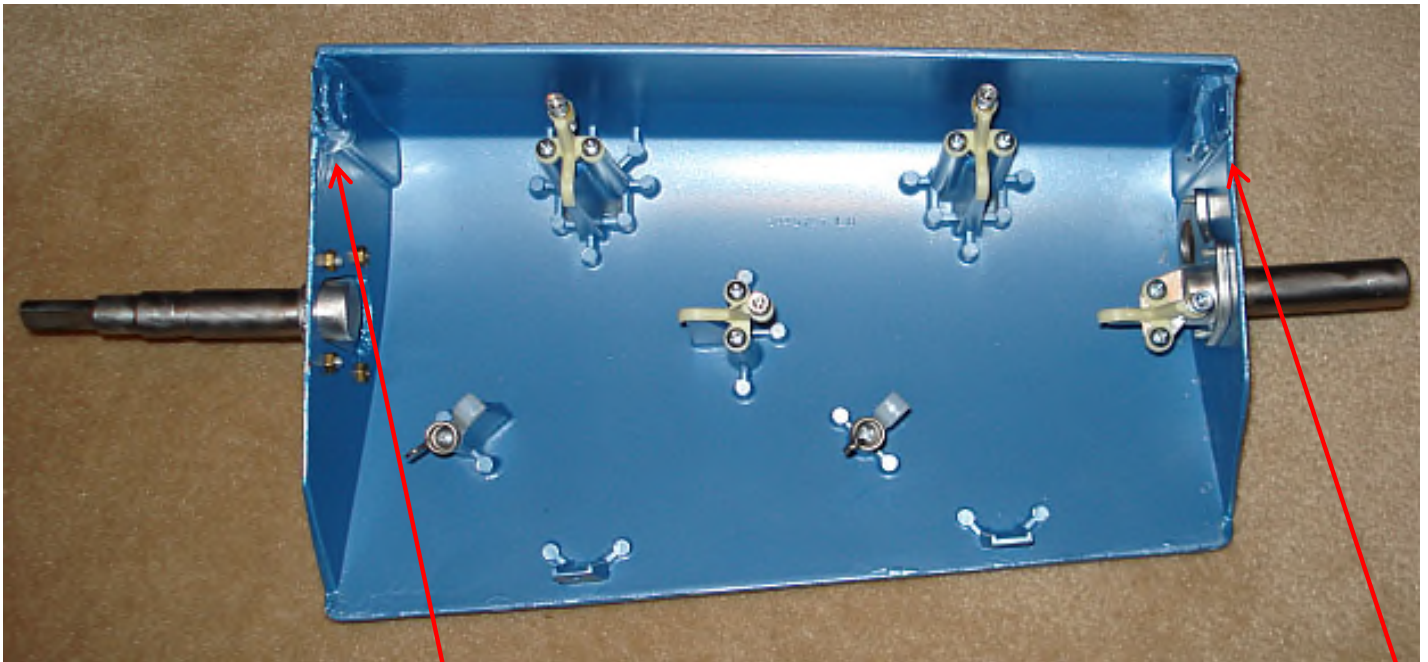
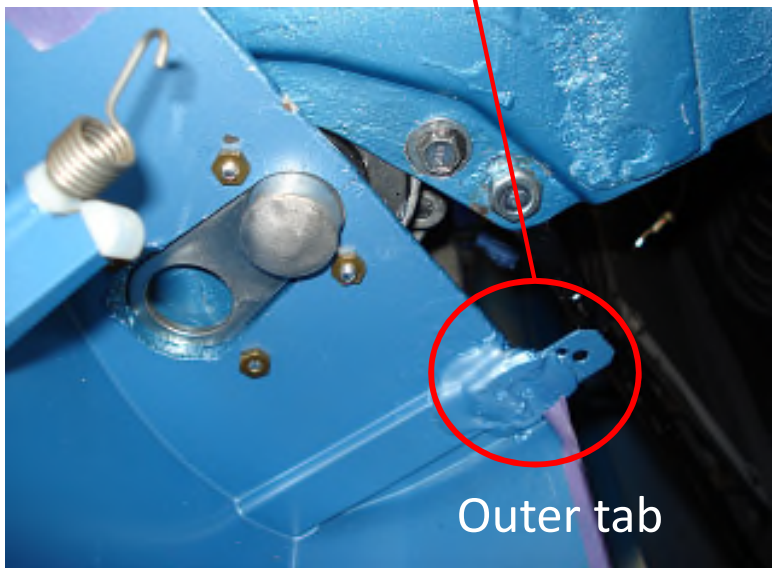
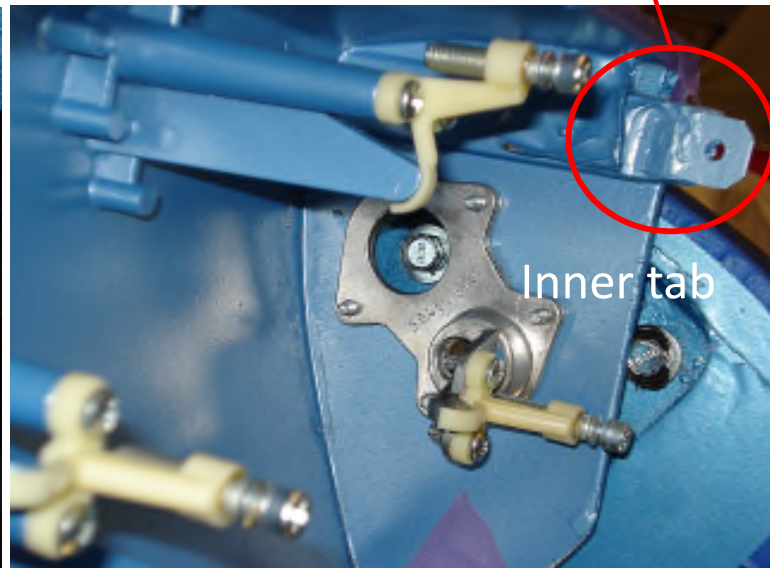
This is what I found on opening the driver-side headlight bucket. Both upper tabs had been replaced with sheet metal tabs JB Welded in place and drilled for sheet metal screws or u-nuts by a previous owner(s). Makes you wonder how they got that way! The makeshift tabs hold OK and so, for now, that’s how they will stay. One tab on the passenger bucket was partially broken but it holds a u-nut OK.

Photos above show how this was repaired, for better or worse, on our '65.

The jury-rigged tabs are a workable repair if you don’t want to buy replacement buckets or try to work on the delicate pot metal housing.

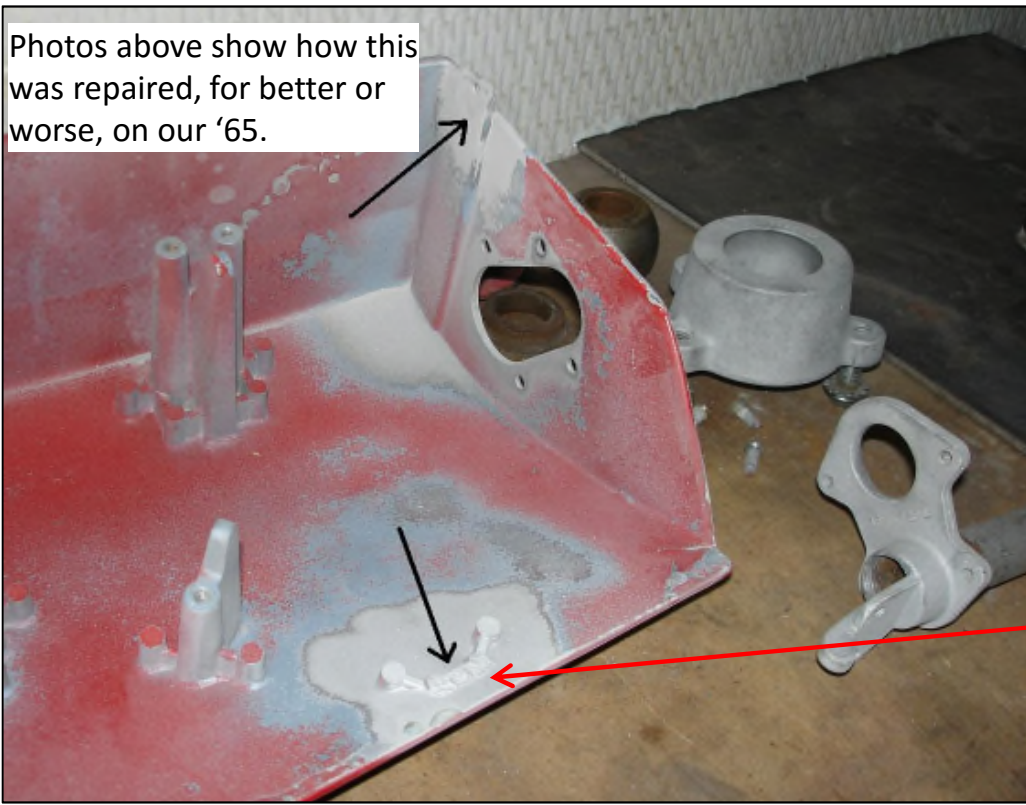
Suggestion for a possible repair of a broken lower bezel attachment tab.

Grind or file this area flat. Bend a right-angle tab out of 1/16th inch aluminum bar of appropriate width and JB weld it to the bucket. Drill the hole before attaching to the bucket. Build up the epoxy around and over the sides of the tab against the bucket to get a solid attachment.
