## #PIC6447: Water Leak - Passenger Side Carpeting May Be Wet When Using the Air Conditioning - (Oct 12, 2021)

Brand:	Model:	Model Year:		VIN:		Engine:	Transmission:
		from	to	from	to		
Chevrolet	Corvette	2020 - 2022		All	All	All	All

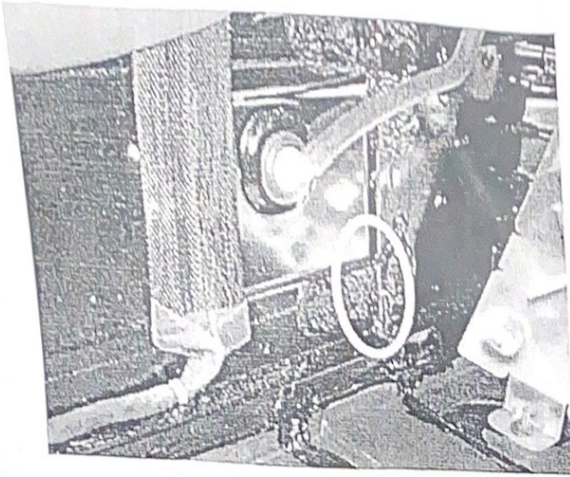
Condition #2 - As previously mentioned, even if an issue was found with Condition #1, all service technicians should also inspect / water test the vehicle for BOTH conditions listed in this document. Another leak point that has been identified on this vehicle is a seam between two body panels that is located just fore and several inches below where the AC drain tube exits the vehicle. This area can be seen in the photo below.

A gap in the seam sealer along this location may also allow water from the AC drain system to leak back inside the vehicle. To correctly repair this leak, a two-step approach is taken. First, the technician must seal the seam between the two body panels **INSIDE** the vehicle with seam sealer, available from any local body shop. Once that has been done, technicians are to seal the **OUTSIDE** of the vehicle to prevent water from getting to this area in the first place. To begin, first lift the car and remove the Floor Panel Tunnel Panel Front Reinforcement (currently found on SI document ID 5358807.) This is the long, narrow panel that covers the area historically referred to as the "transmission tunnel." This will allow access to the "outside" of the panels where the water is leaking in at.

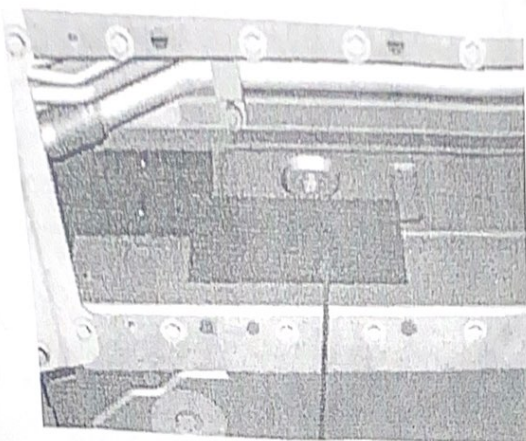
Once this panel has been removed, stand in the middle of the vehicle facing the front of the car. If you look upwards and to the right, you will see the AC drain tube exiting the center console area of the vehicle. Just below this AC drain tube, the technician is to inspect for the presence of a black mastic patch that is covering the seam between these two body panels. This patch can be seen in the computer image seen below.

The patch may or may not be present on the particular vehicle that is being serviced. It was not added at the assembly plant until later built vehicles. If the patch is not present, obtain a large piece of mastic from the parts department and apply it to the body so that this seam area is completely covered. Use the image above as a guide for size and placement. Be sure to wet out the patch correctly, using a roller, or a large socket. This will ensure that the adhesive is completely sealed to the body panels and no water may enter the vehicle in this location. If there already is a black mastic patch present in this location, it should be removed and replaced with a new one. Install the new patch following the same directions as listed above. This two-step repair will provide assurance that no further water leaks will occur in this area again.
