#02-06-04-023A: Audible Spark Knock (Detonation), MIL Illuminated, DTC P0332 Set (Replace Rear Bank Knock Sensor and RTV Area Around Sensor) - (Jun 14, 2002)

Models: 1998-2002 Chevrolet Camaro, Corvette
1998-2002 Pontiac Firebird
with 5.7L Engine (VIN G -- RPO LS1)
1999-2002 Chevrolet Silverado, Suburban, Tahoe
2002 Chevrolet Avalance
1999-2002 GMC Sierra, Yukon, Yukon XL
2002 Cadillac Escalade, Escalade EXT
with 4.8L, 5.3L or 6.0L Engine (VINs V, T, Z, N, U -- RPOs LR4, LM7, L59, LQ9, LQ4)

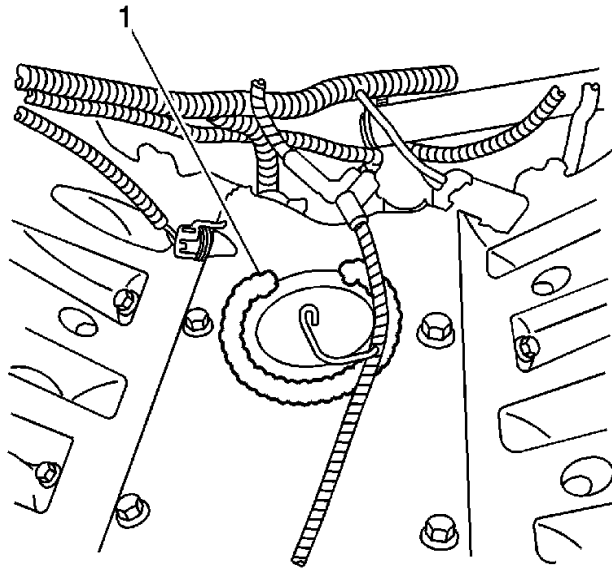
This condition may be the result of corrosion of the rear bank knock sensor due to water intrusion into the sensor cavity. This condition is more apparent on vehicles in which customers frequently wash the engine compartment.

6. Apply a bead of RTV silicone sealant approximately 9 mm (3/8 in) wide and 6 mm (1/4 in) high along the outside edge of the ridge on the engine block valley cover around the rear bank knock sensor. DO NOT form a complete circle. Leave the rear section open as shown.
7. From the underside of the intake manifold, completely remove the rear intake manifold seal (foam material).
8. Install the intake manifold. Refer to the Intake Manifold Replacement procedure in the Engine Controls sub-section of the appropriate Service Manual.
