**Bulletin No.:** 08-08-67-013C

**Date:** July 14, 2009

**Subject:** Snap, Pop, Creak or Rattle Noise From Lift Off Roof Panel While Driving (Verify Condition and Perform Appropriate Repairs)

2005-2010 Chevrolet Corvette

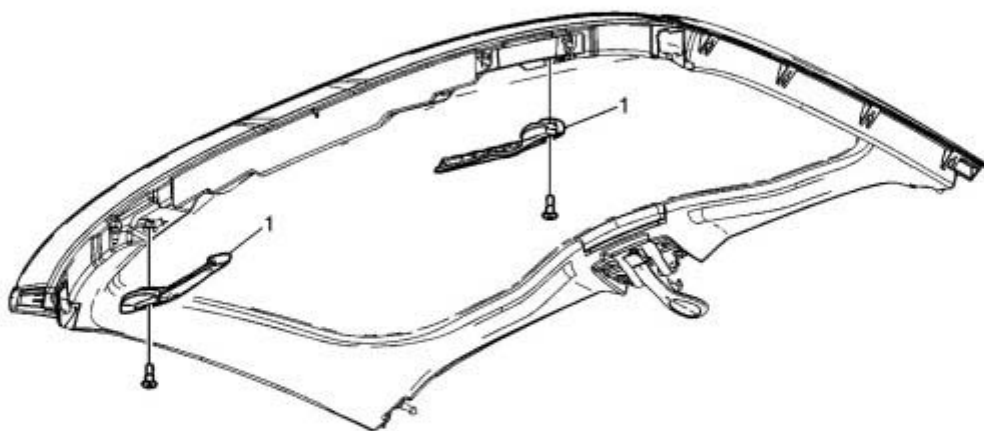
This condition may be caused by the nylon roller inside the left and/or right front roof panel latching handle becoming loose and causing the roller to move on the pin, creating the noise.

- If the roller is round and will spin on its axis (as shown above), they are early design handles and should be replaced. Replace the left and right front lift off roof panel handles with the current handle design parts noted previously, and include the lubrication steps below.

**Important:** For any latch handle replacement, use only P/Ns 19206591 (left) and 19206592 (right). These current handles have a revised roller that was redesigned so it does not roll, but now slides across the latch receiver. All 2009&hyphen;2010 removable roofs (painted and transparent) have the new handle design.

1. If the noise is verified to be coming from the front latch area, remove the latch handles (1) and inspect the handle roller. Refer to Roof Lift Off Panel Front Latch Handle Replacement in SI. Identify the design, and the resulting repair, from the two choices below:

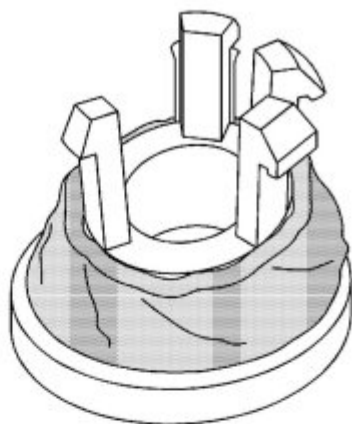
2. Once removed, inspect each insert (1) to verify the cones are not cracked or broken.

The flocking is designed to insulate the cone when roof movement occurs.

3. Also verify that the inserts have a 8 mm (0.31 in) wide wrap of flocking tape toward the top of the cone, as shown above. If the flocking tape is worn or is missing, repair following Corporate Bulletin Number 05-08-59-003E.
