TSB 06.02.35.002 (Service Active Handling) Message

Diagnostic Trouble Code (DTC) C0710 Steering Wheel Position Sensor (SWPS) Signal, Service Stability System (**Service Active Handling**) Message on Driver Information Center (DIC) (Inspect and Secure Wires in SWPS Connector)

2005-2006 Chevrolet Corvette

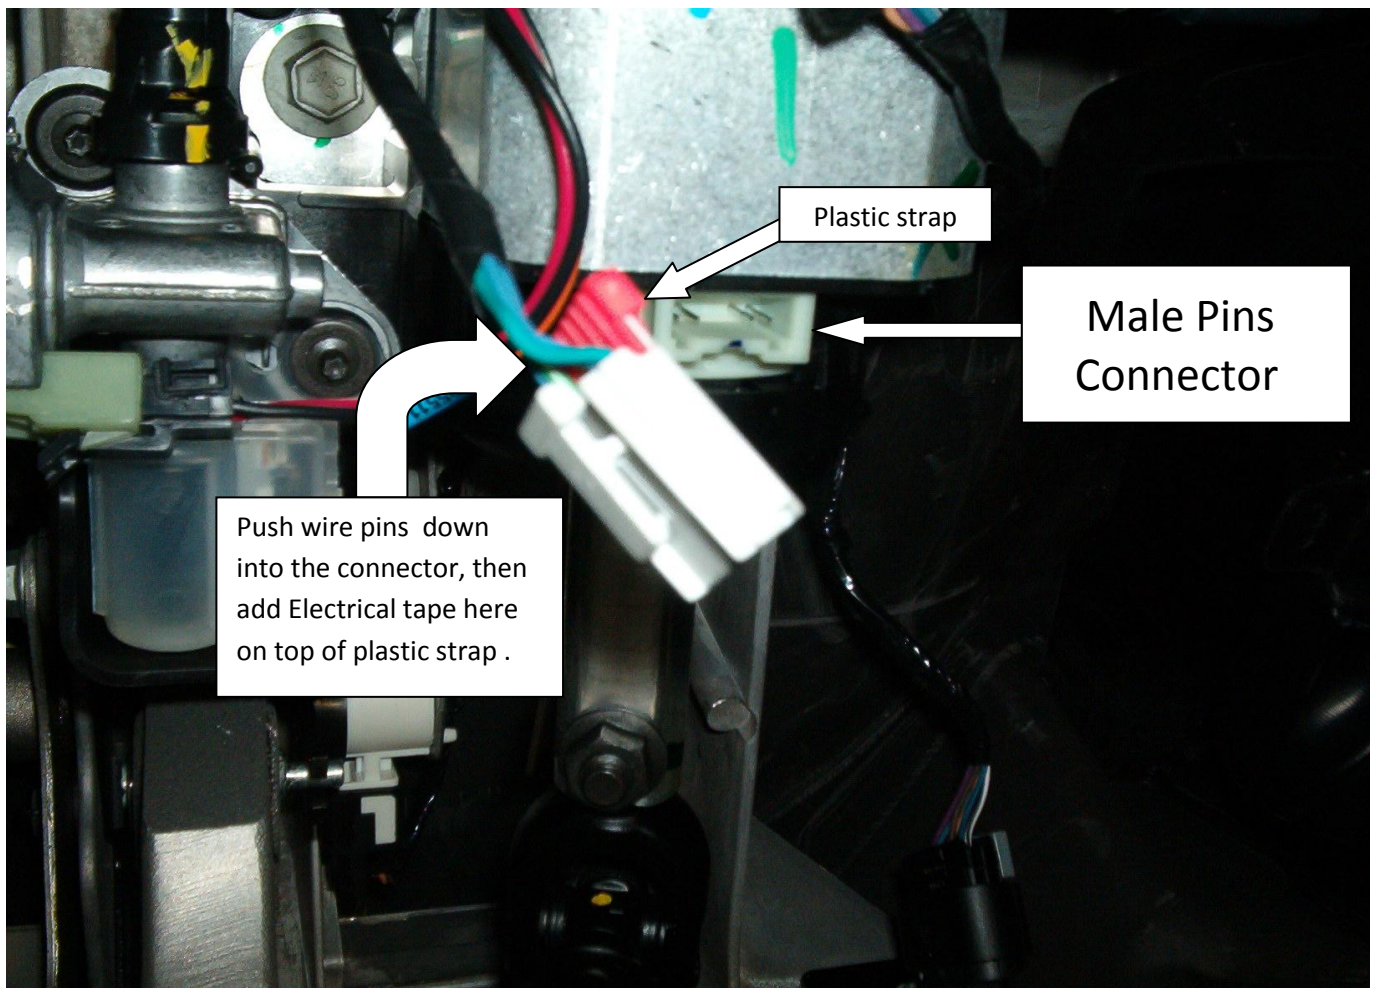
Connector is 4 conductor...very cheaply made...

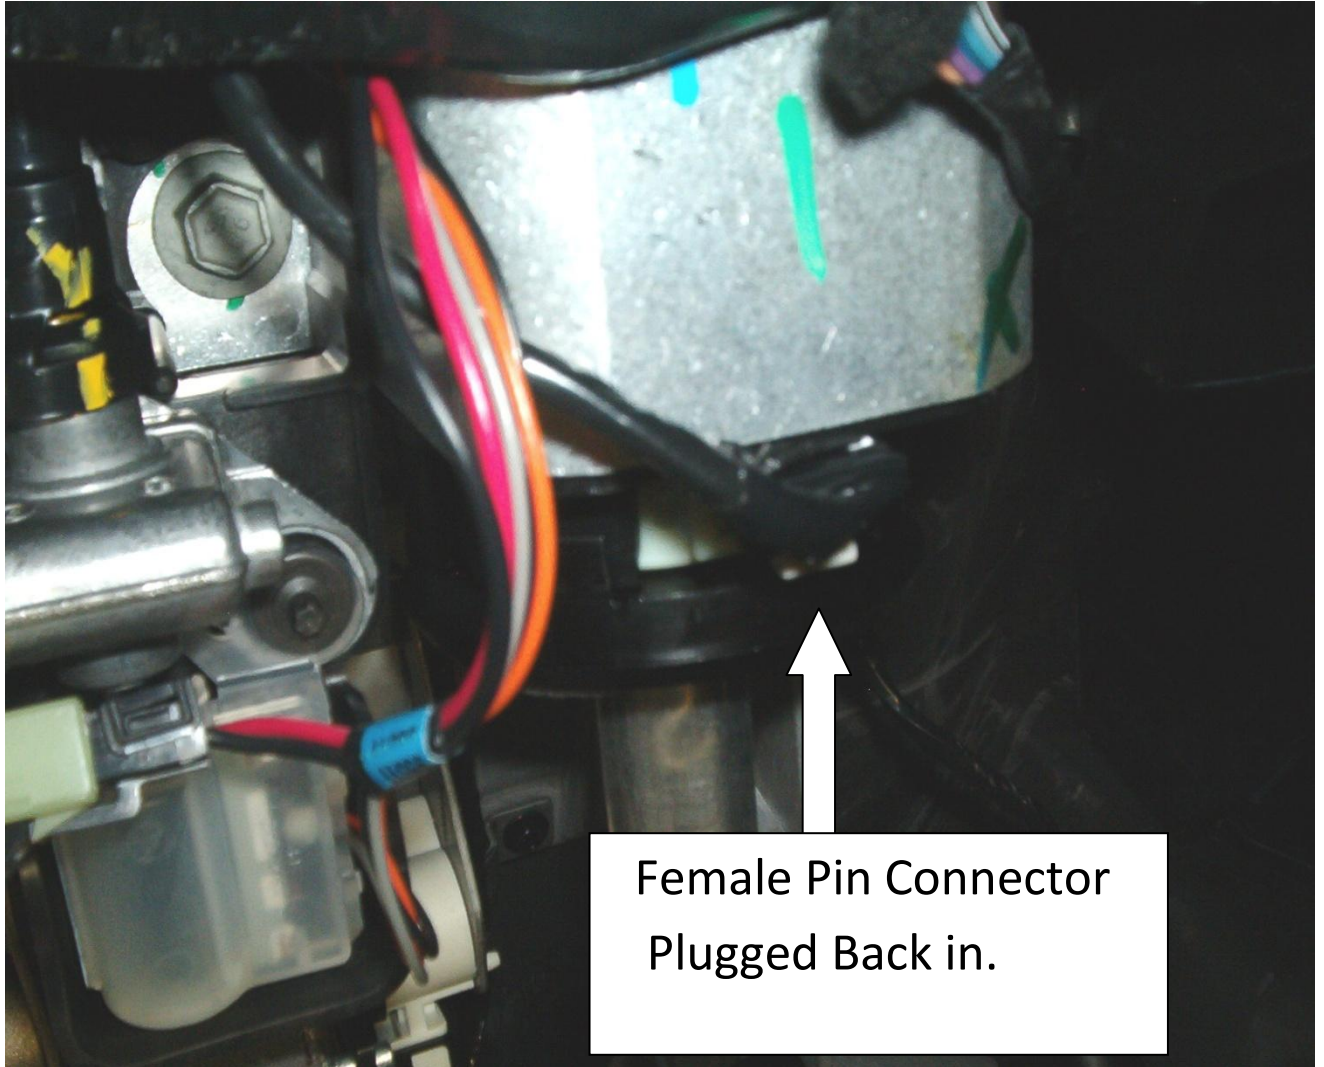
Here's the connector re-plugged into the steering angle sensor....

Female Pin Connector
Plugged Back in.
