## Rear Hatch button repair - DIY

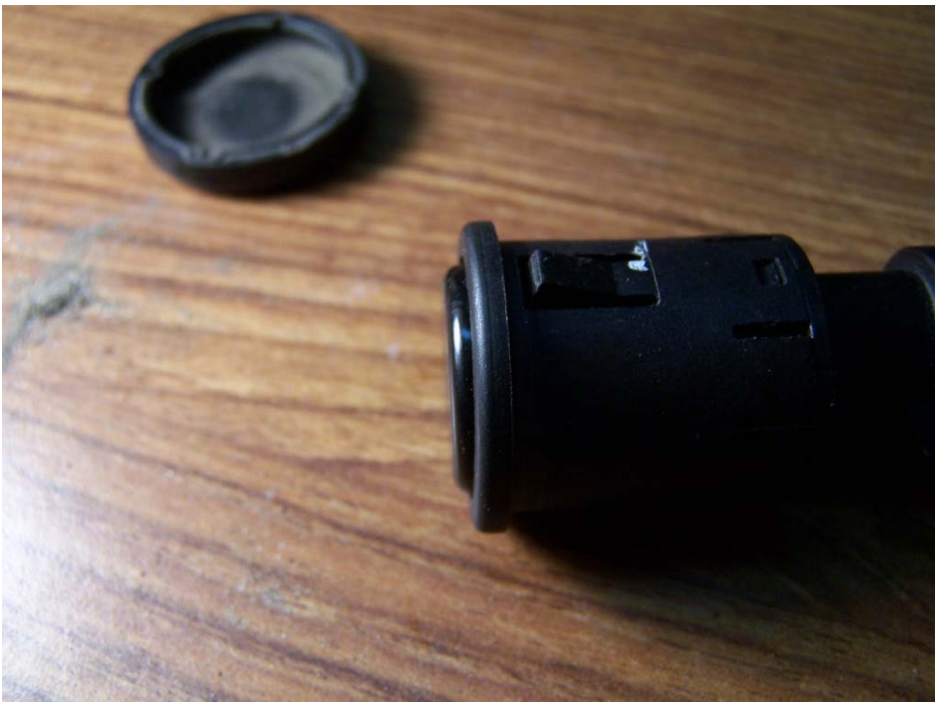
This next picture is how a button should look that will function normally. The plunger should be raised above the switch housing and the plunger should move freely up and down.

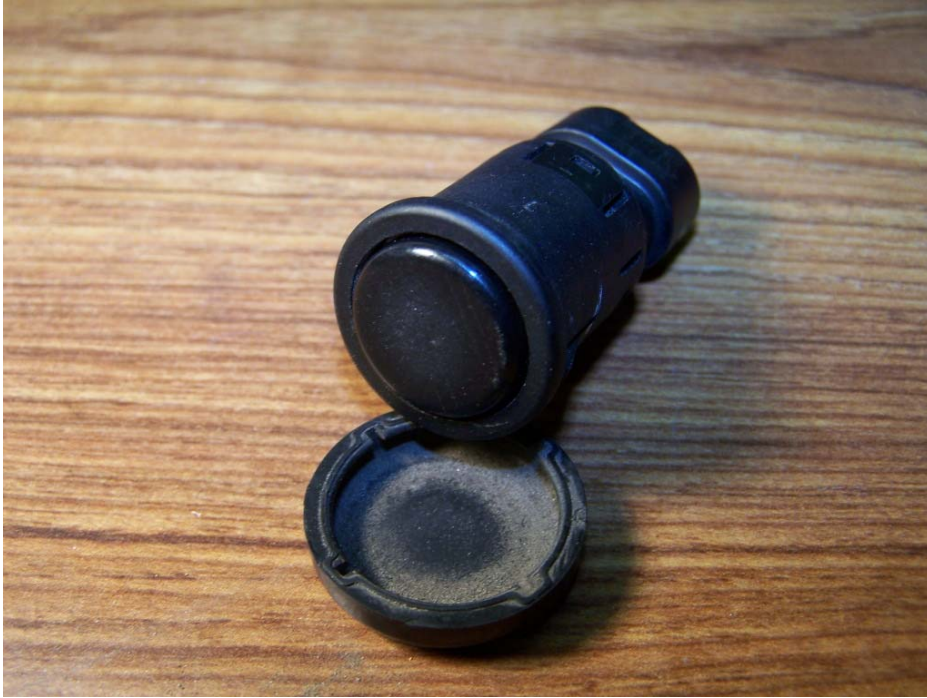
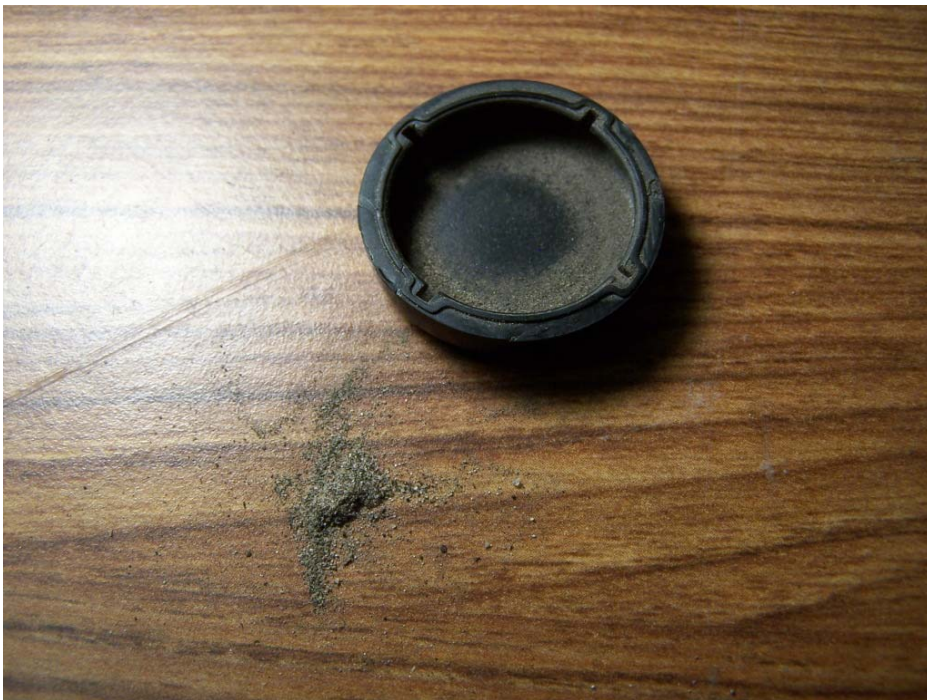
Take a look at what I found in my switch.

This sand and silt is the cause of your switch problems. This was just under the rubber cover. Expect to find more inside.

If your plunger is flush with the surface of the switch it is stuck in the down position and that will be a source of problems. This sand and silt can move around and cause the switch to work intermittently.

Clean out cover and the switch base. Use some compressed air or alcohol and a cotton swab to make sure you get all the sand and contaminants out.

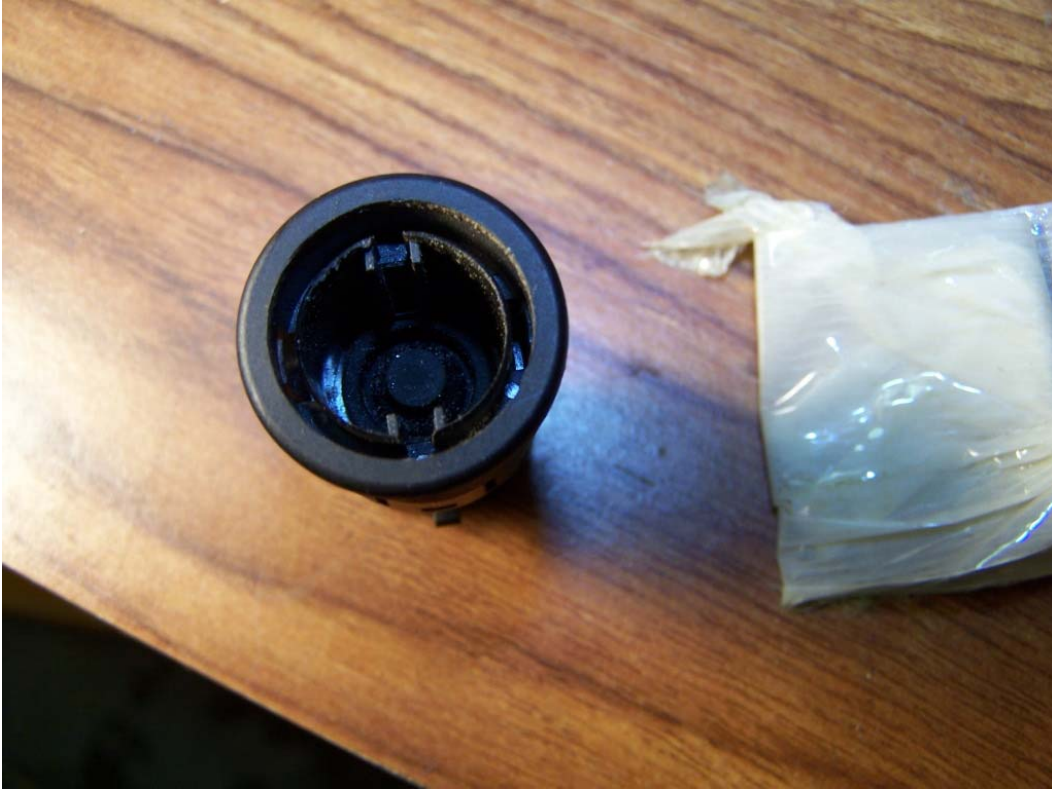
The switch plunger travels in two channels and uses the rubber switch at the bottom as its return spring. It is a sealed switch and there is no need to remove any other components of the assembly. The problem will be the plunger if there is one.
