## #PI0766: Buzz Noise Heard Near Base of Windshield at Highway Speeds - (Jul 17, 2012)

**Subject: Buzz Noise Heard Near Base of Windshield at Highway Speeds**

**Models: 2010-2013 Chevrolet Corvette**

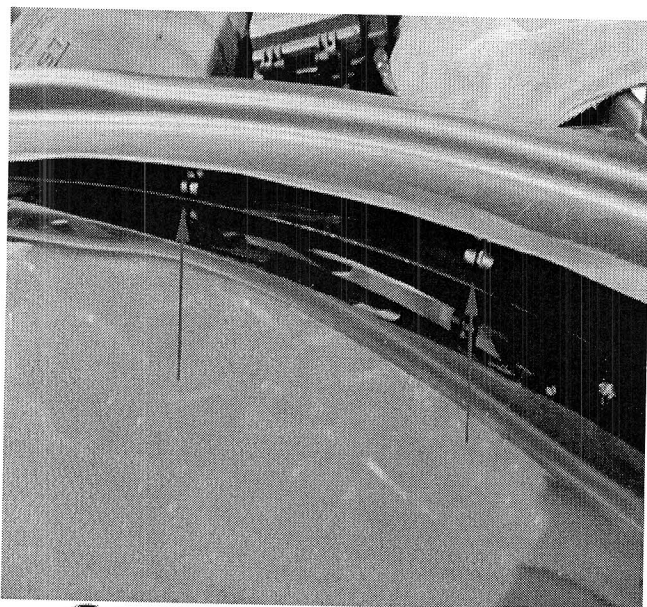
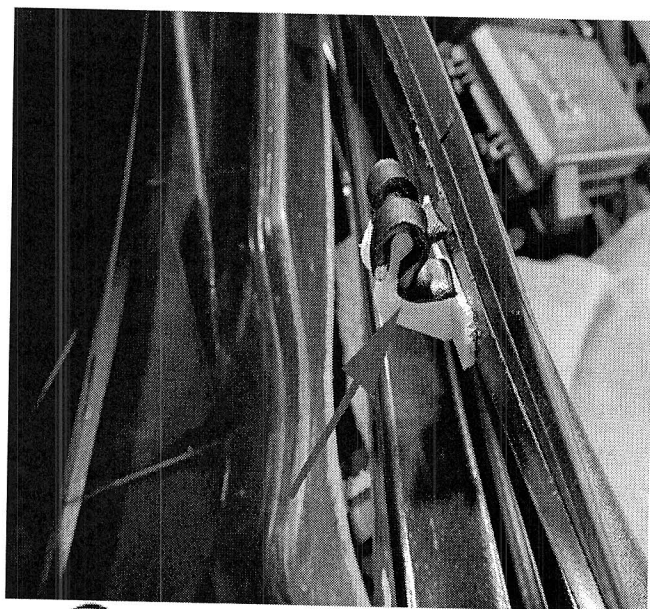
This condition may be caused by the air inlet grille panel (cowl trim panel) fluttering against the windshield glass.

6. Cut four 25 mm (1.0 in) long sections of \*Kent Industries Butyl Rubber Windshield Tape, Part # P20230 or the equivalent, as shown.

7. Install the material on the two right side hooks as shown.  
Ensure the material wraps around the end of the hook.
8. Reinstall the cowl trim panel and ensure the hooks are fastened under the edge of the glass.
9. Reinstall the two right side cowl trim panel clips.
10. Reinstall the right air inlet grille panel screw.
