MOISTURE IN HEADLIGHTS

I've had moisture in my passenger headlight and how I fixed it.

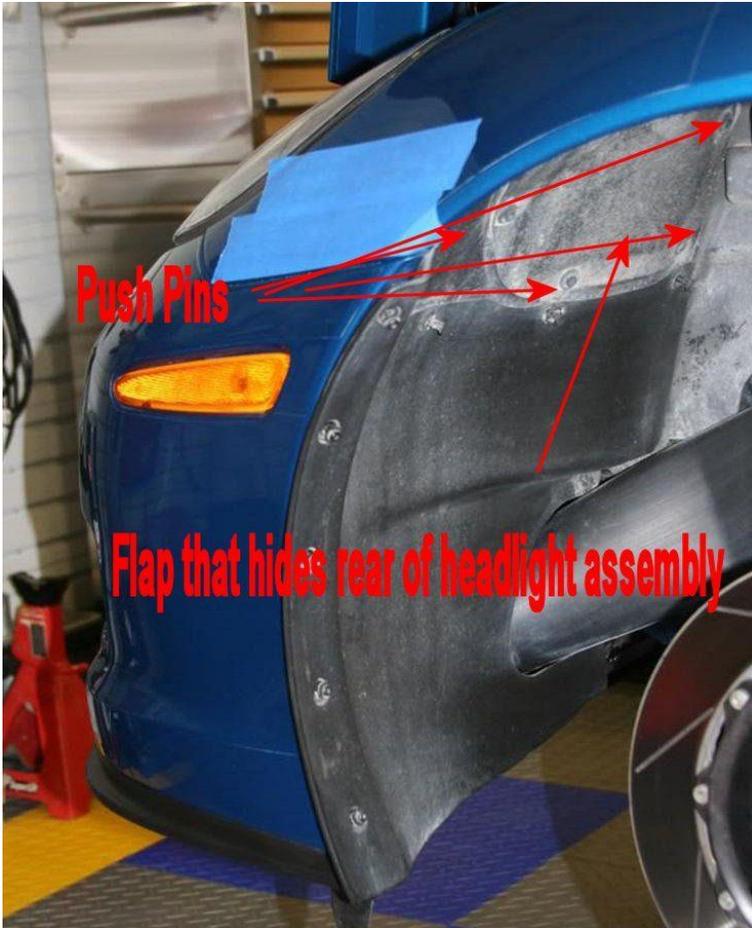
- 1) Jack up passenger side and remove the wheel.
- 2) Remove the push pins of the flap that is high on the plastic liner, in front of the wheel.

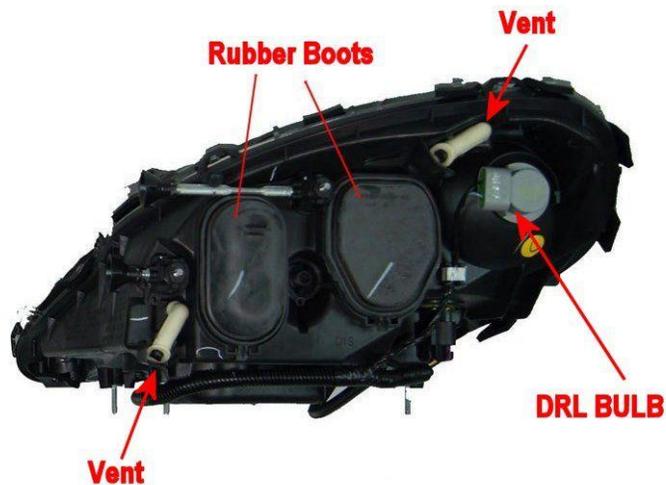
- 3) Once the flap is removed, you will notice the (2) rubber boots) that cover the headlight bulbs.

4) Remove the (2) boots, then use a hair dryer to force heat into those opening until the moisture has been evaporated. It only takes 5 minutes or so.

When you have the headlight clear, re-install the rubber boots, and re-install the flap with the push pins. Install the wheel, and you are done.

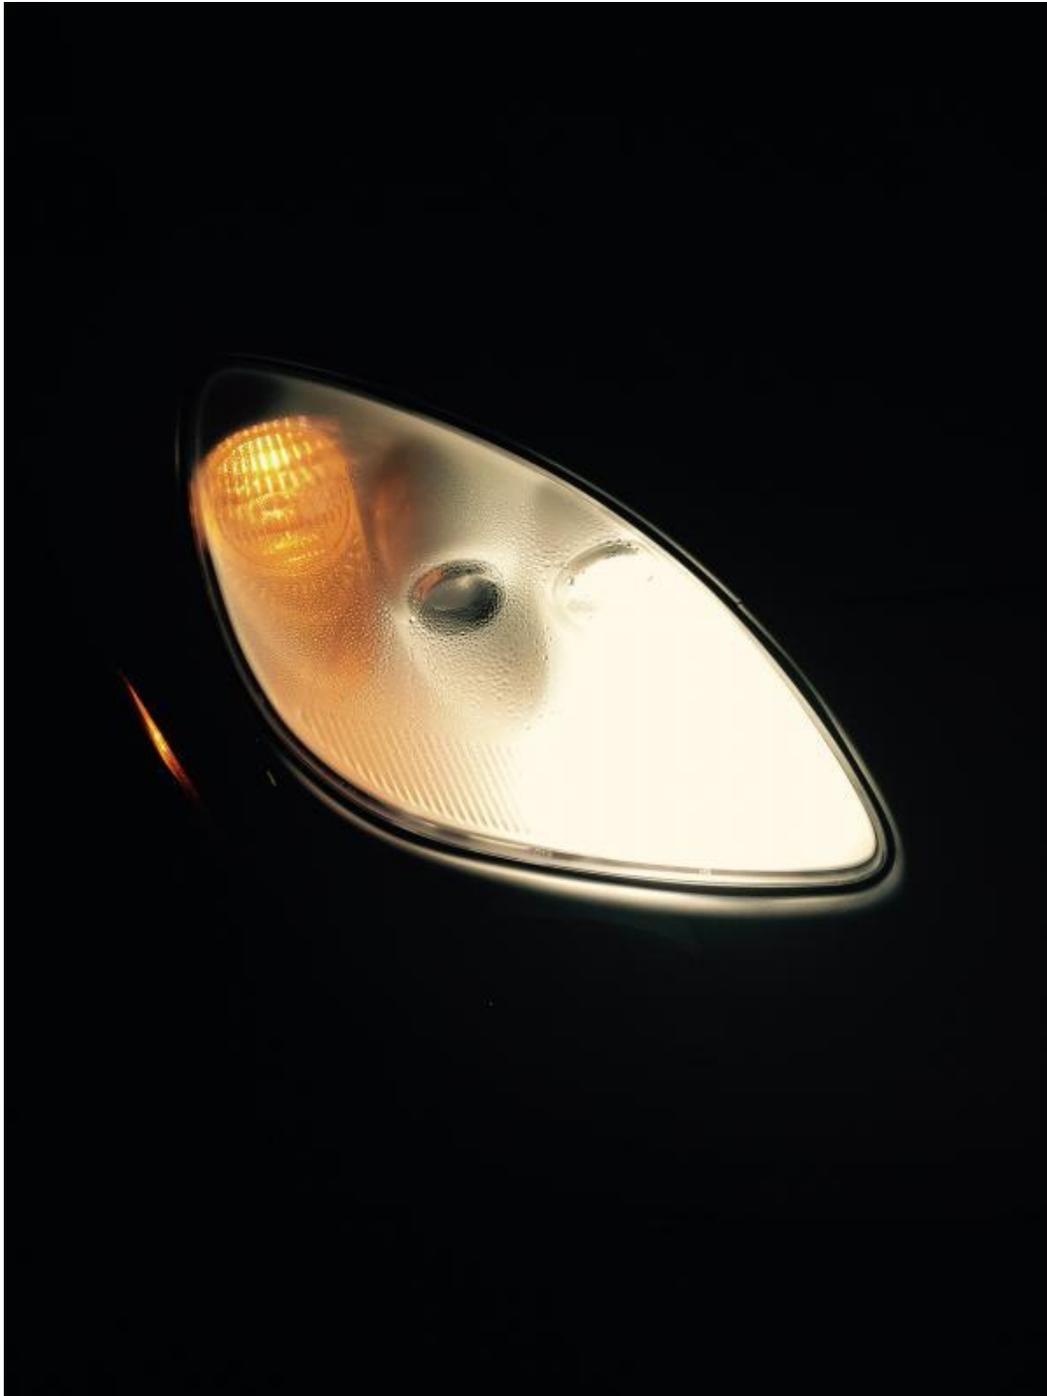
There are a few things to look for, if you are getting alot of moisture in the headlights. As per the pic.

1) Those rubber boots that cover the headlight bulbs could have become loose, or fallen off, thus allowing water to enter.

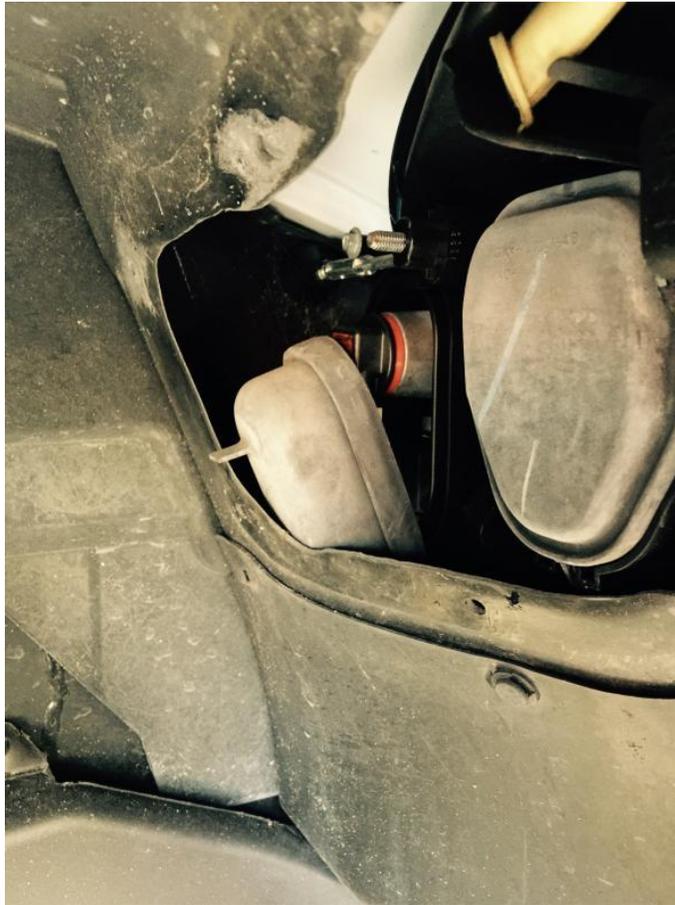
2) Check that the DRL bulb (outer) is tight, and the rubber seal is OK.

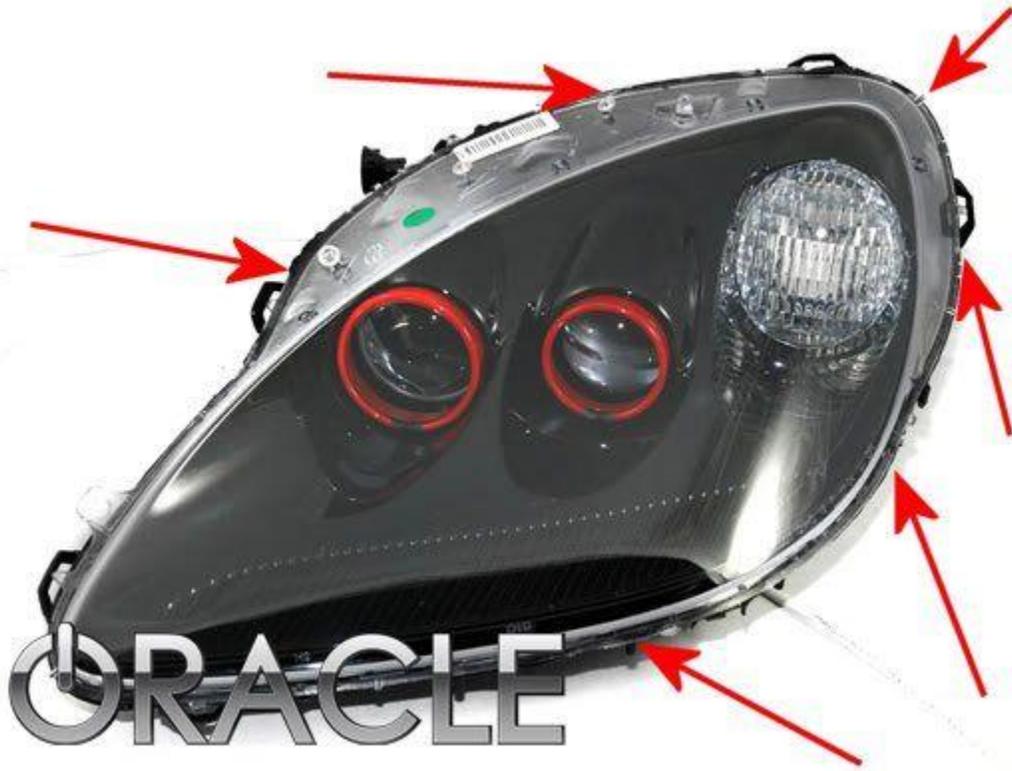
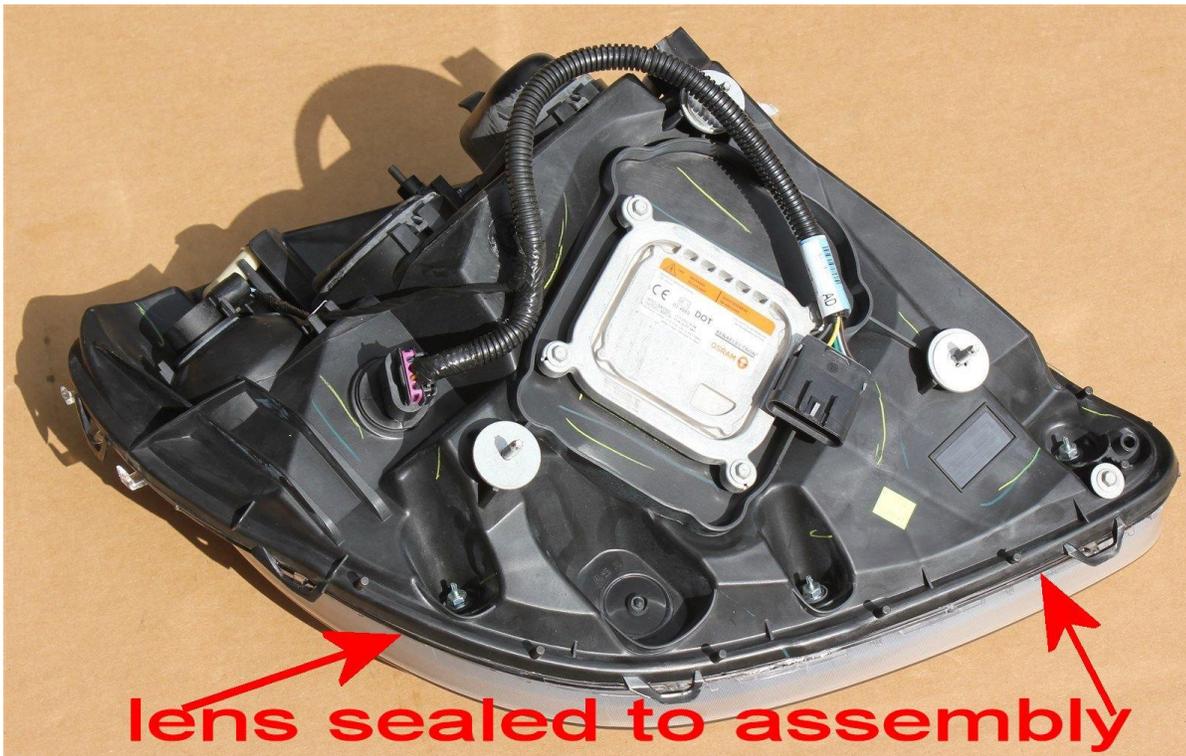
3) If those 2 things are OK, then the only other area water can get in, is between the assembly and the headlight lens.

It's possible that the glue that holds these 2 pieces together has failed, or was not done correctly from the factory. (that was my issue)

Water could work in there under heavy rain, or when I went through a car wash under pressure.

Headlight assembly gap that may be leaking

To fix this, I had to remove my headlight from the car, then solved this issue by using a clear silicone sealant, and went all the way around the headlight, making sure that the gap between the assembly and lens was filled with sealant.

To fix the seal between the lens and assembly, you need to remove the headlight from the car, and may also need to remove the headlight gasket, in a few areas to get access to that gap, all the way around. I've enclosed a pic of the headlight assembly to show the different areas that could let water in.
