Special Coverage Adjustment

15682 Primary Tank Module Flange Fuel and Vapor Leaks

Reference Number: N150682 **Release Date:** September 2016
GWM Number: 2015682 **Revision:** 02
Revision Description: This bulletin is being revised to remove the TAC Part Restriction information from the Parts section. Please discard all previous copies of bulletin 15682.

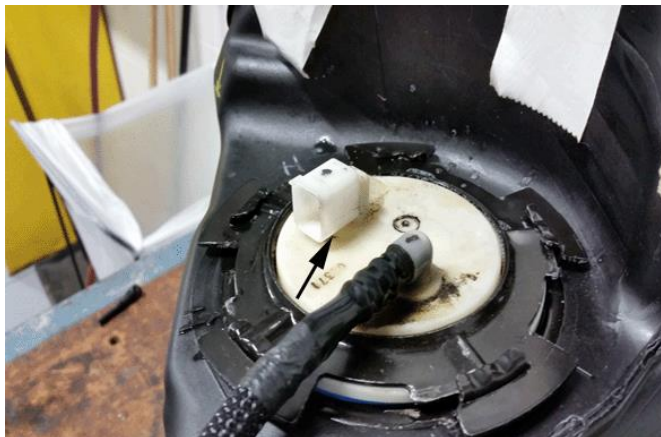
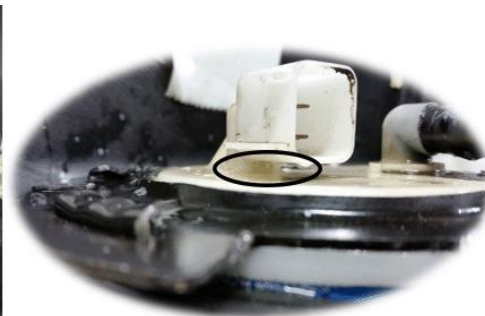
4567575

3. Inspect the area below the electrical connector (as shown above) for evidence of fuel leakage.
 - If there is evidence of fuel leakage, replace the fuel tank fuel pump module. Refer to Fuel Tank Fuel Pump Module Replacement - Left Side (LS3, LS7) or Fuel Tank Fuel Pump Module Replacement - Left Side in SI.
 - If there is NO evidence of fuel leakage, no further action is required. Inform the customer that any additional diagnosis and repairs are not covered under this special coverage.
4. If fuel was removed to perform the evaporative emissions system test in step 1, refuel the fuel tank to the previous level.
