#09-06-03-004E: Intermittent No Crank/No Start, No Module Communication, MIL, Warning Lights, Vehicle Messages or DTCs Set by Various Control Modules - Diagnosing and Repairing Fretting Corrosion (Disconnect Affected Connector and Apply Dielectric Lubricant) - (Nov 28, 2011)

Models: 2013 and Prior GM Passenger Cars and Trucks

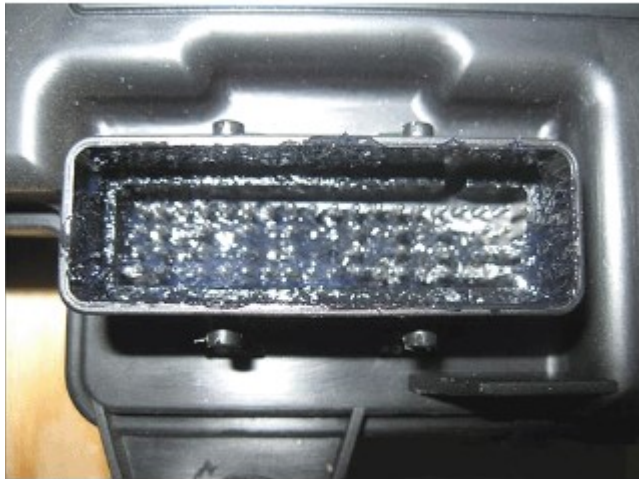
Note: Fretting corrosion looks like little dark smudges on electrical terminals and appear where the actual electrical contact is being made. In less severe cases it may be unable to be seen or identified without the use of a magnifying glass.

Important: DO NOT apply an excessive amount of dielectric lubricant to the connector as shown, as hydrolock may result when attempting to mate the connector.

3. With a one-inch nylon bristle brush, apply dielectric lubricant to both the module/component side and the harness side of the affected connector.
 4. Reconnect the affected connector and wipe away any excess lubricant that may be present.
 5. Attempt to duplicate the condition by using the following information:
 - DTC Diagnostic Procedure
 - Circuit/System Description
 - Conditions for Running the DTC
 - Conditions for Setting the DTC
 - Diagnostic Aids
 - Circuit/System Verification
- ⇒ If the condition cannot be duplicated, the repair is complete.
 ⇒ If the condition can be duplicated, then follow the appropriate DTC, Symptom or Circuit/System Testing procedure. Refer to SI.
