# Service Bulletin

Bulletin No.: PI1126E

**Subject:** Blank Screen After Startup and Reverse, Rearview Camera Message On, Touch Screen Inoperable, Bluetooth® and Navigation Concerns

**Models:** 2014 Buick LaCrosse, Regal  
 2013-2014 Cadillac ATS, SRX, XTS  
 2014 Cadillac CTS Sedan (VIN A), ELR  
 2015 Cadillac Escalade Models  
 2014 Chevrolet Corvette, Impala (VIN 1), Silverado 1500  
 2015 Chevrolet Silverado, Suburban, Tahoe  
 2014 GMC Sierra 1500  
 2015 GMC Sierra, Yukon Models  
 Equipped with RPOs IO4, IO5, IO6

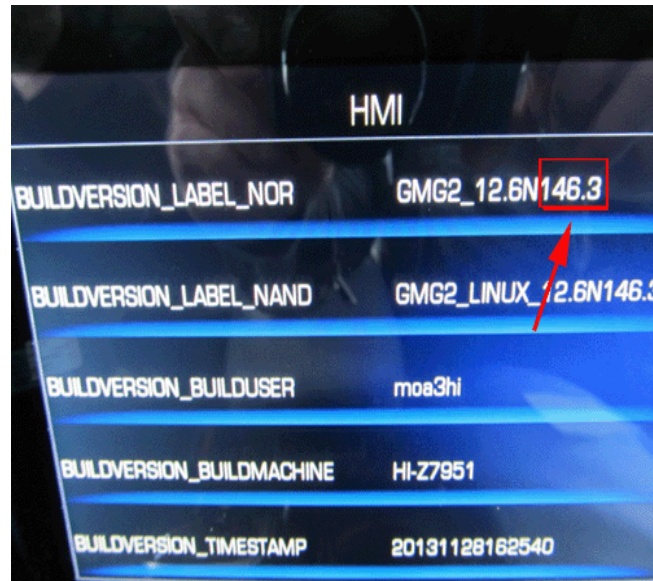
4033005

Before updating software, check the HMI build version. The HMI build version label should be GMG2.12.6N146.3 or earlier.

**Caution:** If the software version is GMG2.12.6N146.3 or lower proceed with this PI. If the version is higher, damage to the HMI module may occur. DO NOT PROCEED WITH THIS PI if the version is higher.
