#16-NA-014: Delayed Engagement After Sitting With Engine Off - (Jun 28, 2016)

Subject: Delayed Engagement After Sitting With Engine Off

North America and N.A. Export Regions

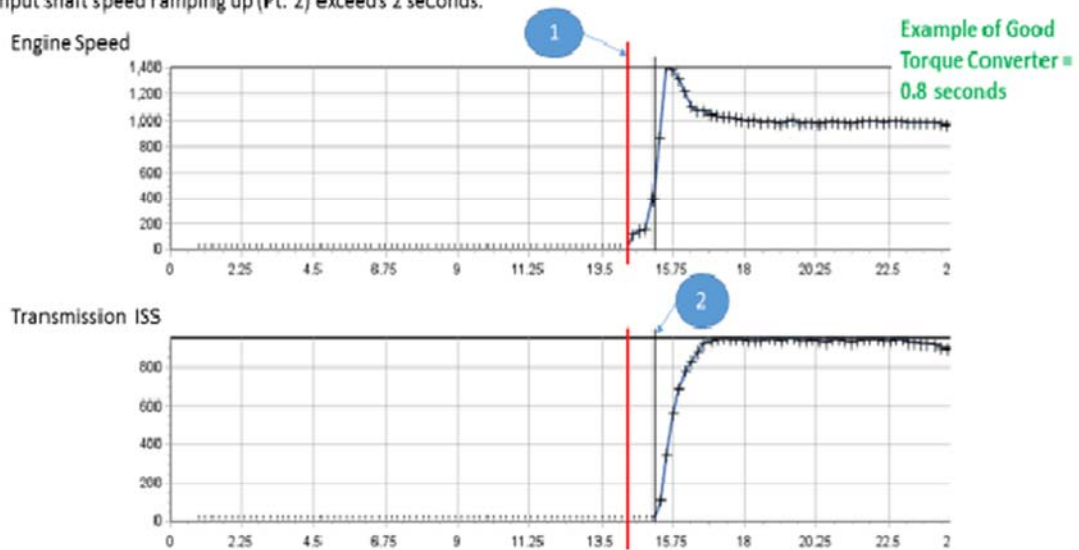
[Not Wanting to Move or Slips - Torque Converter Drain Back](#)

This condition may be caused by the torque converter draining the transmission fluid back into the transmission pan.

Torque Converter Drain Down is present if the time difference between engine speed ramping up (Pt. 1) and transmission input shaft speed ramping up (Pt. 2) exceeds 2 seconds.

If the customer describes the condition as a long engagement with a slip/soft engagement feel and/or the vehicle not wanting to move, the condition should be considered drain back and the following procedure should be followed.

1. Using GDS and monitor engine RPM and transmission Input Speed Sensor (ISS) prior to starting the engine.
2. Start the engine with the transmission in park.
 - ISS should be equal to engine RPM in 3 seconds or less.
 - If ISS takes more than 3 seconds to equal engine RPM than follow the procedure for replacing the stator shaft support described in the service procedure below.
 - *DO NOT* replace the stator shaft support on vehicles taking 3 seconds or less for turbine shaft speed to equal engine RPM.

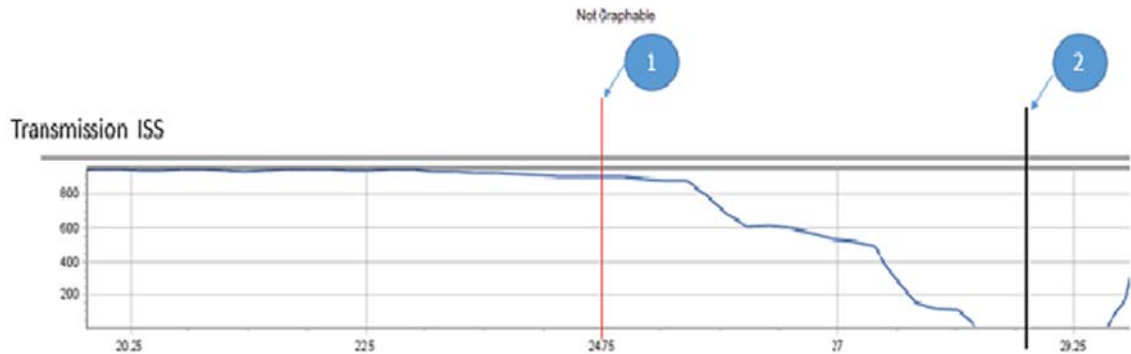
[Delayed Harsh Engagement - Clutch Slow to Fill](#)

Delayed Engagement into Reverse is present if the time difference between Gear Command (Pt. 1) and transmission input shaft speed reaching 0 rpms (Pt. 2) exceeds 1.5 seconds.

Example of C5 Needing to complete Adaptive Learn and several garage shifts in the temperature range of 20 – 30 deg C. = 3.34 seconds.

For 2016 MY vehicle attempt to learn the C5 Clutch using the following procedure:

1. Allow the transmission sump temperature to rise between 20 and 30 degrees C (68 and 86 degrees F).

2. Perform 20 Park to Reverse shifts releasing the brake with each shift.

If the learn procedure does not correct the condition contact GM TAC for review and additional instructions. Prior to contacting TAC record a GDS2 Session log of the delayed engagement.

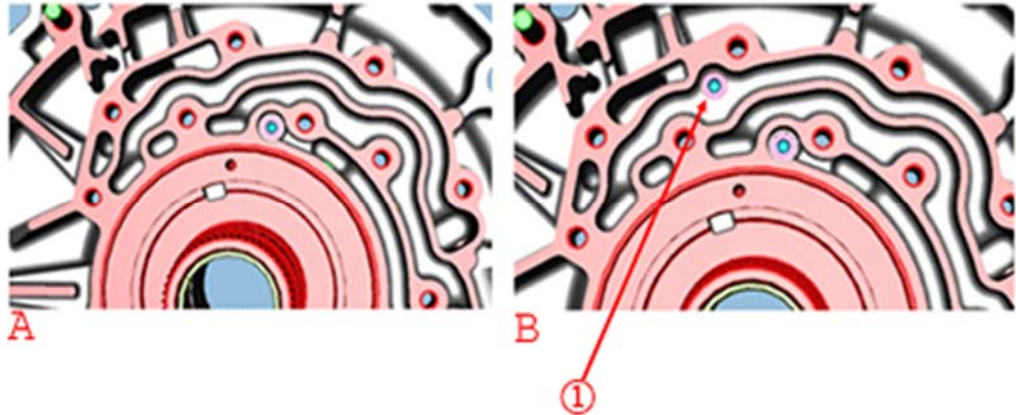
- (A) Old stator support asm
- (B) New stator support asm

Note: The new stator shaft support assembly has a second check ball (1) added (see illustrations).

Install a new stator shaft support assembly that includes an additional check ball. Follow the instructions below to replace the stator shaft support assembly.

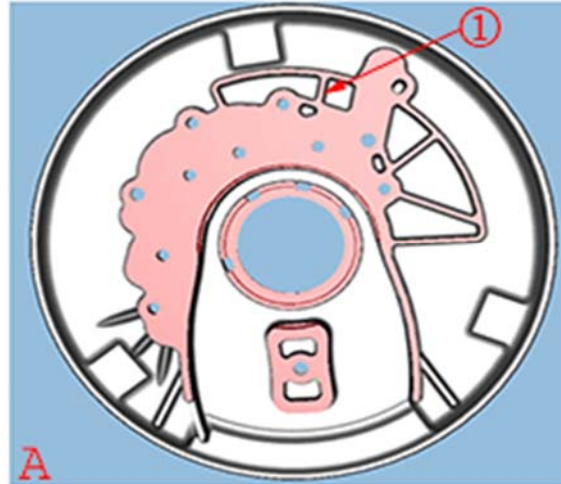
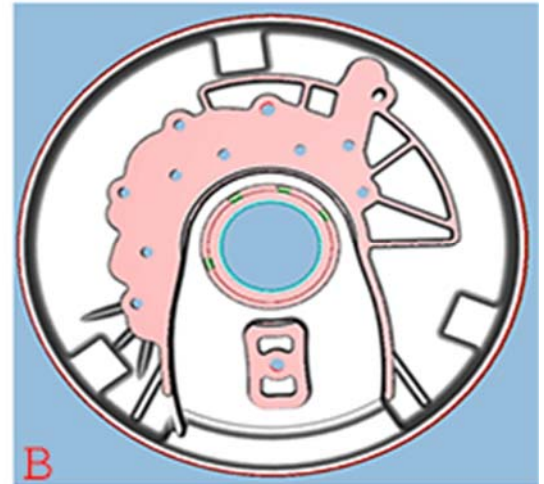
- (A) Old cover - 8L90 Only
- (B) New cover - 8L90 Only

Note: The casting void has been eliminated from the underside of the cover for the 8L90 only (see illustration). The 8L45 is not required.
