## 2015 - 2016 Corvette: Service Bulletin: #16-NA-014: Delayed Engagement After Sitting With Engine Off

# #16-NA-014: Delayed Engagement After Sitting With Engine Off - (Jun 28, 2016)

**Subject:** Delayed Engagement After Sitting With Engine Off

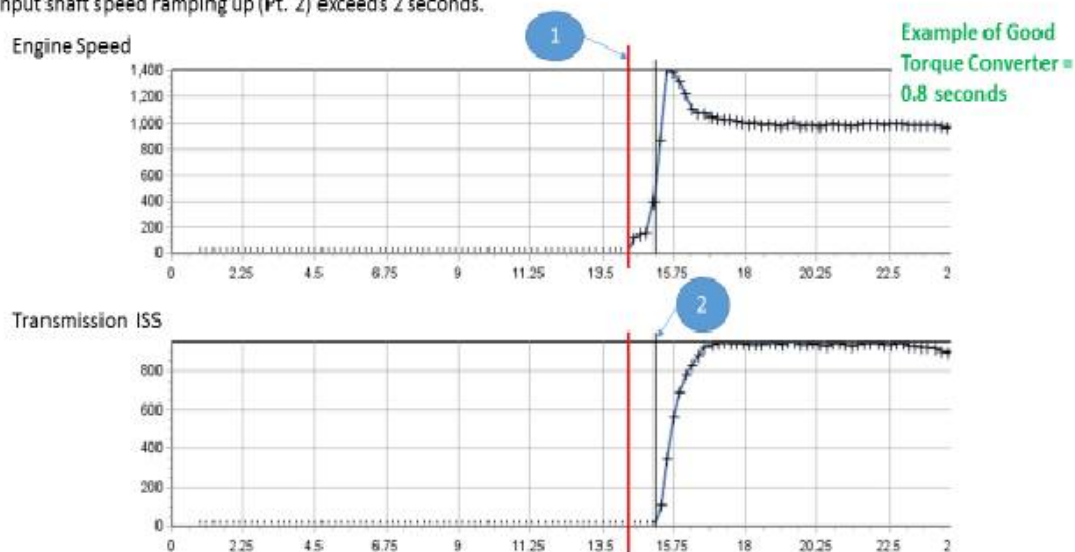
Torque Converter Drain Down is present if the time difference between engine speed ramping up (Pt. 1) and transmission input shaft speed ramping up (Pt. 2) exceeds 2 seconds.

The slide bar on the bottom of GDS 2 screen can be used to aid in discerning time.

If the customer describes the condition as a long engagement with a slip/soft engagement feel and/or the vehicle not wanting to move, the condition should be considered drain back and the following procedure should be followed.

1. Using GDS and monitor engine RPM and transmission Input Speed Sensor (ISS) prior to starting the engine.
2. Start the engine with the transmission in park.
  - o ISS should be equal to engine RPM in 3 seconds or less.
  - o If ISS takes more than 3 seconds to equal engine RPM than follow the procedure for replacing the stator shaft support described in the service procedure below.
  - o *DO NOT* replace the stator shaft support on vehicles taking 3 seconds or less for turbine shaft speed to equal engine RPM.

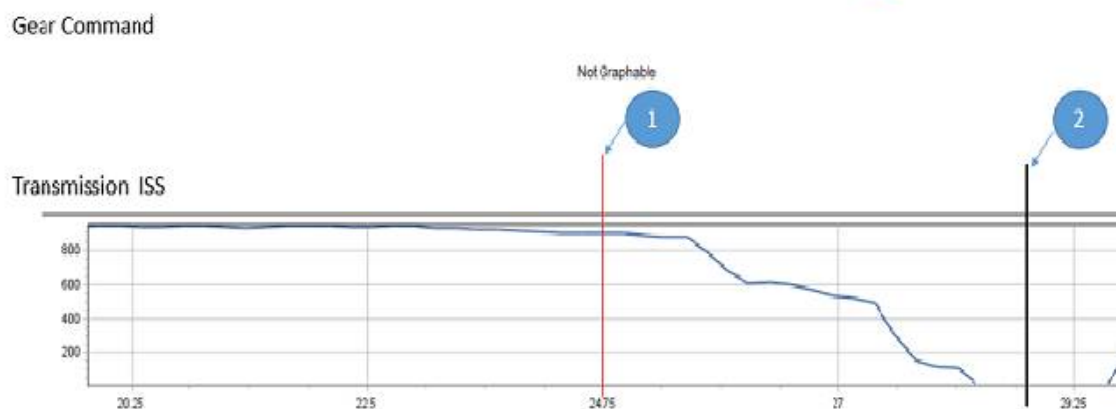
**Delayed Engagement into Reverse** is present if the time difference between Gear Command (Pt. 1) and transmission input shaft speed reaching 0 rpms (Pt. 2) exceeds 1.5 seconds.

**Example of C5 Needing to complete Adaptive Learn and several garage shifts in the temperature range of 20 – 30 deg C. = 3.34 seconds.**

*The slide bar on the bottom of GDS 2 screen can be used to aid in discerning time.*

If the customer describes the condition as a long engagement time with a harsh or bump engagement feel when shifting the vehicle from park to drive or reverse. Using GDS and monitor engine RPM and transmission Input Speed Sensor (ISS) prior to starting the engine. Start the engine with the engine in park. ISS should equal engine RPM in 3 seconds or less. If ISS takes more than 3 seconds to equal engine RPM then follow the procedure for replacing the stator shaft support. If the ISS is equal to engine RPM in 3 seconds or less shift the vehicle from park to drive or reverse leaving the service brake applied. ISS should drop to zero "0" within 2 seconds, this is clutch engagement time. Recording a GDS session log can be useful in diagnosing this condition.

For 2015 MY vehicles Contact GM TAC for review and additional instructions. Prior to contacting TAC record a GDS2 Session log of the delayed engagement.

For 2016 MY vehicle attempt to learn the C5 Clutch using the following procedure:

1. Allow the transmission sump temperature to rise between 20 and 30 degrees C (68 and 86 degrees F).  
**Note:** Do NOT apply the accelerator pedal.

2. Perform 20 Park to Reverse shifts releasing the brake with each shift.

If the learn procedure does not correct the condition contact GM TAC for review and additional instructions. Prior to contacting TAC record a GDS2 Session log of the delayed engagement.

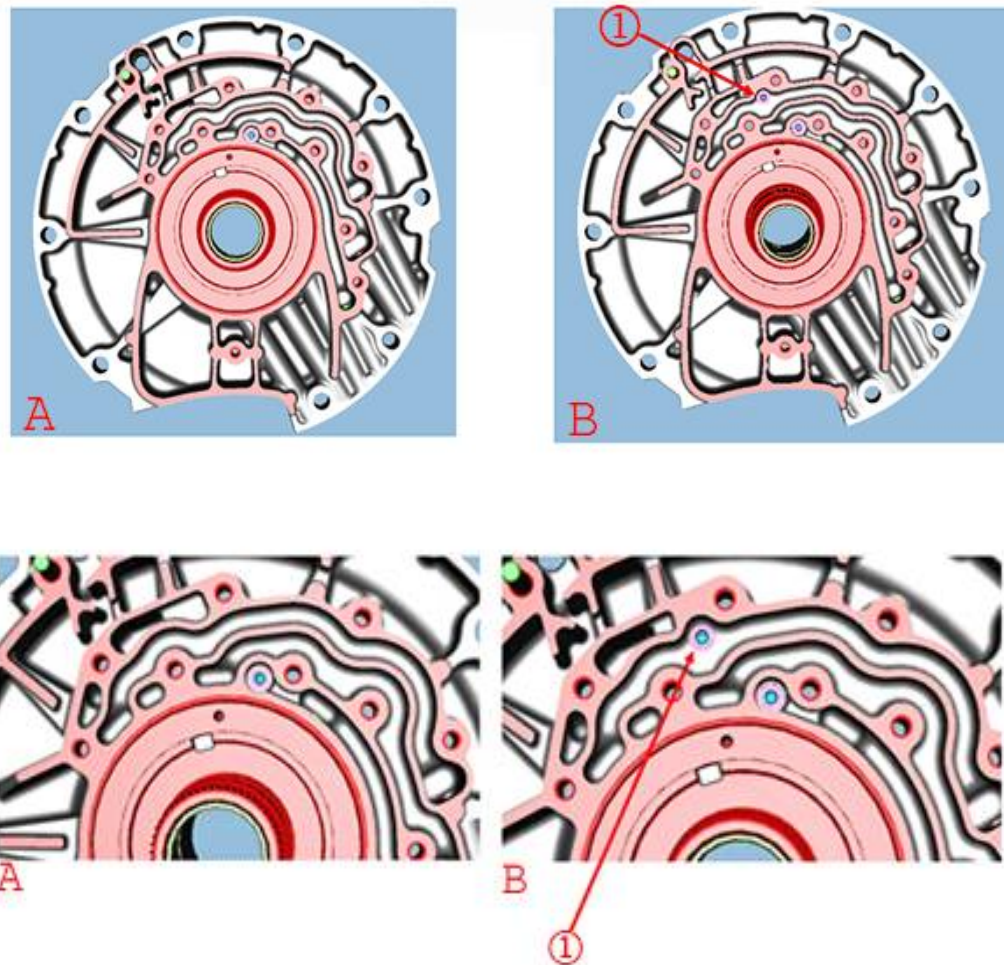
(A)Old stator support asm  
(B)New stator support asm

**Note:** The new stator shaft support assembly has a second check ball (1) added (see illustrations).

Install a new stator shaft support assembly that includes an additional check ball. Follow the instructions below to replace the stator shaft support assembly.

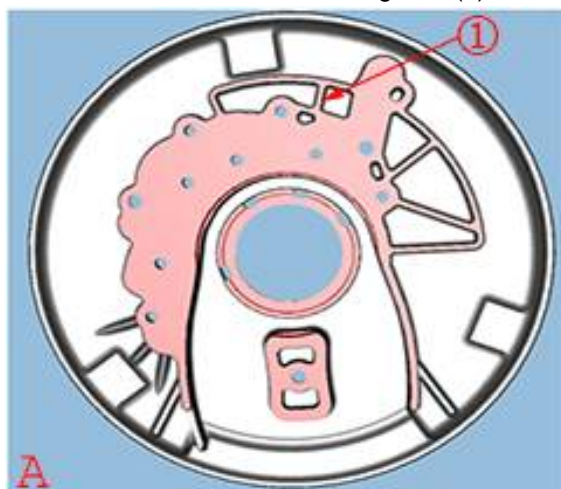
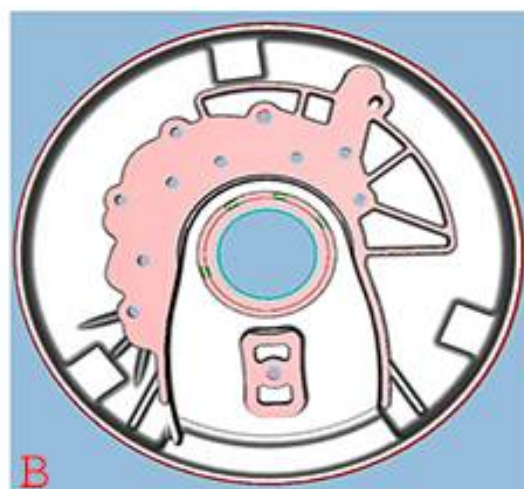
(A) Old cover - 8L90 Only

(B) New cover - 8L90 Only

**Note:** The casting void has been eliminated from the underside of the cover for the 8L90 only (see illustration). The 8L45 is not required.
