SHAKE AND/OR SHUDDER DURING LIGHT THROTTLE ACCELERATION BETWEEN 25 AND 80 MPH (40 AND 128 KM/H) AT A STEADY STATE

#16-NA-175: Shake and/or Shudder During Light Throttle Acceleration Between 25 and 80 MPH (40 and 128 KM/H) at a Steady State - (Oct 10, 2018)

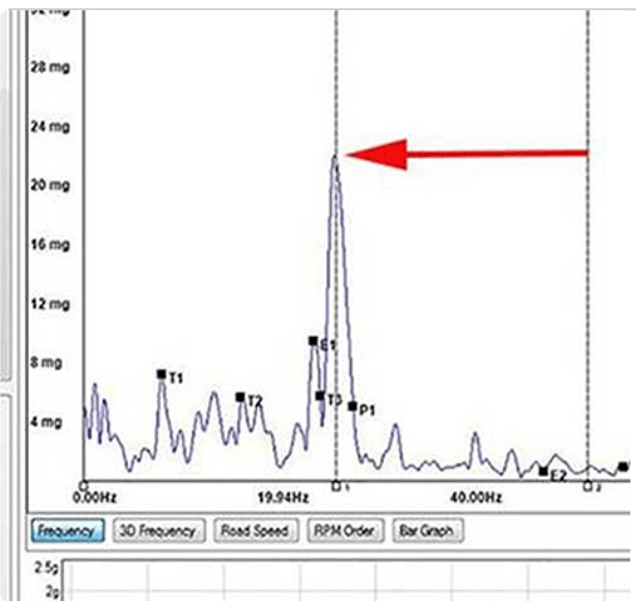
To confirm TCC Shudder, record the PicoScope data while driving in 8th gear in the application specific condition above. Minimize extraneous vibration input by testing on a smooth road and correct any other known vehicle vibration issues (tires, brakes, etc.) before conducting test. If TCC Shudder is present, a vibration peak will appear (highlighted by arrow below) within ± 2 Hz of the frequency listed in the table above. TCC Shudder vibration frequency is stationary in 8th gear. If the vibration frequency follows vehicle speed or engine speed, then it is NOT TCC Shudder.

In the above illustration, frequency and default view have been selected.
