Service Bulletin

Bulletin No.: 08-08-67-013H

Subject: Snap, Pop, Creak or Rattle Noise from Lift Off Roof Panel While Driving
(Verify Condition and Perform Appropriate Repairs)

Models: 2005-2013 Chevrolet Corvette
Equipped with Removable Clear Roof Panel RPO CC3, Removable Sun Roof Panel
RPO CF7 or Dual Removable Roof Panels RPO C2L

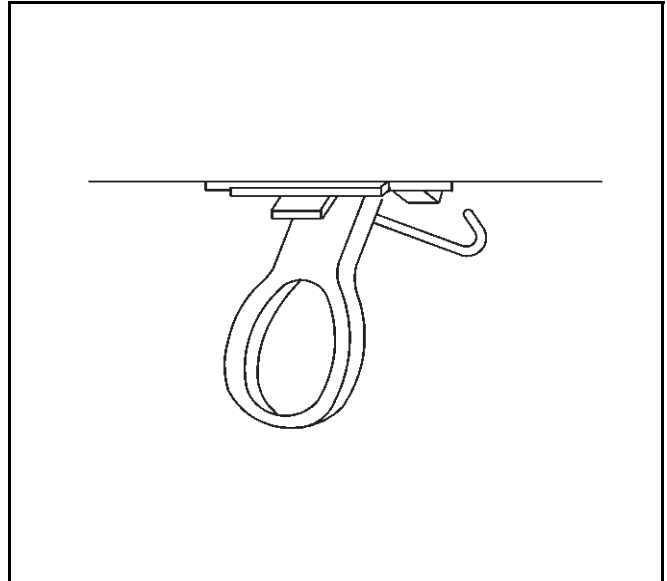
167241

- Insufficient clearance between the lift off roof panel and the leading edge of the rear roof bow.
- Possible crack at the rear edge of the lift off roof panel.
- Insufficient tension on the roof rear latching mechanism.

1. Verify there is sufficient gap, and that the lift off roof panel is not hitting the leading edge of the rear roof bow. If this condition exists, adjust the roof panel. Refer to Roof Lift Off Panel Adjustment in SI.
2. Inspect the rear edge of the lift off roof panel for cracks or chips. If a roof panel is dropped, or has been set down hard on the rear edge, it may crack the edge and cause a noise.

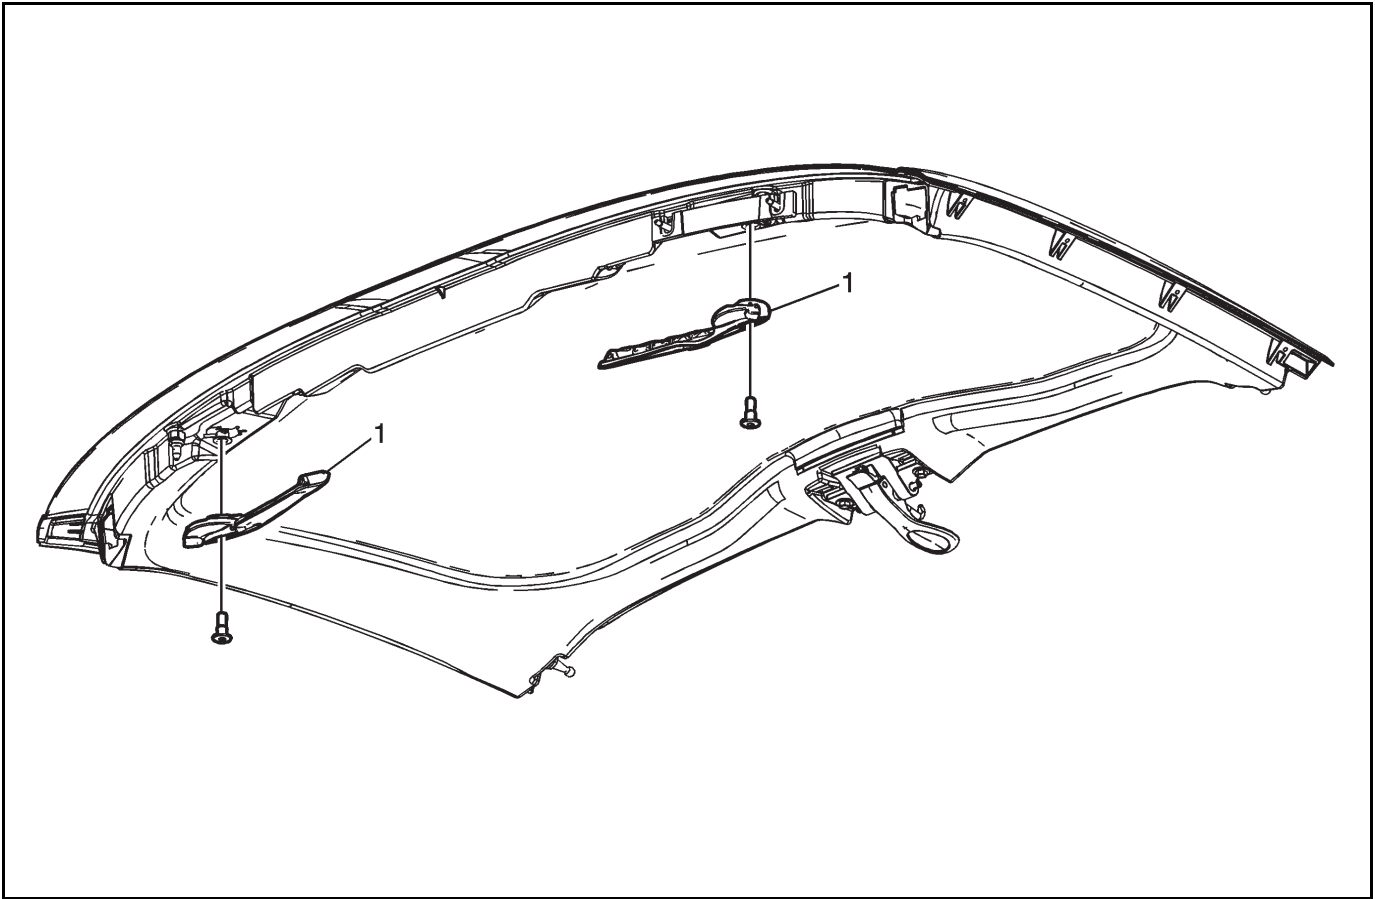
2128668

This condition may be caused by the nylon roller/slide block inside the left and/or right front roof panel latching handle becoming loose and causing the roller to move on the pin, creating the noise.

Important: For any latch handle replacement, use only P/N 19206591 (left) and P/N 19206592 (right). These current handles have a revised roller that was redesigned so it does not roll, but now slides across the latch receiver. All 2009-2013 removable roofs (painted and transparent) have the new handle design. **Handles should not be changed for vehicles built after the beginning of production for the 2009 model year.**
