## #16-NA-175: Shake and/or Shudder During Light Throttle Acceleration Between 25 and 80 MPH (40 and 128 KM/H) at a Steady State - (Oct 11, 2018)

Subject: Shake and/or Shudder During Light Throttle Acceleration Between 25 and 80 MPH (40 and 128 KM/H) at a Steady State

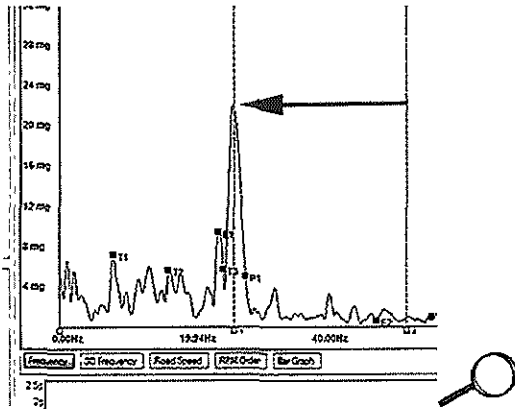
To confirm TCC Shudder, record the PicoScope data while driving in 8th gear in the application specific condition above. Minimize extraneous vibration input by testing on a smooth road and correct any other known vehicle vibration issues (tires, brakes, etc.) before conducting test. If TCC Shudder is present, a vibration peak will appear (highlighted by arrow below) within +/-2 Hz of the frequency listed in the table above. TCC Shudder vibration frequency is stationary in 8th gear. If the vibration frequency follows vehicle speed or engine speed, then it is NOT TCC Shudder.

In the above illustration, frequency and default view have been selected.
