#16-NA-175: Shake and/or Shudder During Light Throttle Acceleration Between 25 and 80 MPH (40 and 128 KM/H) at a Steady State - (Oct 11, 2018)

Subject: Shake and/or Shudder During Light Throttle Acceleration Between 25 and 80 MPH (40 and 128 KM/H) at a Steady State

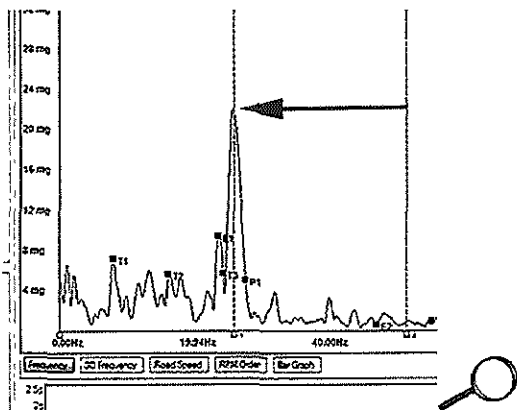
To confirm TCC Shudder, record the PicoScope data while driving in 8th gear in the application specific condition above. Minimize extraneous vibration input by testing on a smooth road and correct any other known vehicle vibration issues (tires, brakes, etc.) before conducting test. If TCC Shudder is present, a vibration peak will appear (highlighted by arrow below) within +/-2 Hz of the frequency listed in the table above. TCC Shudder vibration frequency is stationary in 8th gear. If the vibration frequency follows vehicle speed or engine speed, then it is NOT TCC Shudder.

In the above illustration, frequency and default view have been selected.
