#23-NA-115: Ticking, Tapping or Snapping Noise from Engine - 5.5L RPO LT6 Realign Camshaft Caps as Required - (Jun 28, 2023)

| Brand: | Model: | Model Year: | | VIN: | | Engine: | Transmission: |
|---|---|---|---|---|---|---|---|
| Chevrolet | Corvette | 2023 | 2023 | — | — | 5.5L (RPO LT6) | — |

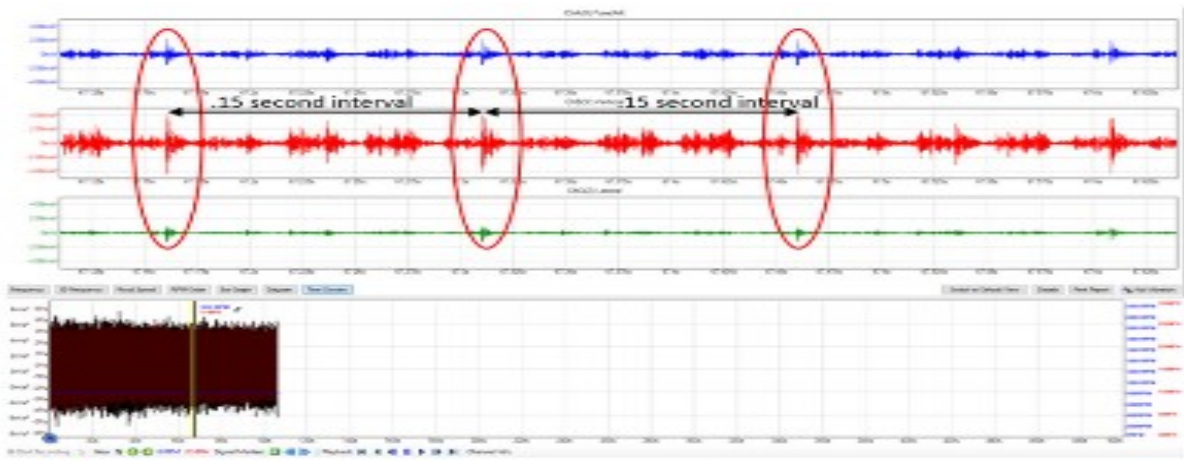
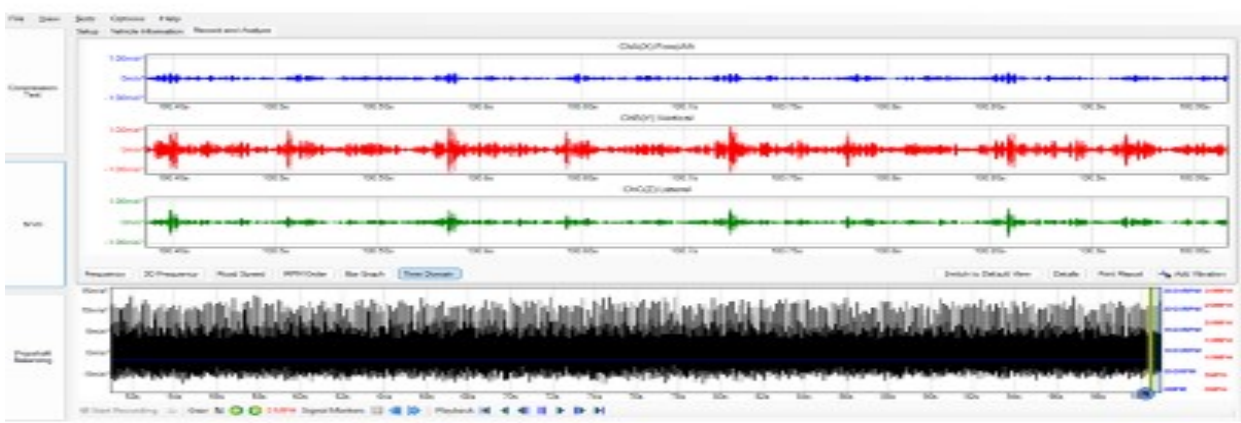
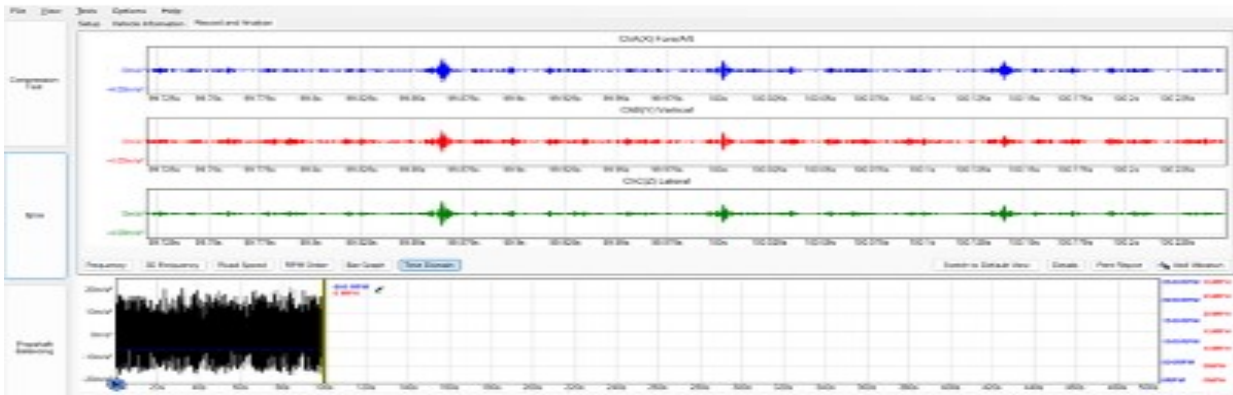
Examples of Tick:

- Right click in the time domain display and change the display mode to single.
- If scales on the left end for each channel are not ranging from $-4 m/s^2$ to $4 m/s^2$, right click in the time domain display and select "reset scale."
- Pull the yellow window cursors on the bottom in as close together as they will go.
- Look at the channel lines in the time domain window for ticks with a .15s gap between them.
⇒ Compare to the examples below for an engine with a tick and an engine without a tick:

Once it is determined which bank the noise is coming from, it will be necessary to follow the service procedure below to adjust the camshaft cap torque.
