283 CI Engine Build for Harmonic Balancer, Water Pump, Generator Pulleys & Brackets

I built a parts buck to show a stock 1959 - 1961 to help clear up confusion about brackets and pulleys. I will also show methods to help align the generator to the pulley system, as this design was not ideal and allows much movement during assembly, and some critical areas that must be observed. There are many photos and measurements shown to help visualize assembly.

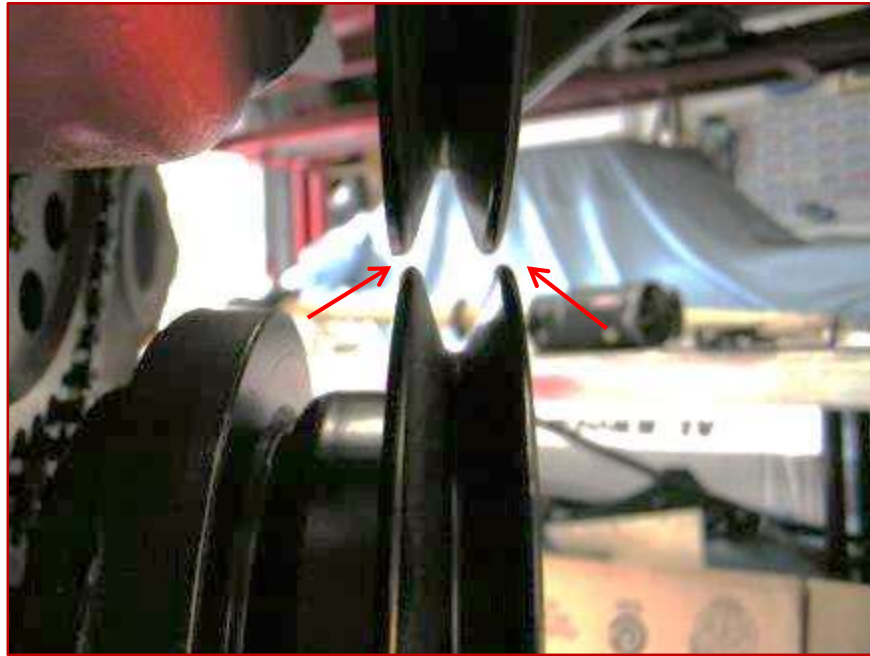
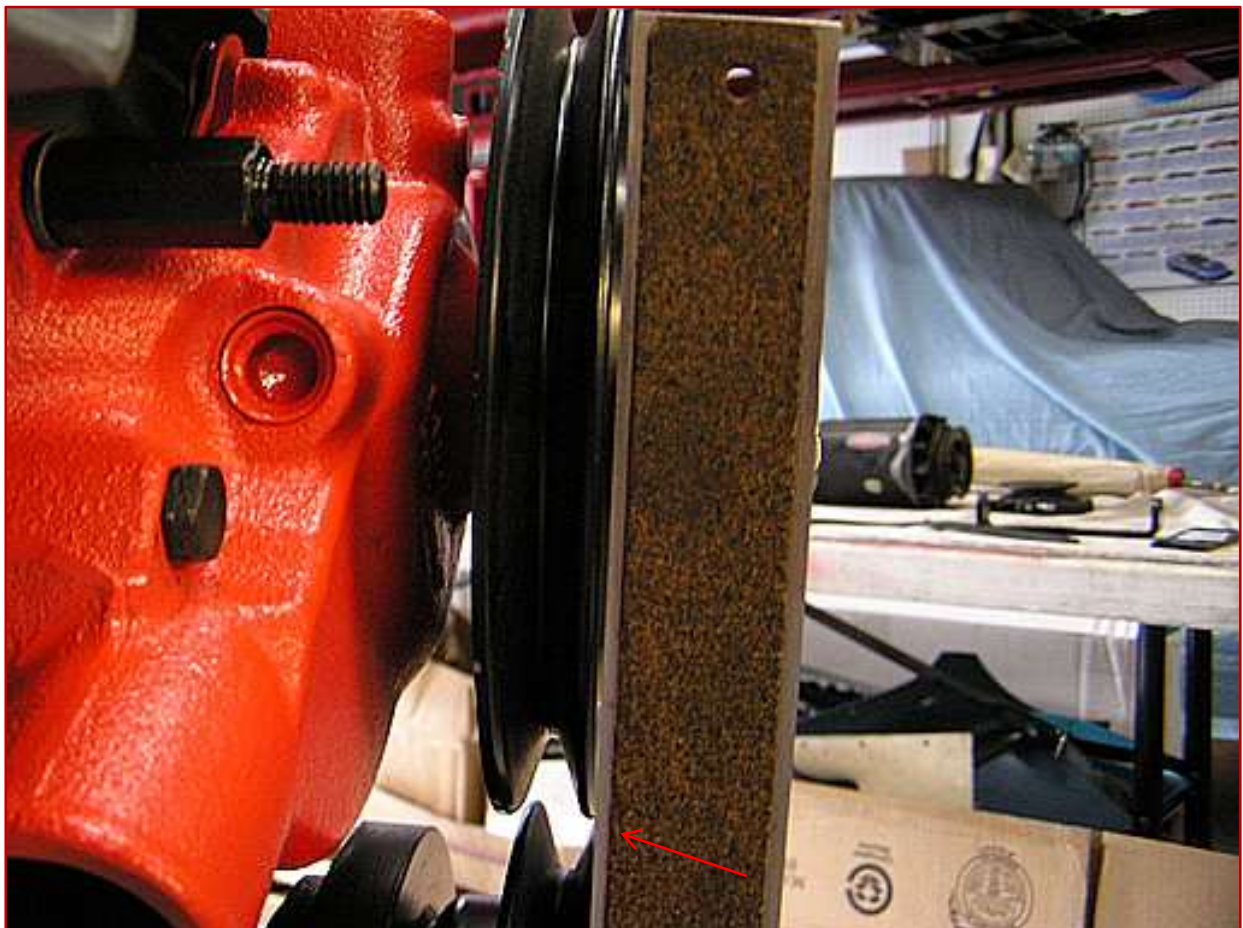
As you can see below, there is a mismatch of the HB pulley to the WP pulley. It's off by about 1/8". Why is this? Variations in pulleys, water pumps and their hubs, and varying gasket thickness can play a role in these tolerances. But there are ways to correct these anomalies.

Here I have added one additional WP pulley reinforcement to help get better pulley alignment. This may not have been done at original build, as it's costly for many cars, but in your case it may make your build easier and produce a better finished product.

Another alternative to alignment is more involved. The Water Pump Hub can be adjusted to match, or can be adjusted to correct rebuild shop errors when it was installed. In this case, the hub could be "Pulled" forward using a 3-jaw puller to make up the difference. Do this very slowly and carefully, as you do not want to pull it too far out. **Proceed in small steps and measure carefully between steps.**

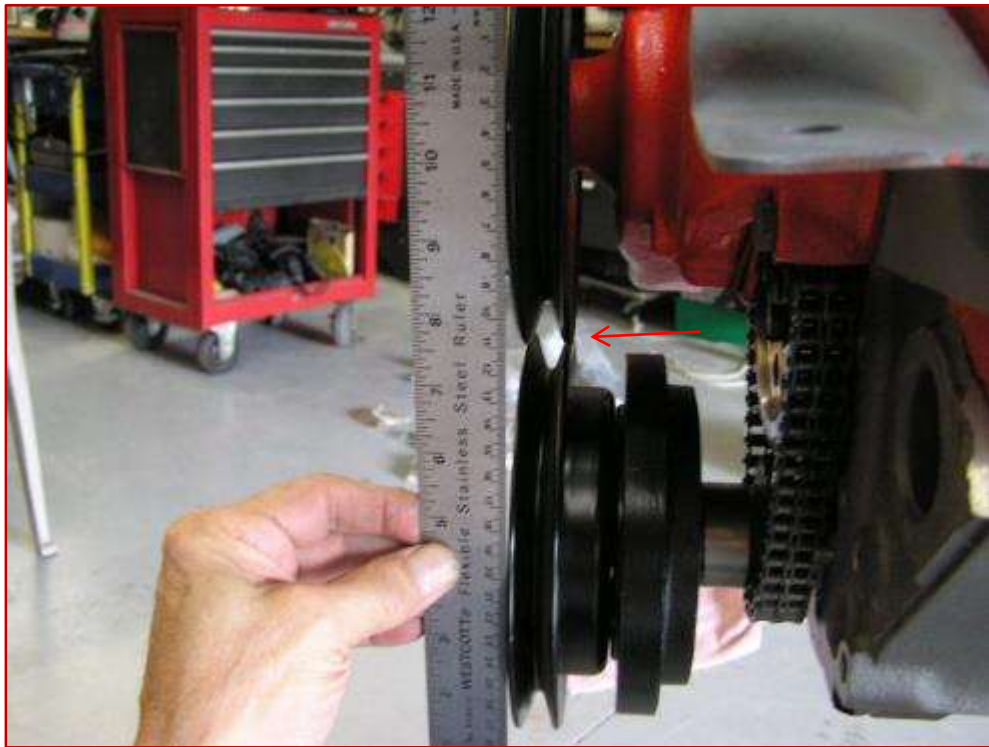
Now it's closer.

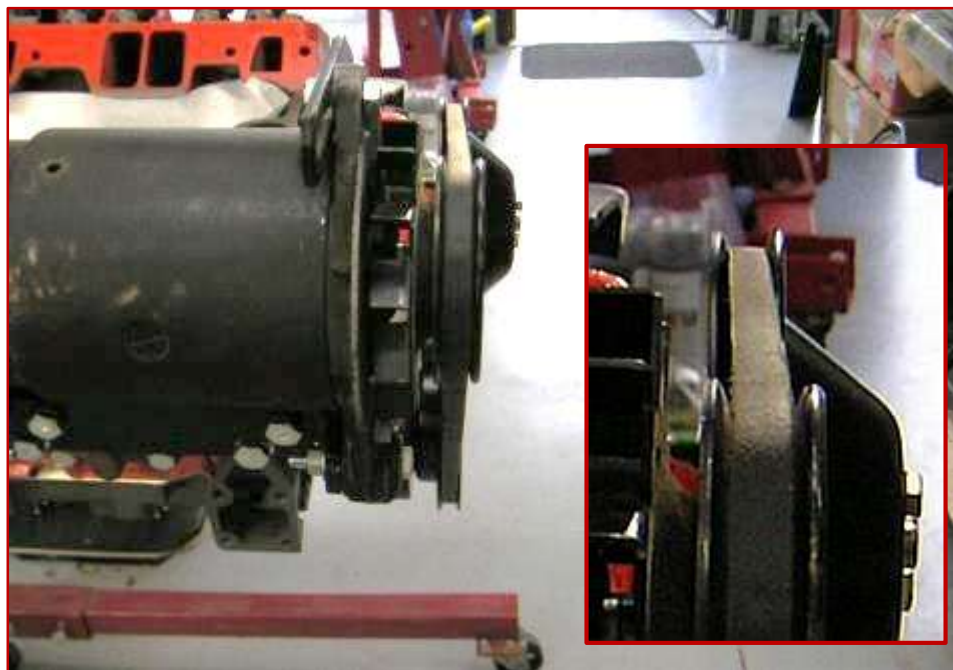
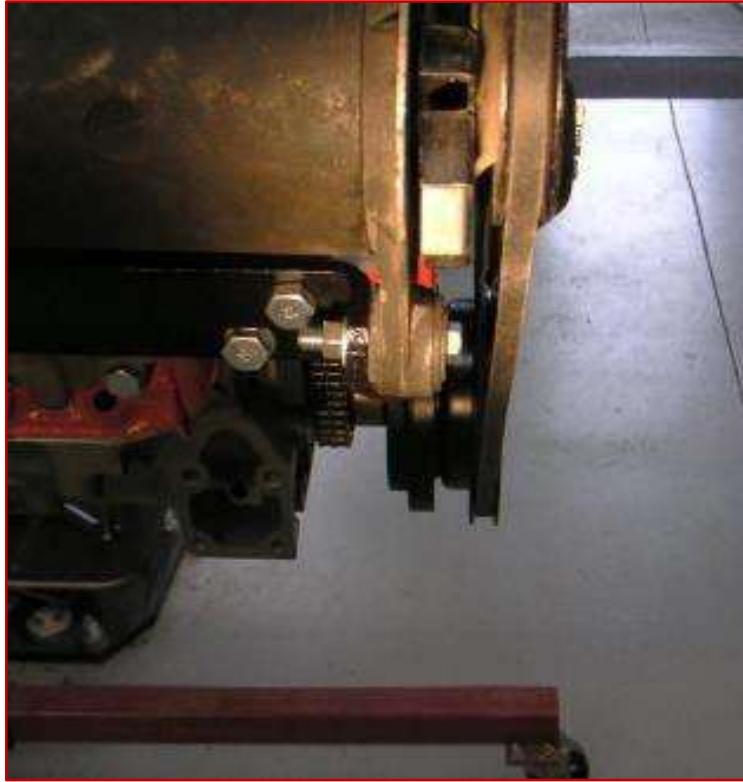
Here is the generator using the correct offset pulley again. It's off approx. 1/8" forward, measured using a straightedge as shown below. You can see the alignment error in the photo by looking at the belt as it exits the top of the generator pulley.

Note the rubber bushings on the lower mounts. One side has a flat outer ring. Insertion direction of these bushings in the generator end-frames can help offset small variances in the alignment. The pointer shows a ridge on one side of each bushing. Replacement bushings do not always have this feature. Because of this, the generator can move forward or rearward when tightening the adjustment brace while pulling the drive belt tight.

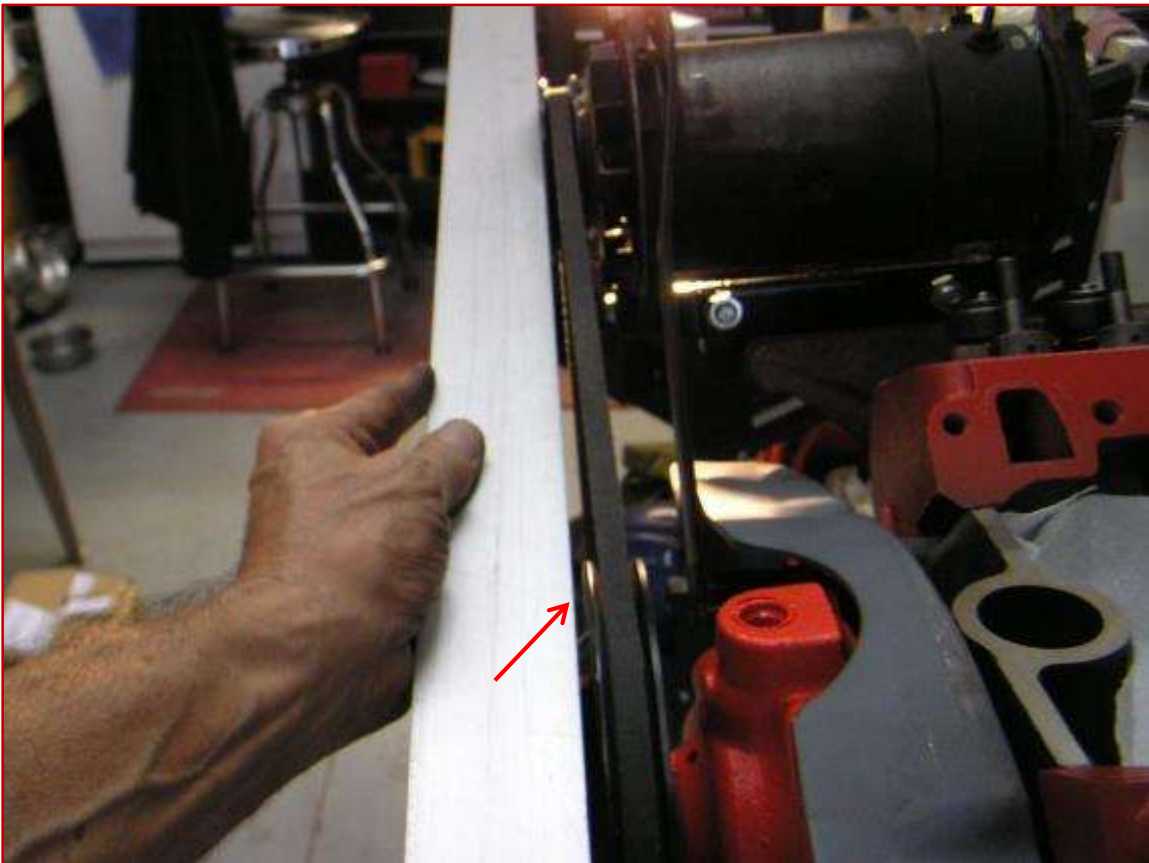
Here I've placed the straightedge against the generator pulley to see the alignment error at the WP pulley.

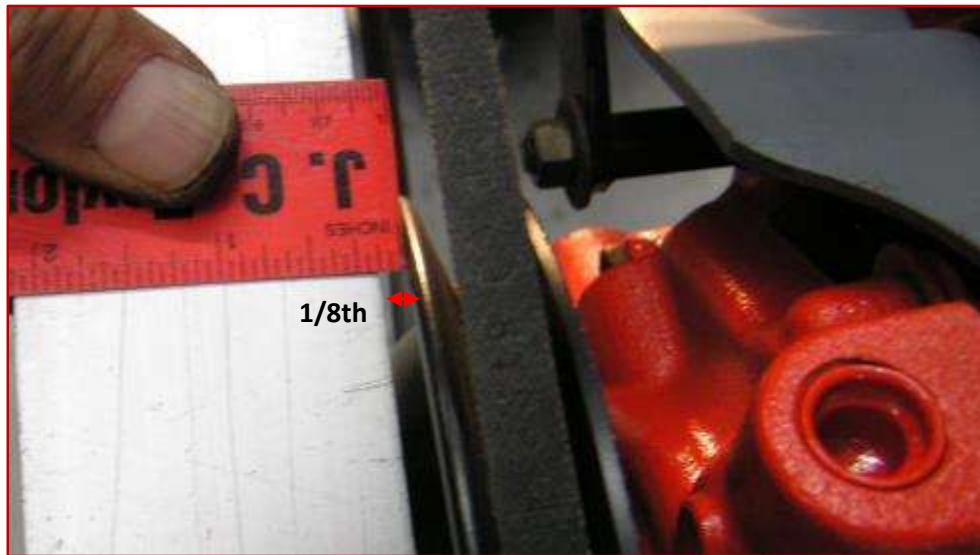
It's off approx. 1/8".

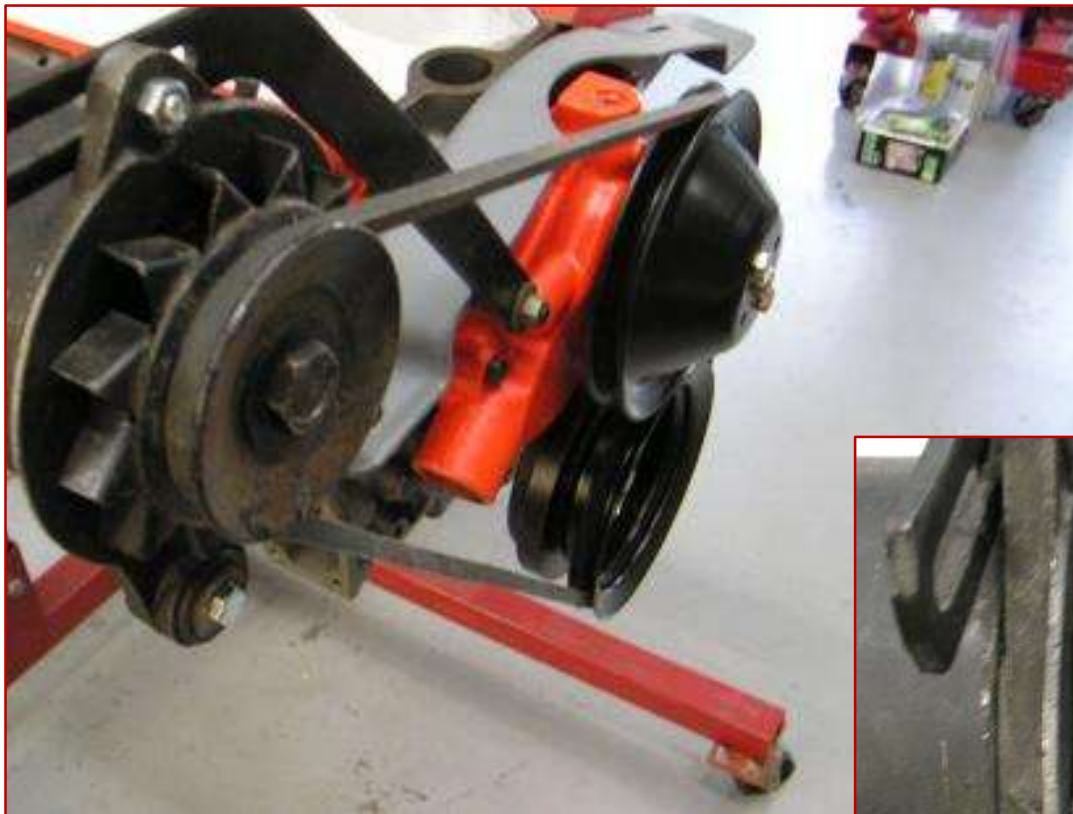
Here I've installed the NO-offset generator pulley as an experiment. It now shifts the alignment error rearward.

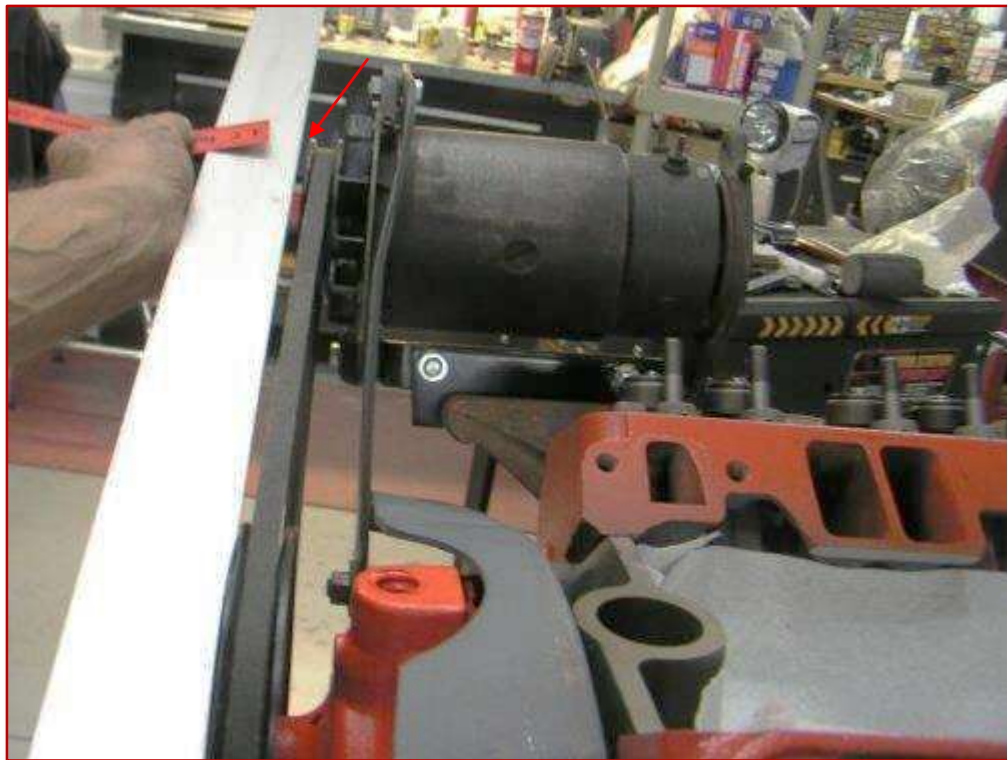
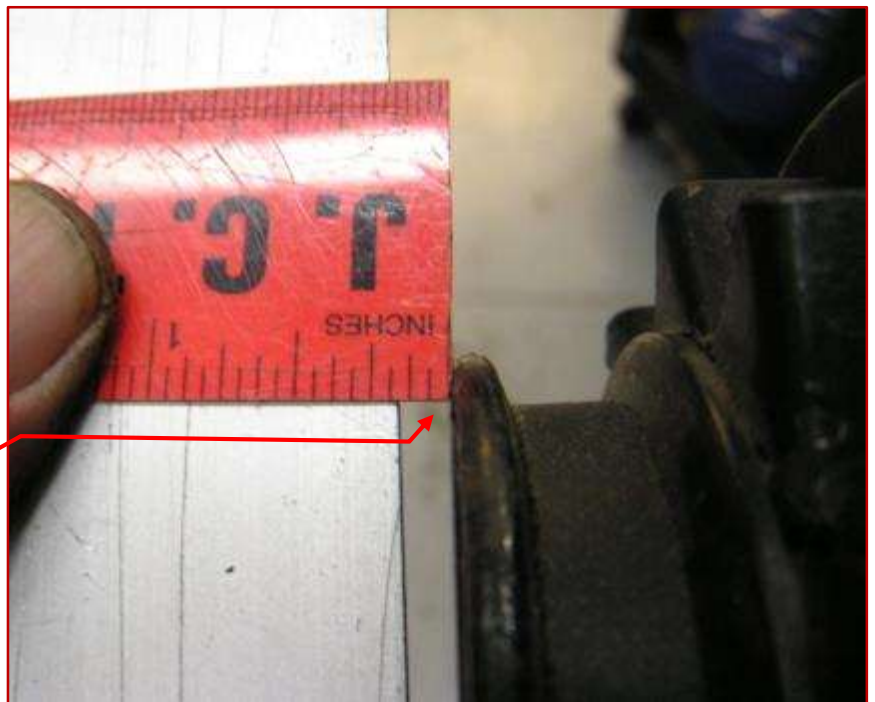
Approx. 3/16" error rearward using the **NO**-offset pulley.

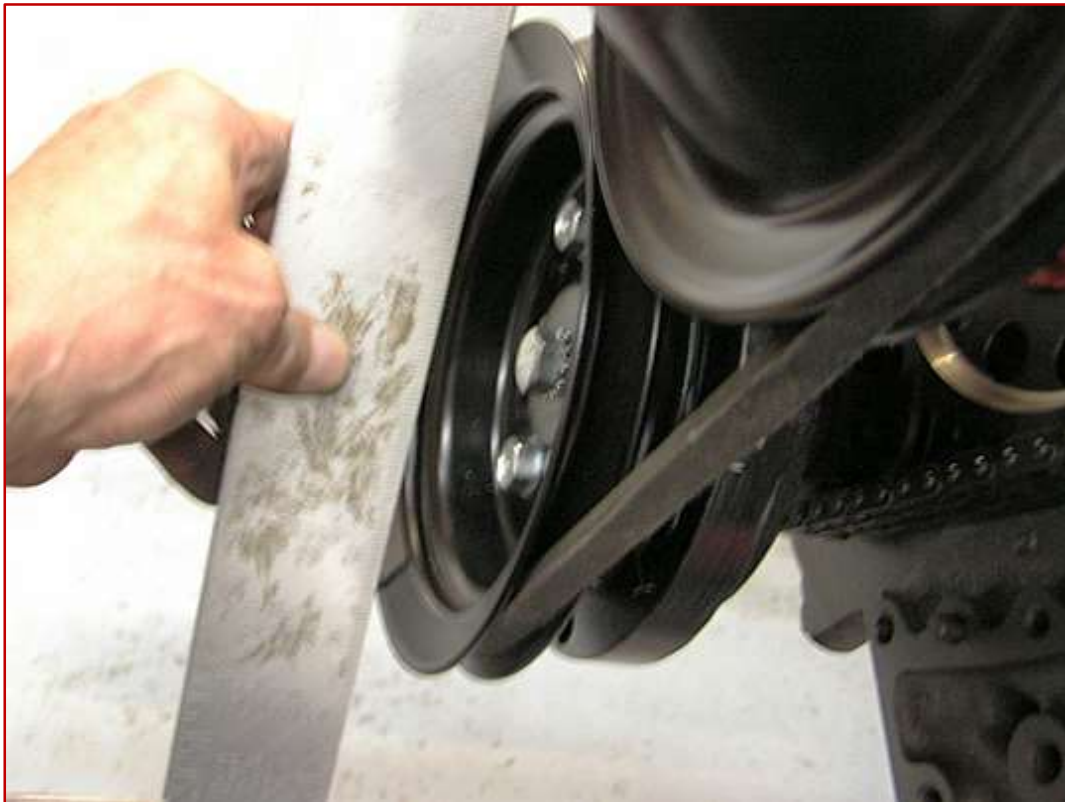
However, when the straightedge is placed between the HB pulley and generator pulley, a small error persists, this time forward.....

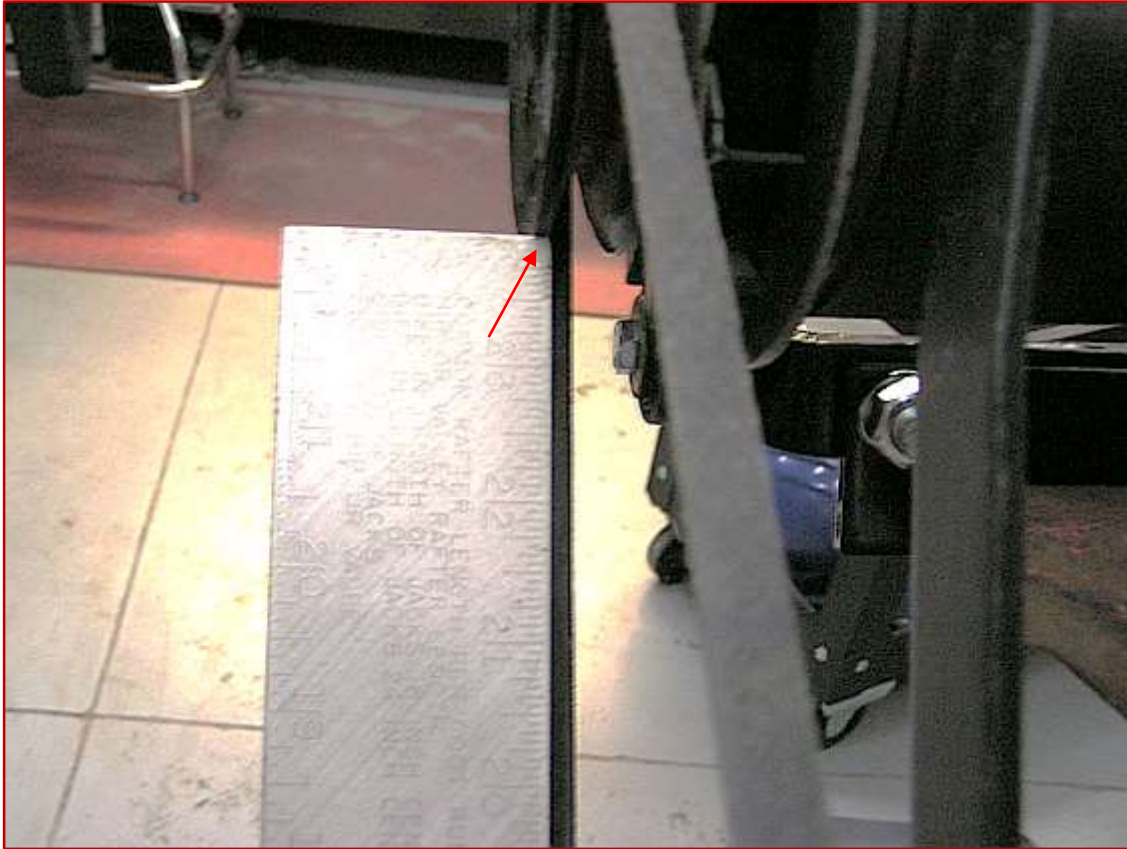
....as shown here.

Then by loosening the generator U-Bracket, and manifold bracket, as there is a small amount of play in the holes of those mounts, I was able to align the generator even closer to both pulleys.

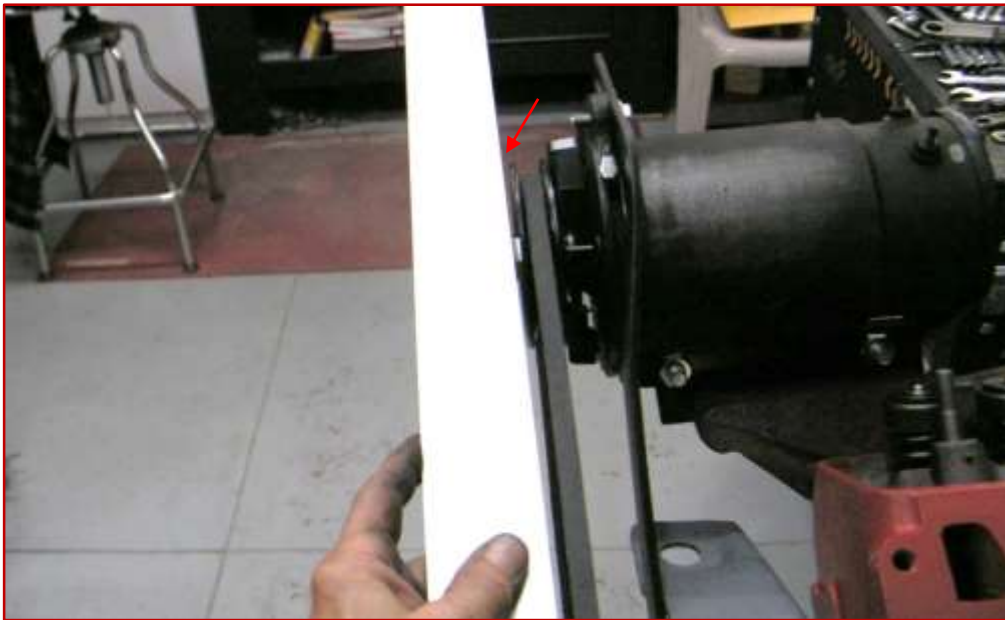
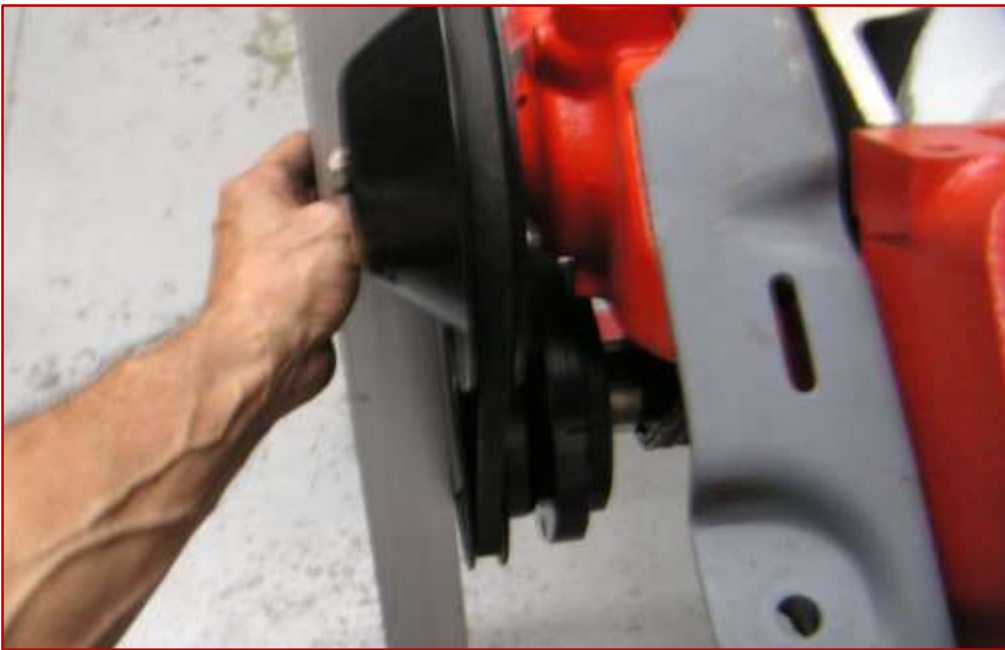
When first attached, alignment was off about 1/8"....

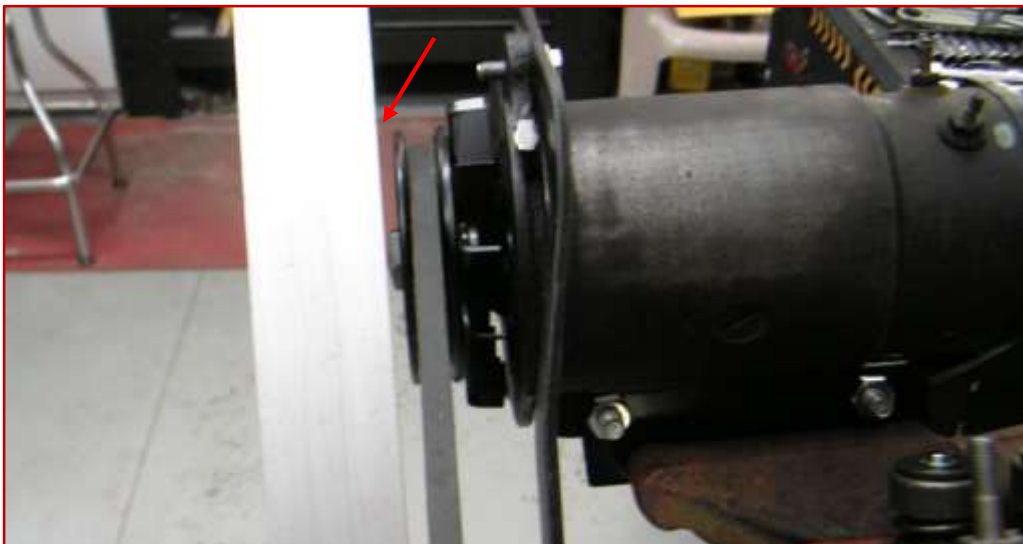
....as seen more closely here.

By loosening all bracket bolts, as well as the exhaust manifold bolts, and then pulling everything more forward before re-tightening, I'm able to bring the alignment in to near perfect.

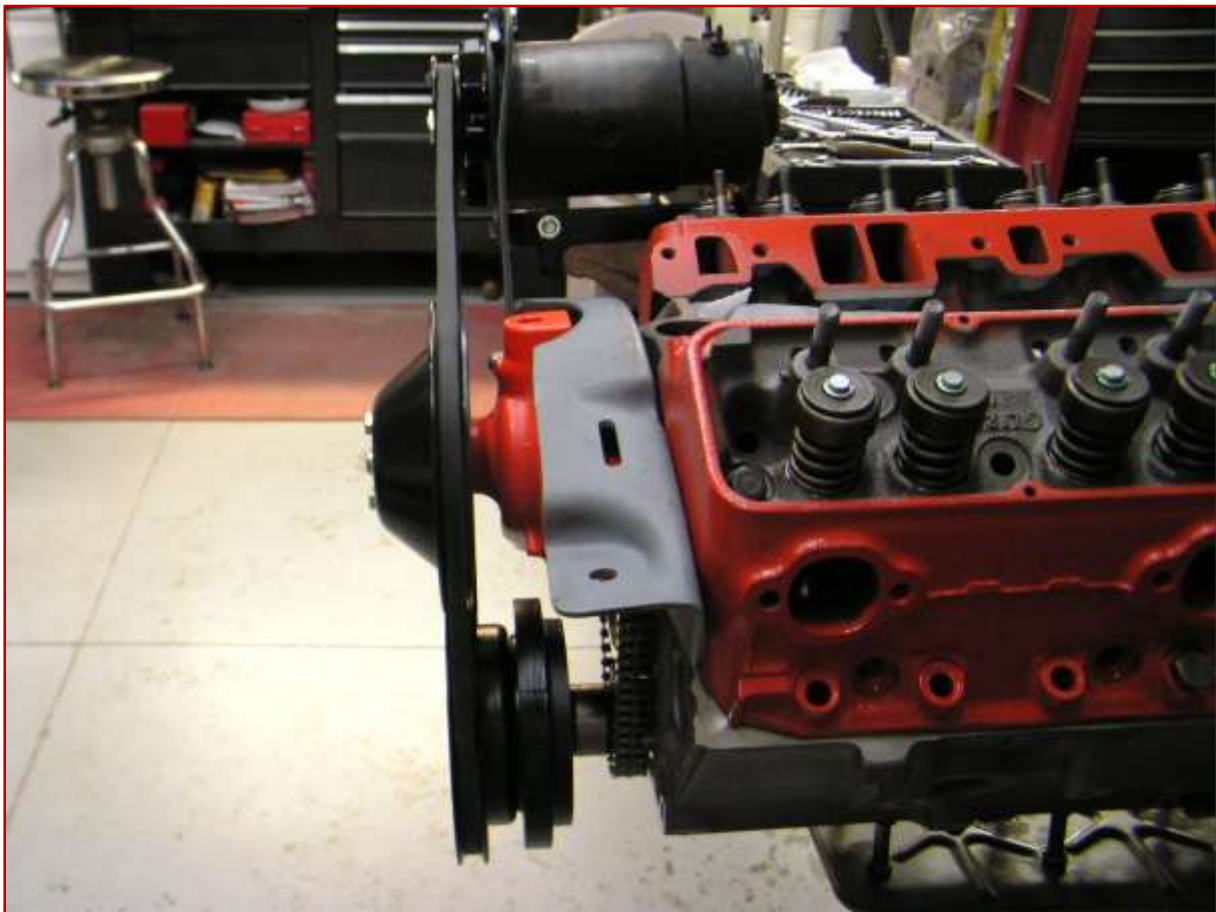
Here is the result of making minor adjustment to all generator mount points.
