Peening the hinge pivot rivet:

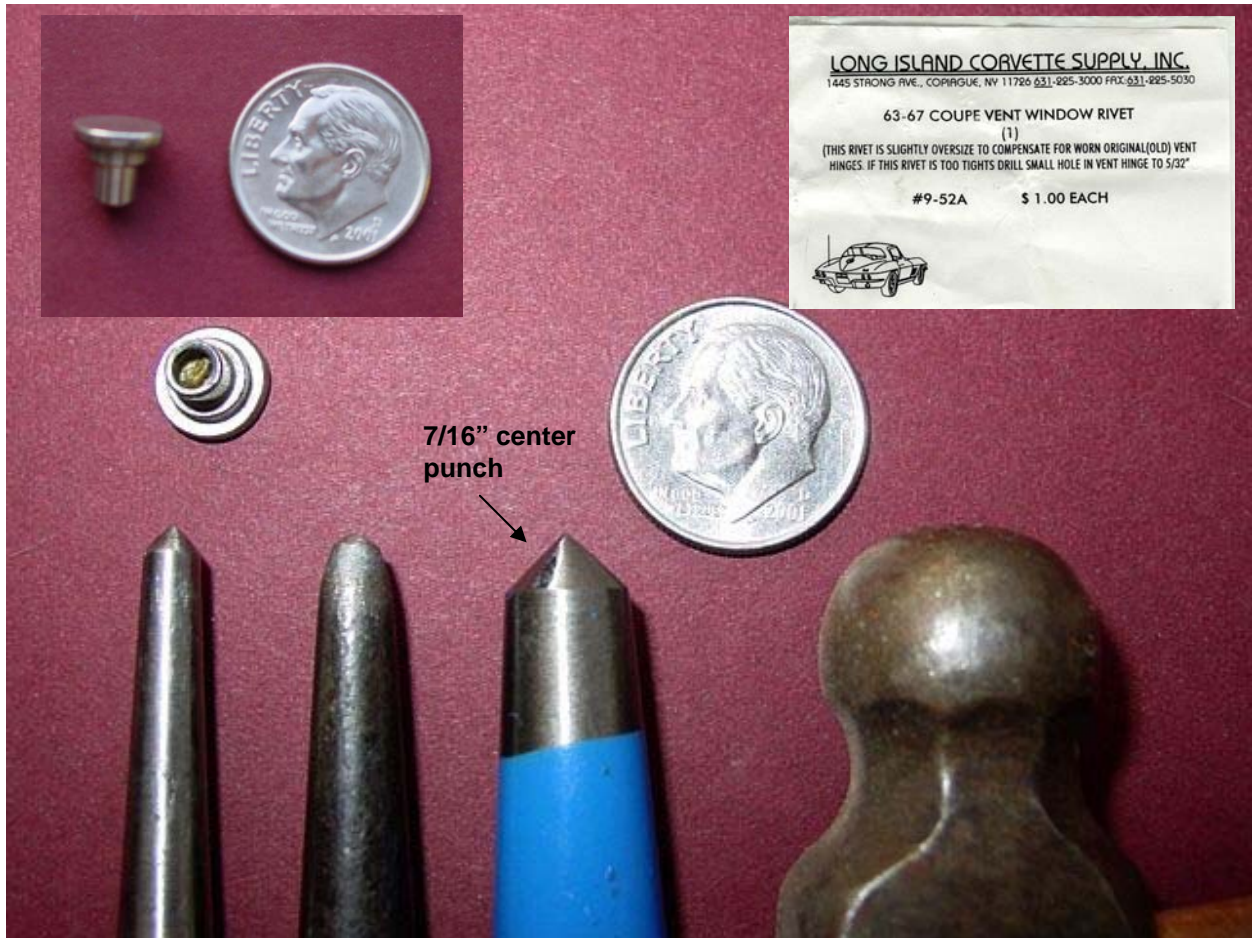
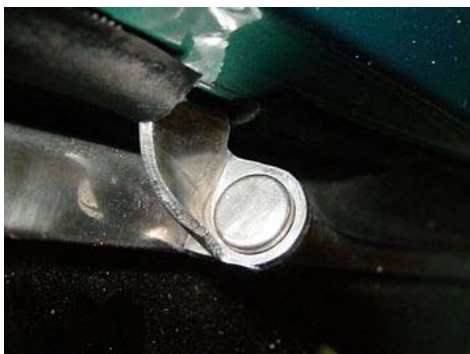
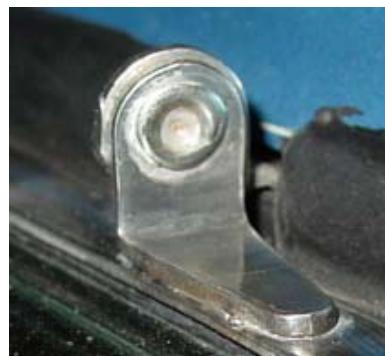
We used a series of punches, a small ball-peen hammer and finally a flat piece of bar stock. The vent window assembly was out of the car at the time. We were replacing the vent window rubber, all the window channel liners and a broken T-post on the vent window frame. The vent-window assembly was held upside down so the bottom of the rivet faced upward. We used a piece of rectangular steel bar-stock (approx. $\frac{1}{2} \times \frac{3}{4}$ ") mounted vertically in a vice to back up the rivet head. My wife held the assembly in the vertical position while I did the pounding. We gradually expanded the shank of the rivet using the punches and hammer above. The ball peen was used like a punch, i.e., struck with another hammer. Finally, we flattened the expanded shank with a piece of round bar-stock. Be sure to keep the hinge down around the "collar" of the rivet while striking the punches. This may not be the best way to do the job, but with patience, it worked for us.

If you can find or rent a rivet squeezer the job is probably a bit easier.
