10-1A-8 NOISE REDUCTION

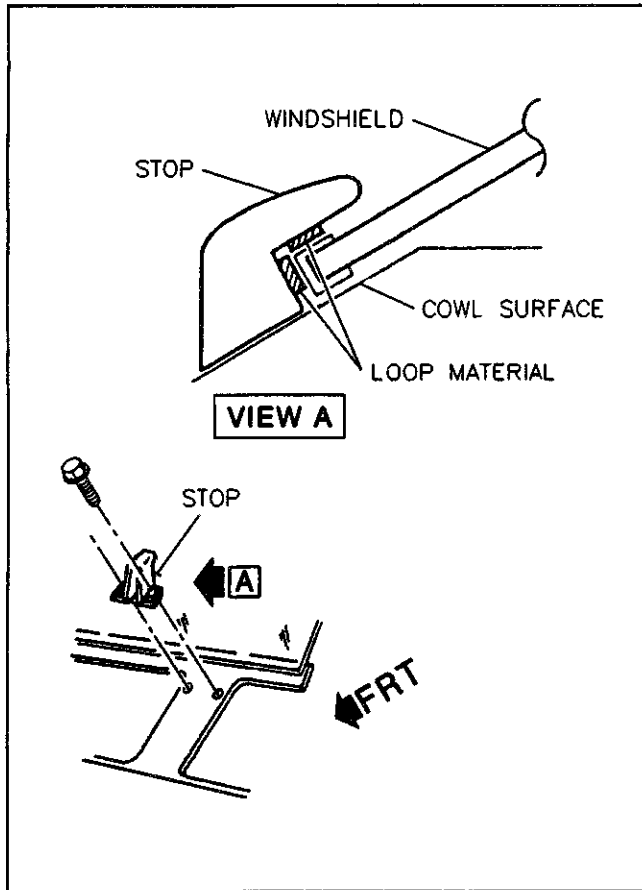
Figure 11 - Front of Vehicle—Windshield Wiper Stop

- Popping, light rattle at front of windshield.

- Windshield wiper park stop rubbing on edge of windshield.

- Remove stop and apply loop portion of hook and loop tape in two places as shown.
- Reposition stop for slight clearance.

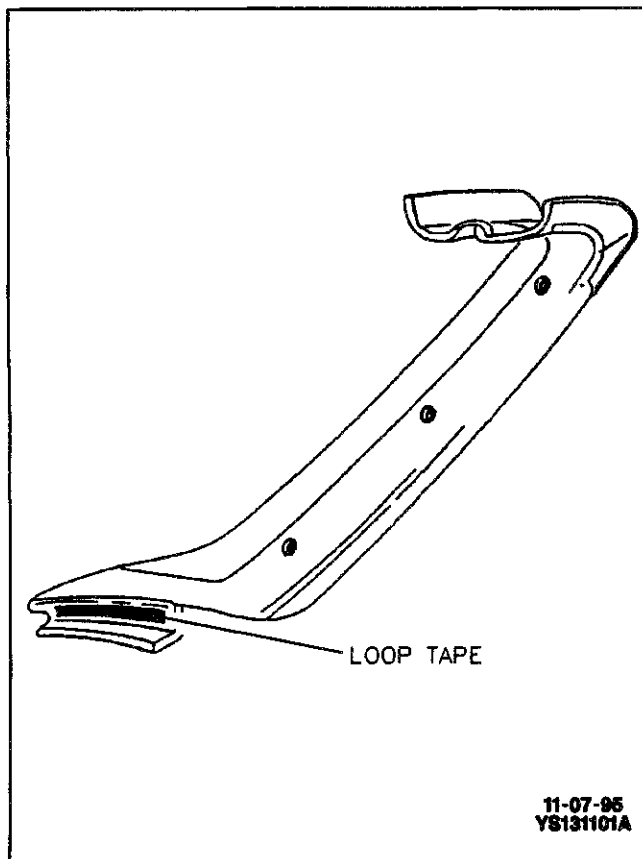
Figure 12 - Instrument Panel—A-Pillar Garnish Molding

- Itch coming from “A” pillar at front corner of Instrument Panel (I/P) upper trim pad.

- Garnish molding rubbing on I/P upper trim pad.
- Garnish molding contacting I/P carrier. Refer to Instrument Panel - Garnish Molding to Carrier Attachment.
- Door window rubbing “A” pillar weatherstrip. Refer to Door - Window to “A” pillar Weatherstrip.

- Remove garnish moldings and apply foam tape as shown.

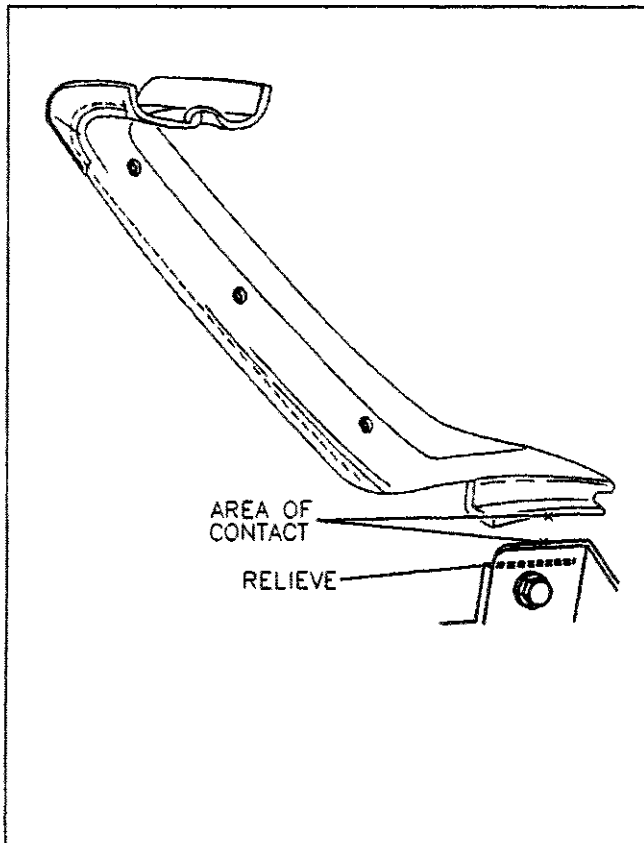
Figure 13 - Instrument Panel—Garnish Molding to Carrier Attachment.

- Itch from lower drivers side “A” pillar.

- Garnish molding contacting Instrument Panel (I/P) carrier upper attachment.

- Relieve upper edge of I/P carrier attaching tab to eliminate interference and isolate with felt tape.

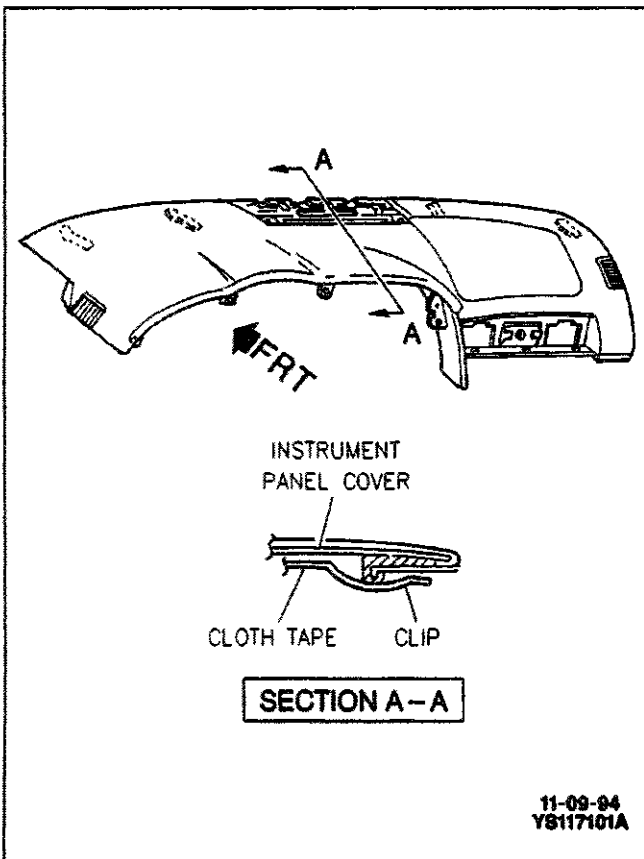
Figure 14 - Instrument Panel—Upper Trim Pad Retaining Clips

- Itch from Instrument Panel (I/P) upper trim pad at windshield.

- Trim pad retaining clips.

- Install cloth tape completely around each trim pad retaining clip. Use caution not to bend clips.

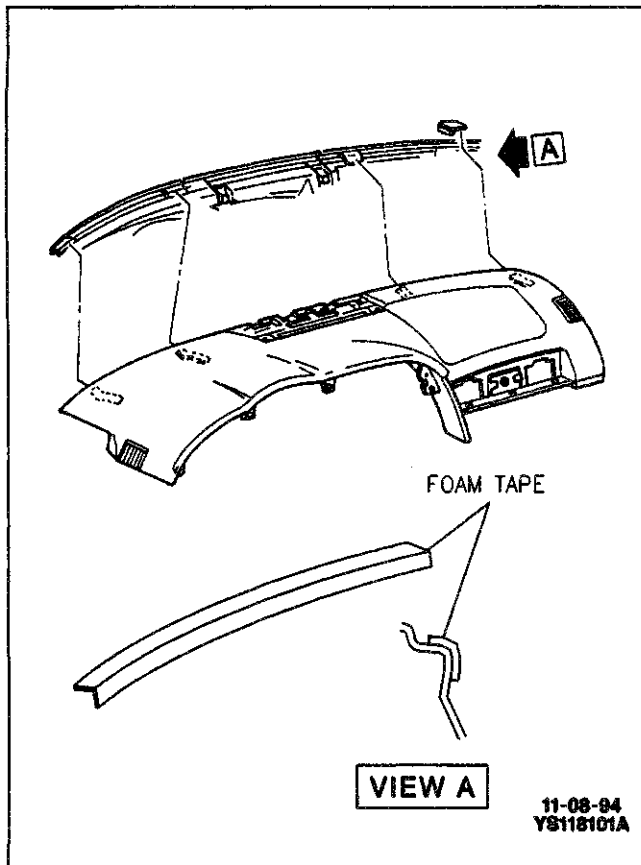
Figure 15 - Instrument Panel—Upper Trim Pad at Windshield

- Rattle from instrument panel upper trim pad at windshield.

- Trim pad contacting windshield lower steel panel.

- Add 4 mm thick 50 mm wide (3/16 x 2 inch) strip of foam tape full length of exposed metal surface of top and vertical surface of windshield lower frame, except defroster grill opening. Slit lower edge of foam at openings for I/P clips.

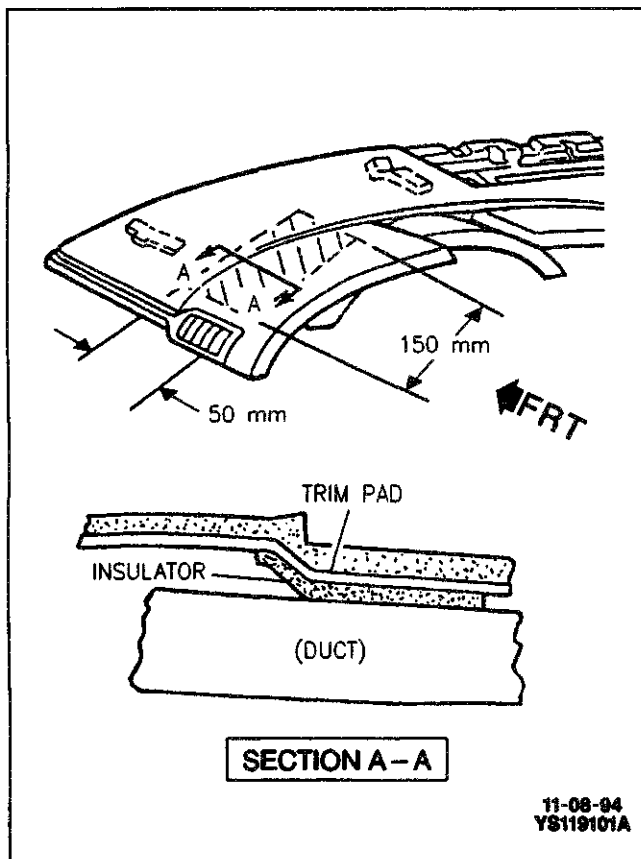
Figure 16 - Instrument Panel—Upper Trim Pad to A/C Duct

- Rattle forward of instrument panel cluster.

- Top of air conditioning duct rattling on under side of upper trim pad.

- Install a foam pad 50 mm by 150 mm (2 inch by 6 inch) to underside of upper trim pad to insulate area of air conditioning duct contact.

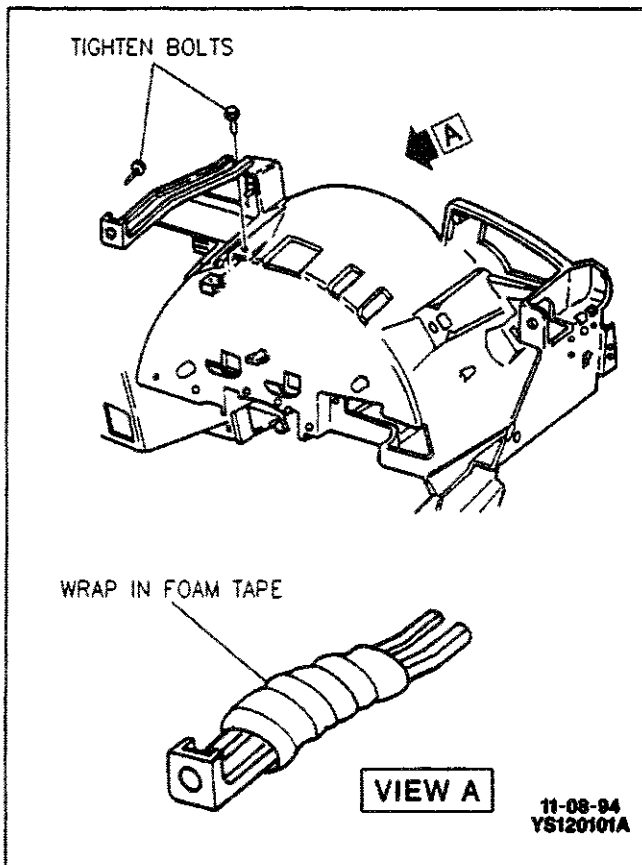
Figure 17 - Instrument Panel—Support Bracket

- Buzz or rattle at driver's side of instrument panel (I/P).

- Loose instrument panel upper support bracket bolts and/or support bracket contacting upper trim pad or I/P.

- Tighten bolts. Wrap bracket in foam tape.

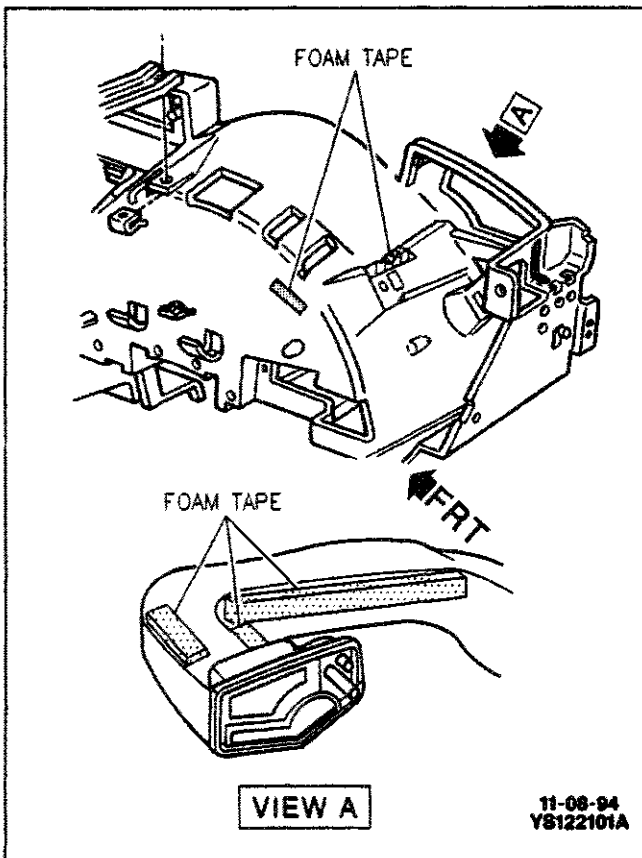
Figure 18 - Instrument Panel—Air Distribution Duct—LH

- Rattle at top of Instrument Panel (I/P) near I/P cluster.

- A/C air distribution rattling on top of I/P.

- Pull up on the air distribution duct and install a 3 mm (1/8 inch) thick foam tape insulator to the I/P and air duct in area of contact.

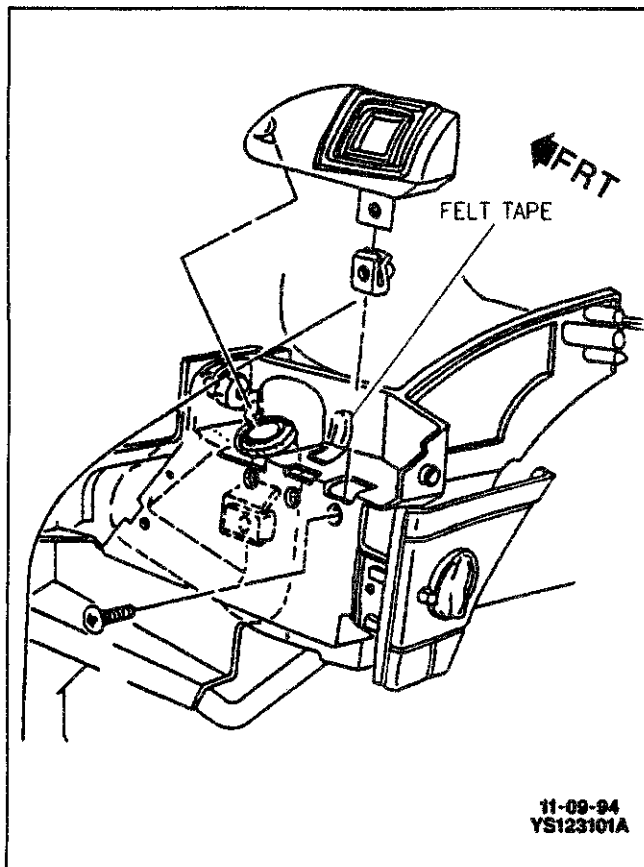
Figure 19 - Instrument Panel—Side Window Defogger Outlet

- Buzz coming from left side of instrument panel.

- Side window defogger duct outlet buzzing on instrument panel.

- Remove instrument panel upper trim pad and side window defogger duct outlet. Install a 13 mm by 75 mm (1/2 inch by 3 inch) section of felt tape to the instrument panel where shown.

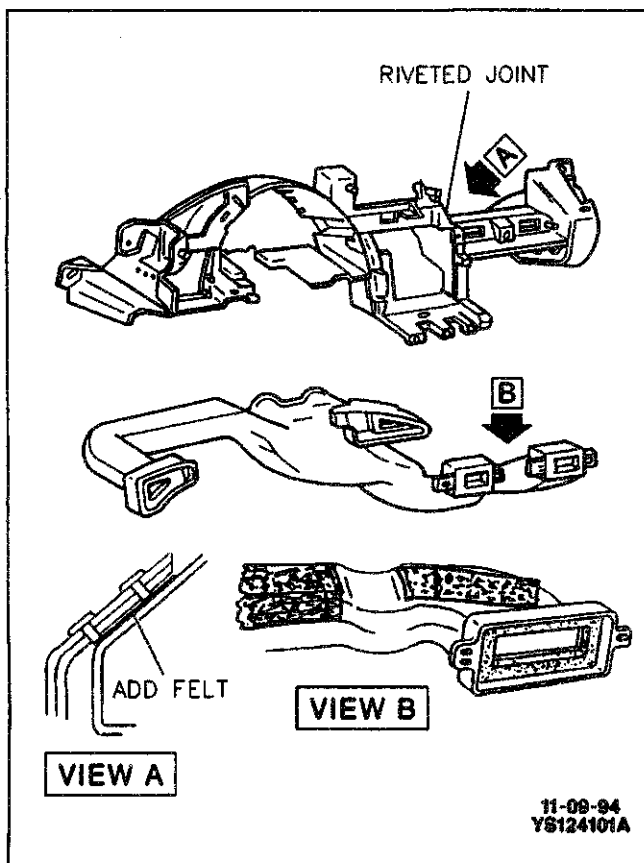
Figure 20 - Instrument Panel—Air Distribution Duct—RH

- Rattle at passenger side of Instrument Panel (I/P).

- A. Air distribution duct contacting I/P riveted joint between center and right air outlets.
- B. Air distribution duct contacting air bag module.

- A. Add felt tape under rivets between air duct and instrument panel as shown in "VIEW A."
- B. Add foam tape to air duct as shown in "VIEW B." If foam tape was previously installed, insure outboard and inboard foam insulators are positioned outward and inward respectively enough to prevent I/P to air bag module contact.

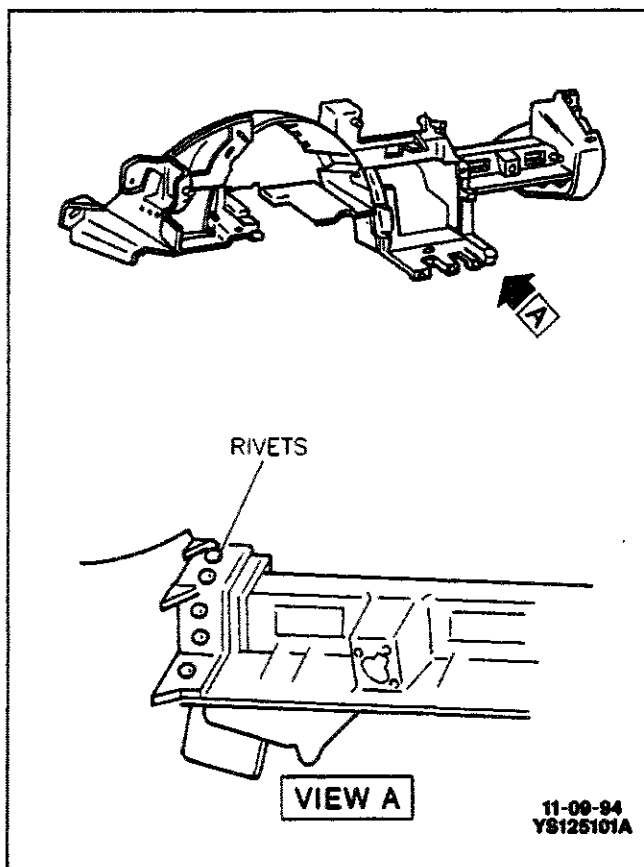
Figure 21 - Instrument Panel—Right Side Rivets

- Buzz from passenger side of Instrument Panel (I/P).

- Loose rivets attaching I/P extension, or loose mandrel.

- Replace loose rivets, or glue mandrels in place.

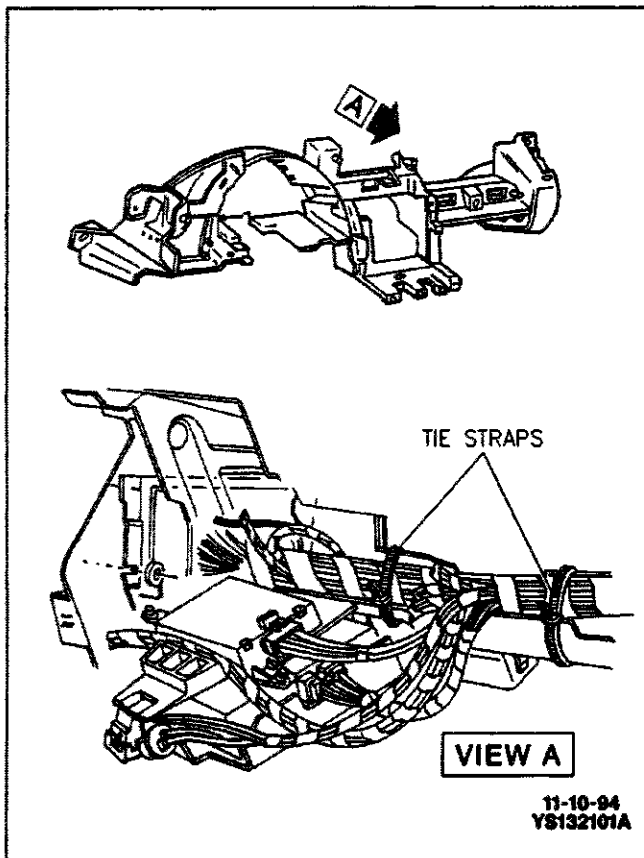
Figure 22 - Instrument Panel—Instrument Panel Harness

- Rattle at passenger side of Instrument Panel (I/P).

- I/P wire harness bouncing on multi-use relay bracket.

- Replace tie straps.

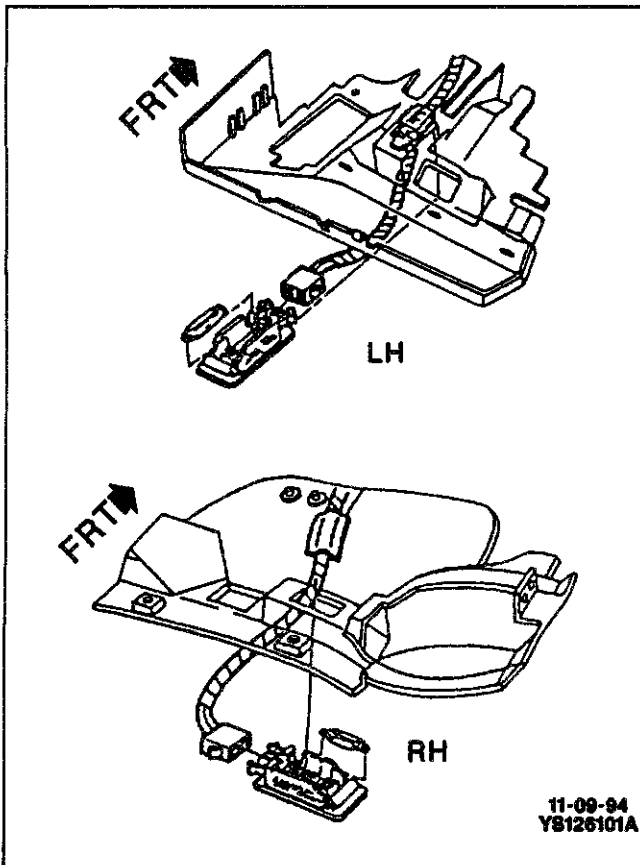
Figure 23 - Instrument Panel—Courtesy Lamp Bulb

- Buzz coming from under instrument panel.

- Courtesy lamp bulb holder loose.

- Replace lamp assembly.

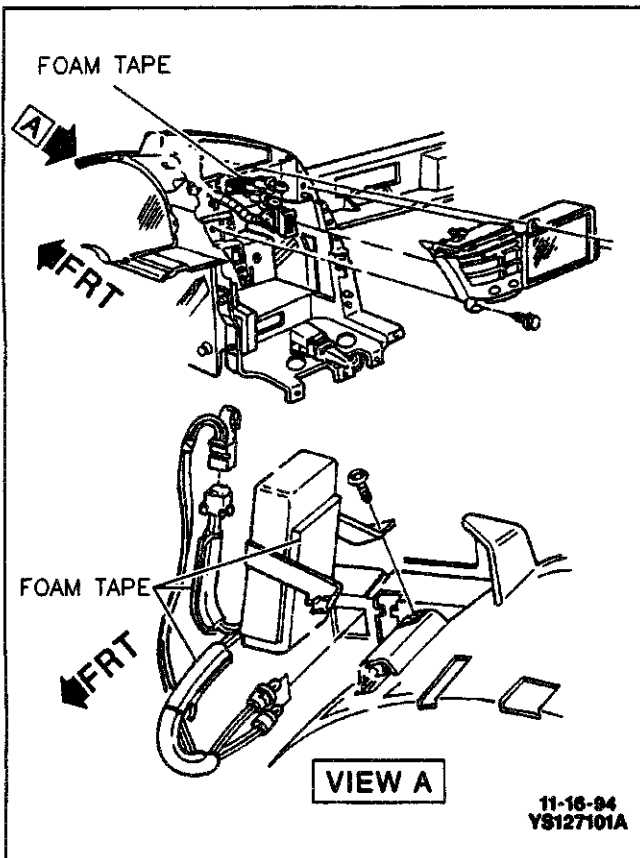
Figure 24 - Instrument Panel—LTPWS Module

- Rattle at center of Instrument Panel (I/P).

- Low Tire Pressure Warning System (LTPWS) module and/or associated wiring contacting I/P.

- Wrap wires to module and wires from module to Driver Information Center with foam tape at I/P contact points. Position foam tape on module as shown and between module and I/P.

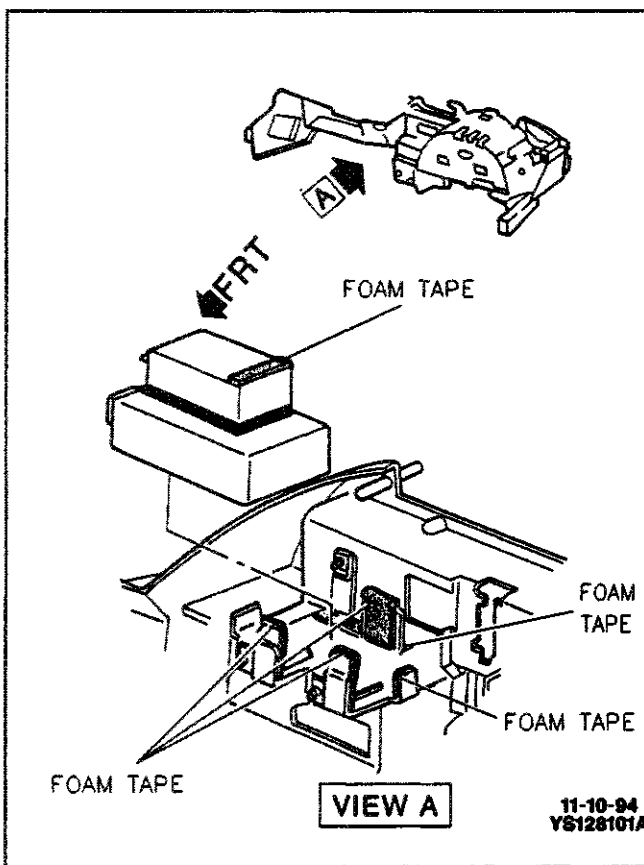
Figure 25 - Instrument Panel—PKE Module

- Rattle at center of instrument panel.

- Passive Keyless Entry (PKE) module loose in bracket and/or module or bracket contacting air duct.

- Add foam tape between bracket and air duct, bracket and module, and module and air duct.

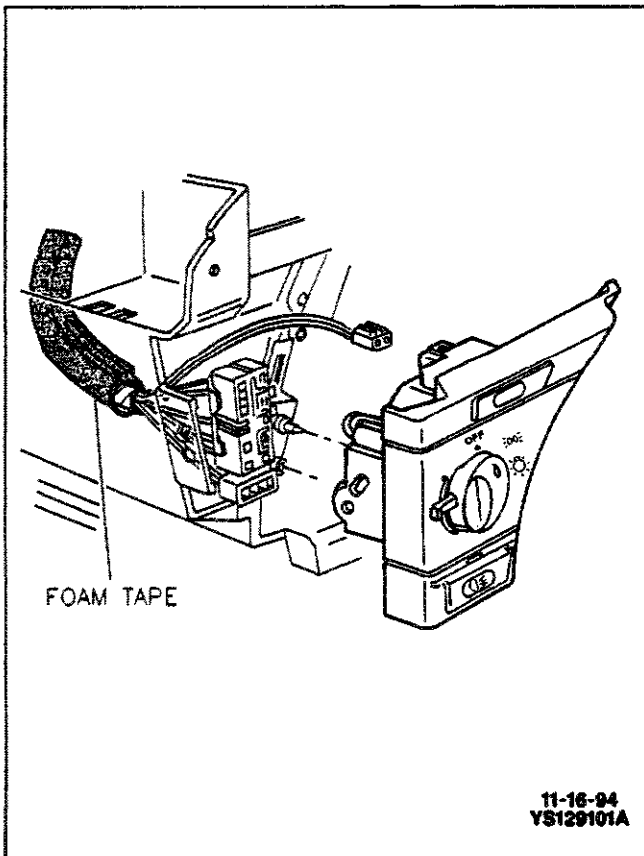
Figure 26 - Instrument Panel—Headlamp Switch Harness

- Rattle at left side of Instrument Panel (I/P) near headlamp switch.

- Headlamp switch wire harness contacting I/P.

- Wrap headlamp switch wire harness with foam tape as shown.

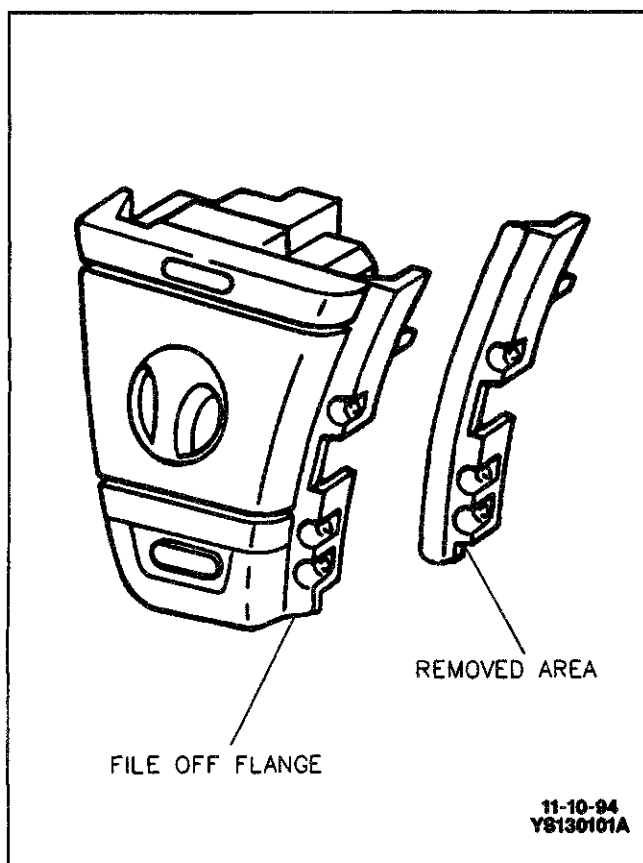
Figure 27 - Instrument Panel—Headlamp Switch

- Itch at left side of instrument panel cluster.

- Headlamp switch contacting instrument panel cluster trim plate.

- Remove headlamp switch and file down flange as illustrated.

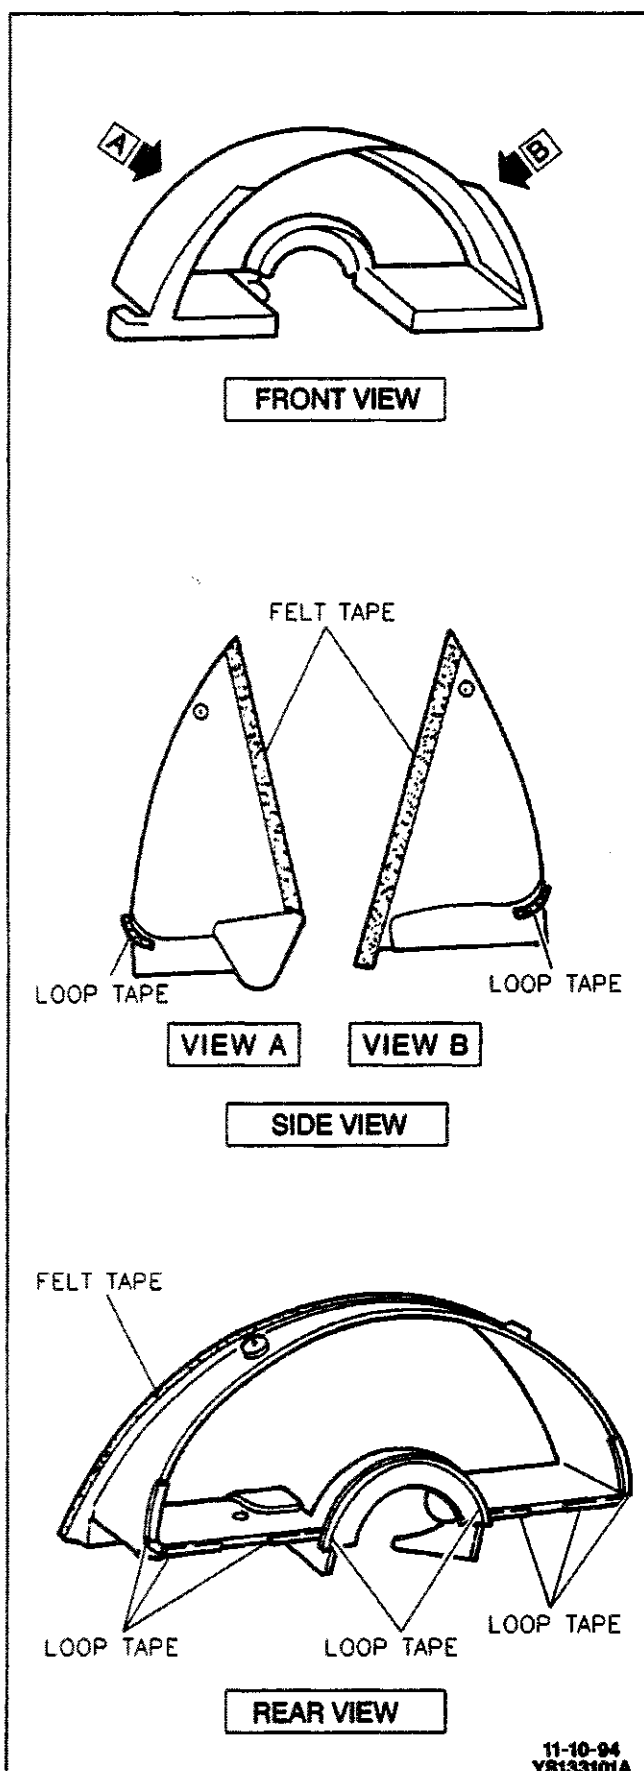
Figure 28 - Instrument Panel—Cluster Trim Plate

- Squeak, rattle, buzz, itch, from Instrument Panel (I/P) cluster.

- Cluster trim plate contacting I/P.
- Cluster trim plate contacting cluster.
- Cluster lens contacting I/P.
- Cluster trim plate contacting headlamp switch. Refer to "Instrument Panel—Headlamp Switch."

- Remove cluster trim plate.
- Install loop portion of hook and loop tape in 50 mm (2 inch) long strips to rear of trim plate as shown in rear view.
- Install loop tape around steering column opening as shown in rear view.
- Install felt tape behind front upper edge of trim plate as shown in side and rear views.
- Install tape just up to the edge so that it does not show when trim plate is installed.

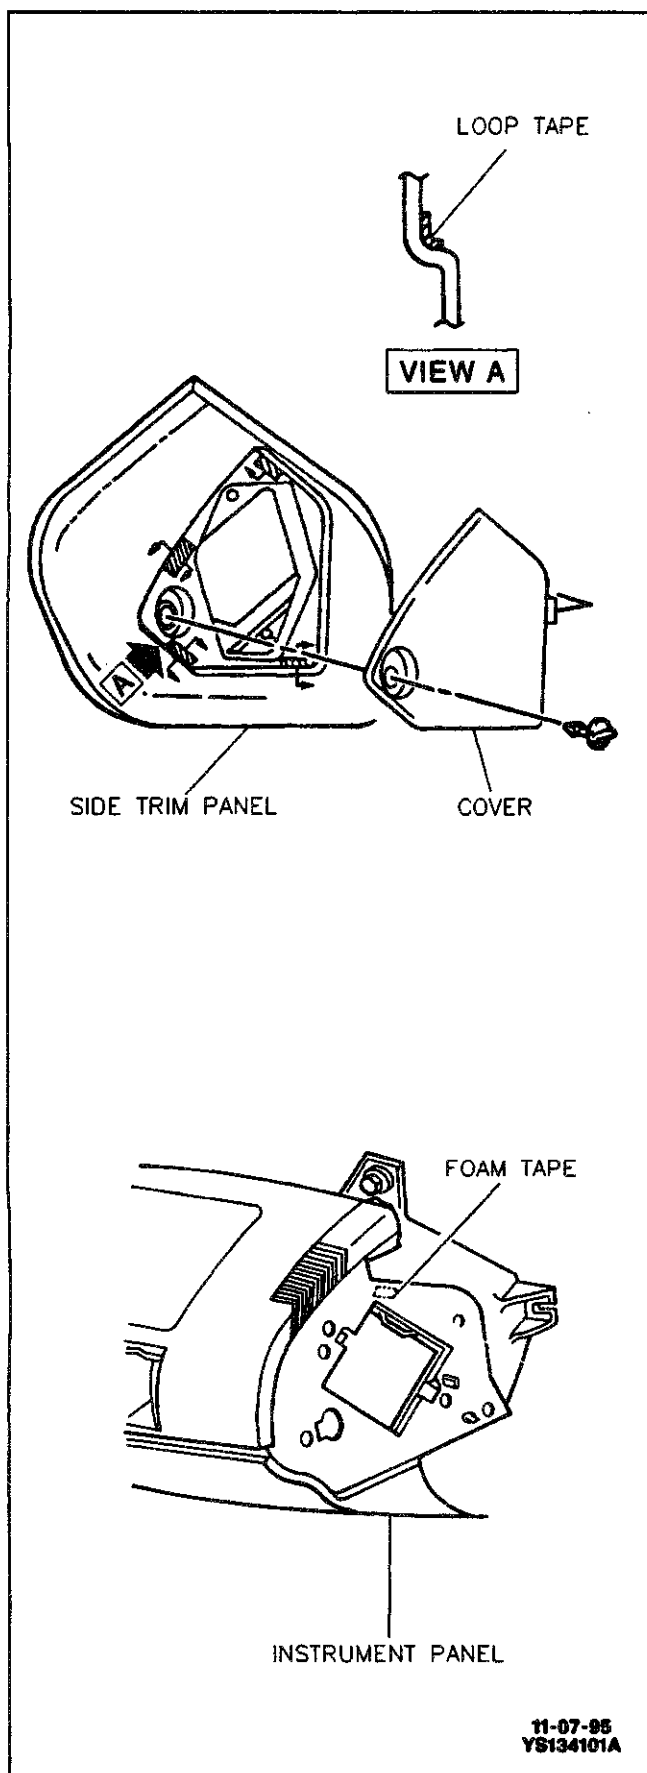
Figure 29 - Instrument Panel—Fuse Box Rivets and Cover

- Buzz at right side of instrument panel.

- Fuse box cover vibrating against instrument panel side trim panel.
- Instrument panel side trim panel contacting fuse box rivet heads.

- Remove fuse box cover and apply 6 mm by 25 mm (1/4 inch by 1 inch) section of hook and loop tape (loop portion) to side trim panel where cover makes contact.
- Remove side trim panel and install 6 mm (1/4 inch) foam tape between rivet heads on instrument panel and side trim panel.

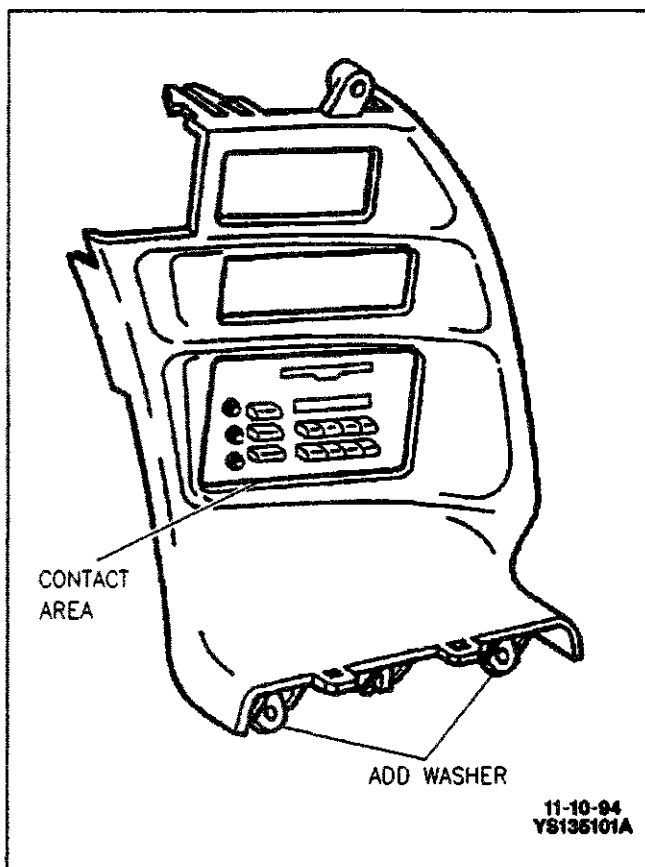
Figure 30 - Console—Radio Control

- Itch bottom of radio control to instrument panel (I/P) accessory trim plate.

- Radio control contacting I/P accessory trim plate.

- Remove accessory trim plate, hot glue a 1 mm (3/64 inch) thick flat washer to back side of lower trim plate mounting tabs.

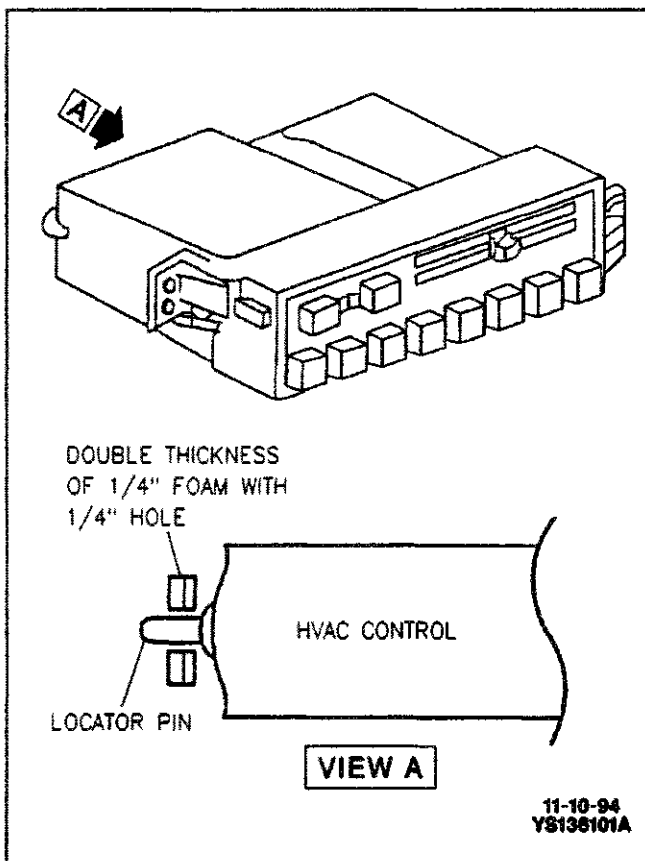
Figure 31 - Console—HVAC Control

- Buzz coming from center of dash.

- Heating, Ventilation and Air Conditioning (HVAC) control locator pin.

- Remove the HVAC control and apply a double thick 6 mm (1/4 inch) section of foam tape with a 6 mm (1/4 inch) hole around the locator pin.
