Power window motor from my 65 coupe

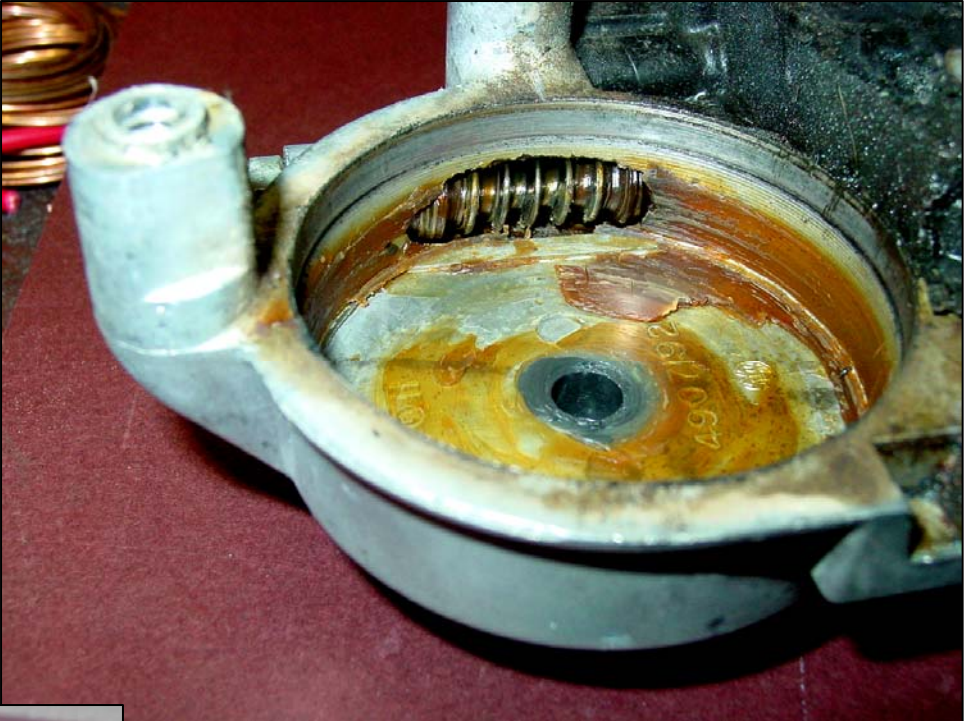
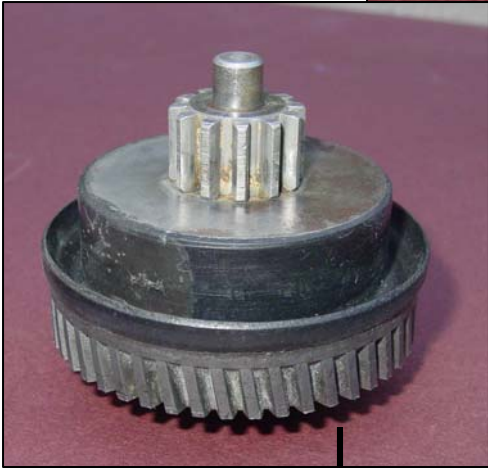
Drive-gear housing before and after cleaning

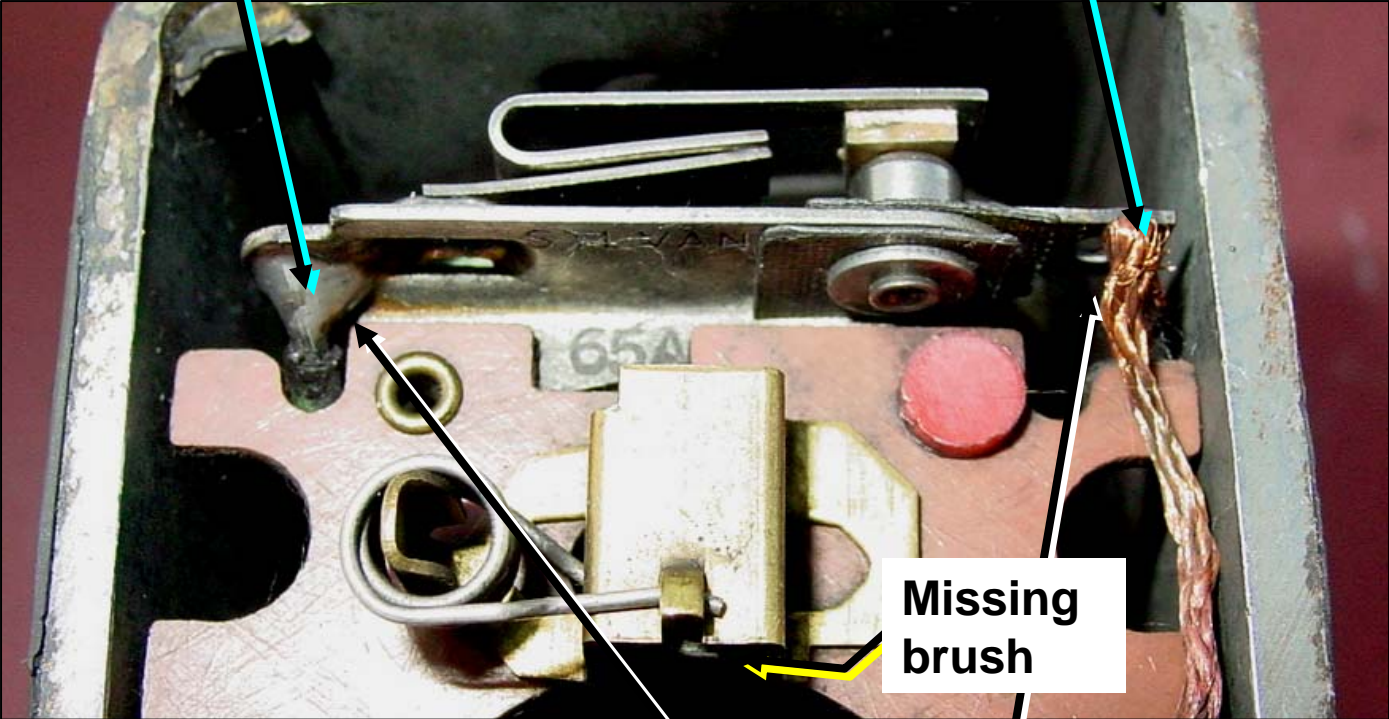
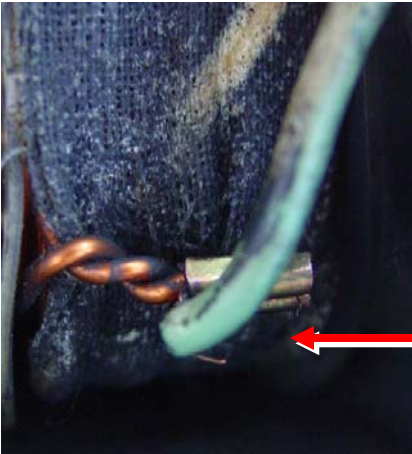
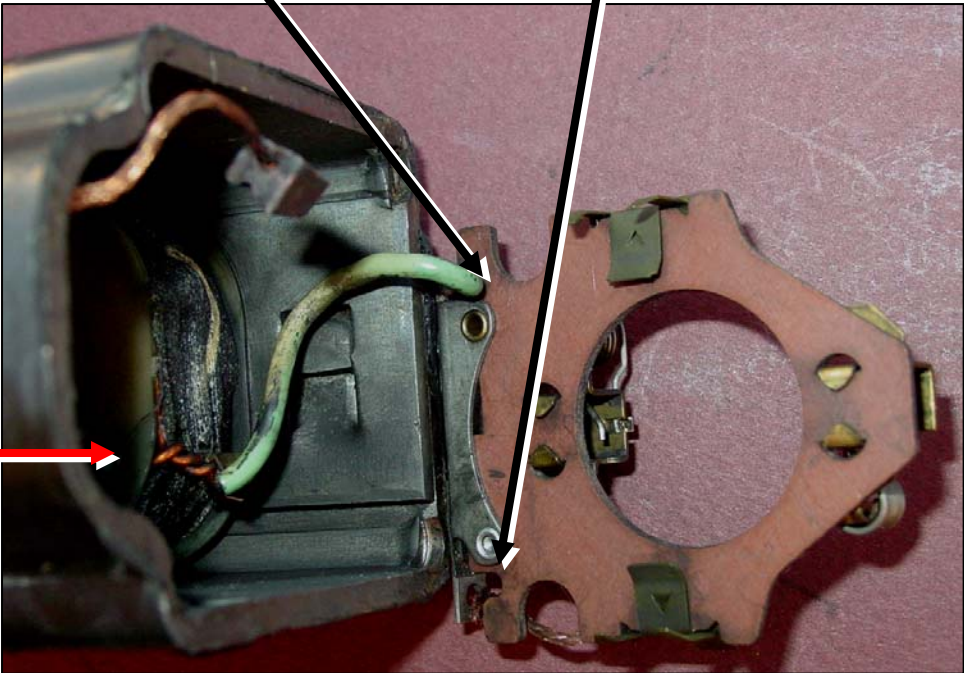
“Brush plate assembly” with the armature out of the motor

Connection to
"field" on motor
housing

Connection for
other brush
