# RARECORVETTES.COM

### *1953-1962 TURN SIGNAL SWITCH and CANCELING CAM*

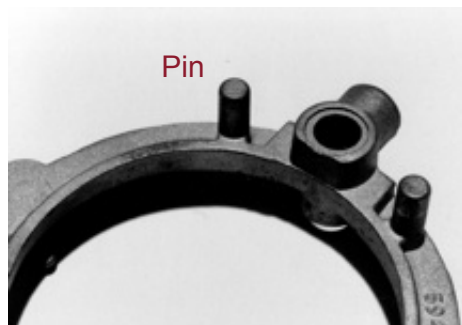
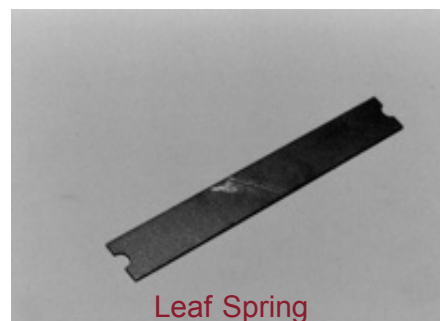
The reason the cancelling cam doesn't center the switch is often because of wear on the pins which bear against the leaf spring within the switch housing (see photo of pins on previous page). It is also possible for other causes to occur such as:

The four problems noted above are only diagnosed after disassembly and inspection, and they may be repaired as required. The wear on the pins, however, would normally require a new turn signal cancelling ring. This part was serviced as Delco/Guide part number 897064. Since that part is no longer available, I have developed a simple way of repairing it.

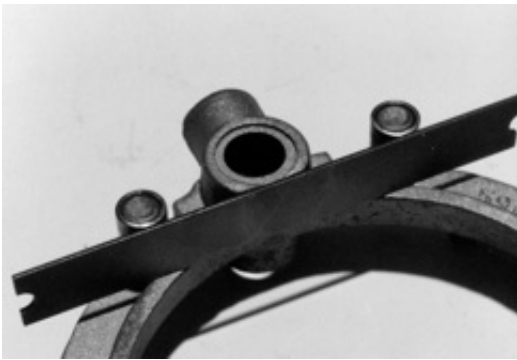
**Leaf Spring shown against repaired pins**

The leaf spring shown in the other photo on the previous page is designed to snap the assembly smartly back to the center position when the cancelling ring disengages the turn signal switch at the conclusion of a turn. If the pins which bear against the leaf spring are worn from rubbing against the spring, the action will be sluggish, and the switch will not be fully centered when this happens. The photo at the far left (opposite page) shows the relationship of the pins on the ring to the leaf spring.

The worn pins may be resized by simply fitting a short length of brass tubing over them. I was able to buy a piece of brass tubing just right for the job at a hobby shop. The tubing measures 1/4-inch outside diameter and .213-inch inside for a wall thickness of .037-inch. I cut two pieces to a length of 3/8-inch, which just covers the pins. This brass tubing not only repairs the worn pins but also actually makes them a little larger than they originally were which makes up for wear in the slots, which hold the leaf spring. This method therefore repairs two problems at once. The photo above left (opposite page) shows the leaf spring in the slots of the housing.

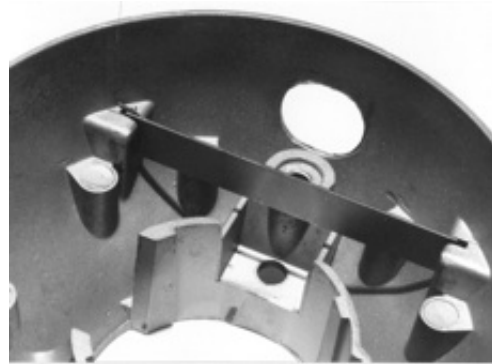
**Leaf Spring shown installed in housing**

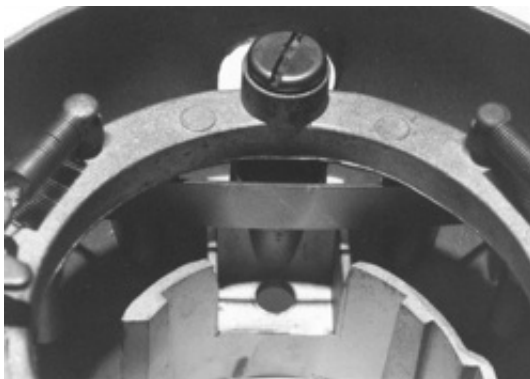
Parts installed in housing

Additional photos at right show the parts and how they relate to each other. When the parts are installed don't forget to put a little lithium grease on the wear points of the leaf spring and pins, and a drop of light oil on all the pivot points of the ring and cancelling dogs (the small parts which are held in position by the two small coil springs).

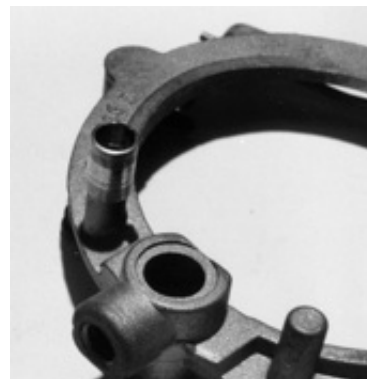
Tubing ready to slide over pin
