## 1956 to 1962 Corvette Windshield Post Tab Breakage and Repair

### Rich's Restoration Site Antique Automobile & Boat Restoration

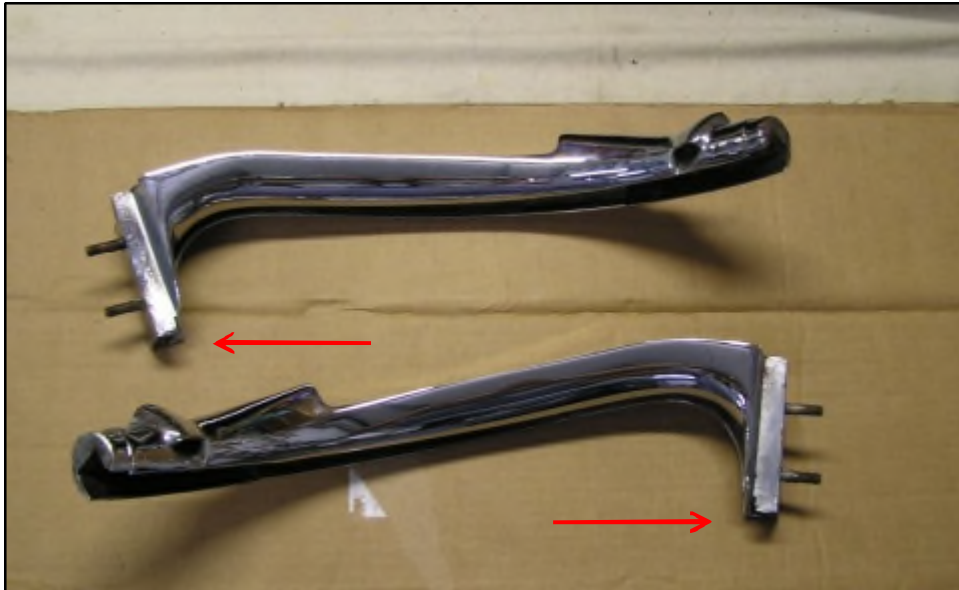
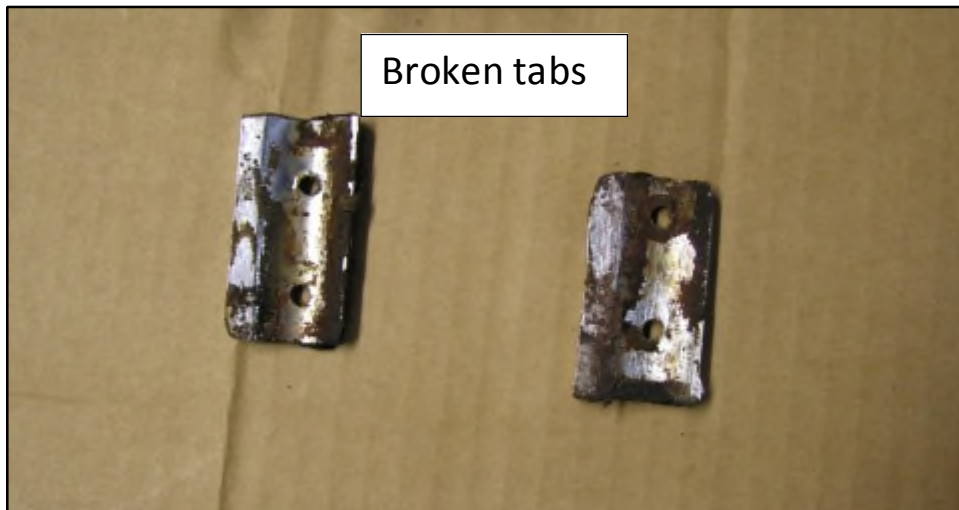
Below are 2 posts with broken post tabs. It may cause your header to pull away from the glass, especially when you try to attach a tight soft top while clamping down. Typically, when I restore a car, even if the tabs are not broken I send them out for steel replacements. The original castings are delicate and break easily. The replacements are much stronger.

Services are available to repair them.

My favorite supplier of this repair is Paul Mazut. His website is here:

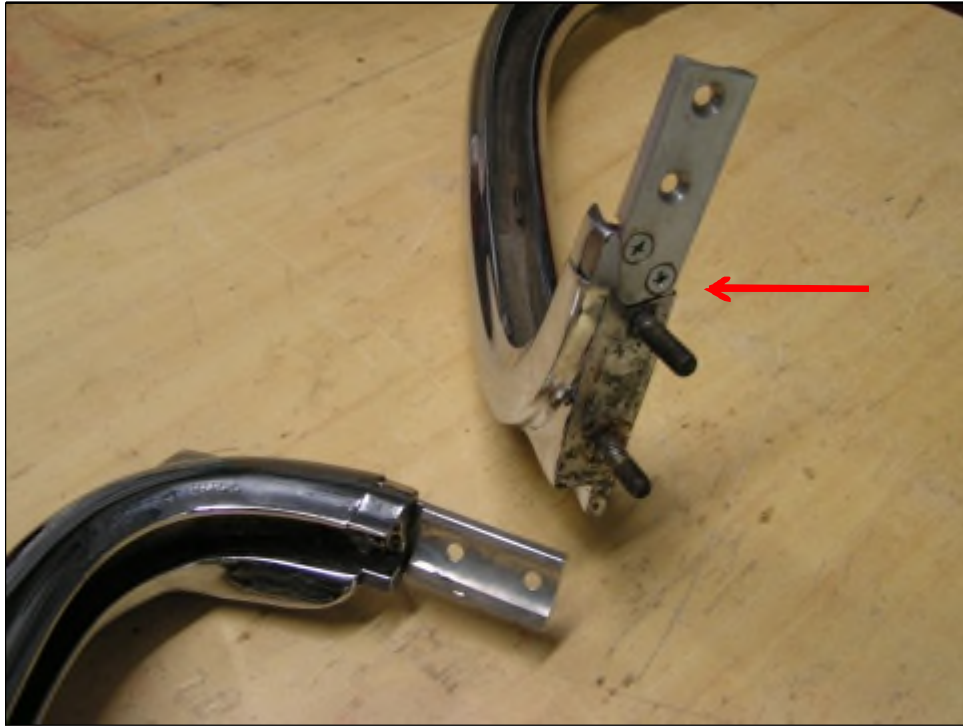
## After repair:

As you can see, the tab is now permanently attached to the post and can be removed for post chrome plating or other work if needed.
