C1 Door Switch Rebuild

By: Tom Hoyer

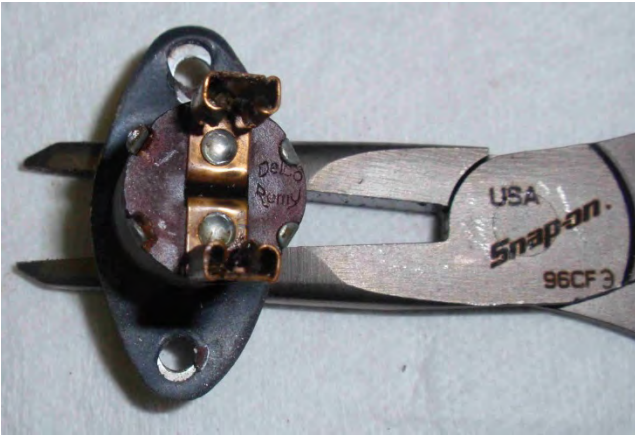
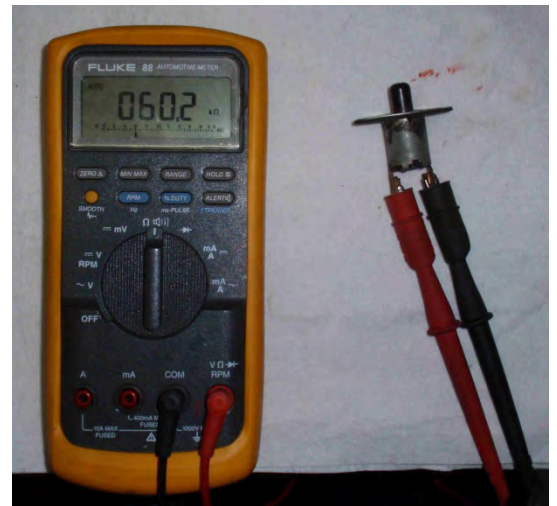
Before installing the door switches back into the 58 I'm working on, I decided to check their function. Connecting a DVM set to measure ohms, I was not surprised to see that they were not providing very good switch action. With the plunger fully extended, you should read a direct short across the terminals. Pressing the plunger in should show an open circuit. Both of my door switches exhibited high resistance (over 60k ohms) with the plunger extended indicating that they needed some attention.

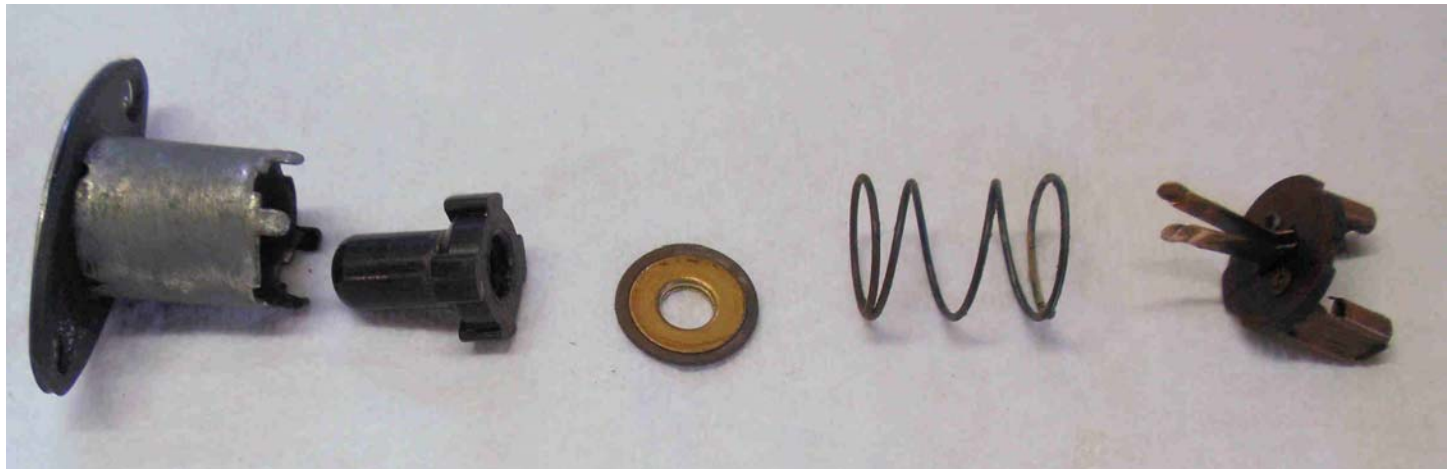
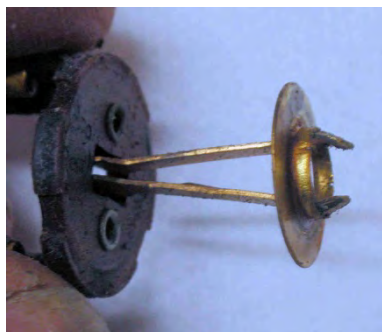
The switch is fairly easy to open, being held together by four small tabs on the rear of the housing that are bent over to secure the assembly together. A minute or two with a screw driver and some needle nose pliers and you can bend the tabs up enough to extract the switch guts from the housing.

Once everything was apart, it was interesting to see how the switch was made and how it actuated. The plunger pushes down on a brass disc that is insulated from the housing by a fiber washer. The long contacts that are attached to each terminal ride inside the brass ring. When the plunger is fully extended (door open, lights on), the brass ring makes contact with the ends of the two long terminals effectively shorting them together. When the plunger is pushed in (door closed, lights off), the brass ring travels down along the

terminals to a point where it no longer makes contact with the terminals effectively opening the circuit. The terminals also extend into the plunger which pulls the close together as it is depressed. The spring is there to push the brass ring / plunger out when the door opens.

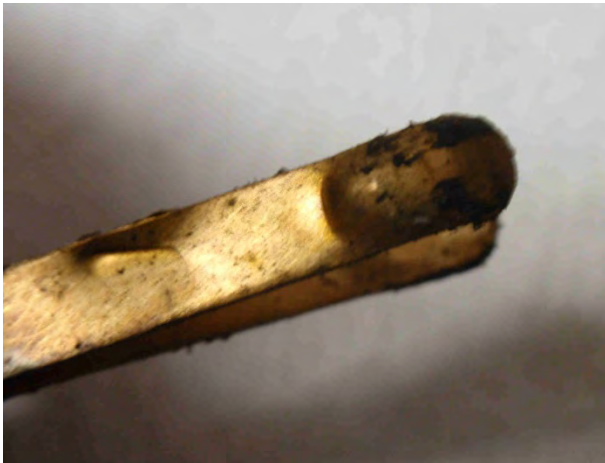
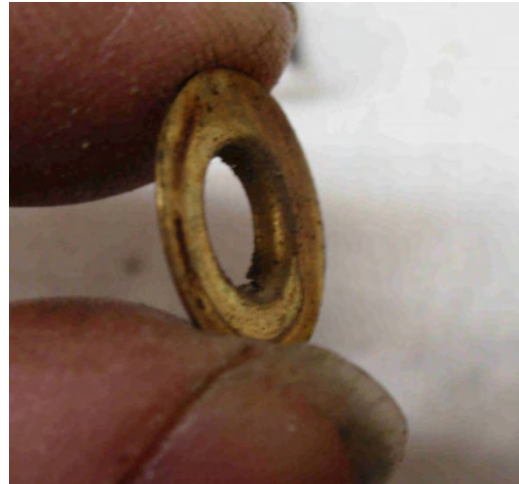
Inspecting the contacts in my switches showed a fair amount of crud build up on both the terminals and the brass ring. I cleaned them with alcohol and sprayed them with a deoxidizer made specifically for electrical contacts. All of the parts received a good cleaning including the inside of the housing where the fiber washer slides up and down the walls of the housing. My switches were pretty sticky inside probably from the breakdown of the old dielectric grease the used in the switch back in 58.
