1967 (Late) - 1968 CORVETTE STANDARD (NON-ADJUSTABLE) STEERING COLUMN DISASSEMBLY & REPAIR INSTRUCTIONS PAPER #2

1967 & 1968 NON-ADJUSTABLE (STANDARD) STEERING COLUMN LOWER BEARING PACKAGE

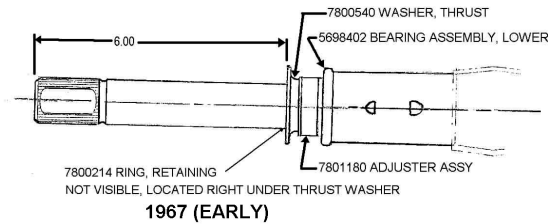
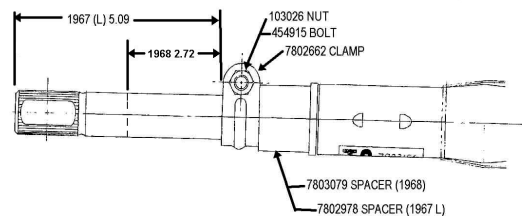
All part numbers in parenthesis () refer to Steering Column Mounting Pics on page 3. All part numbers beginning with # refer to the Steering Column Blowup on page 4. The 1967 model year saw the introduction of the General Motors first generation, energy absorbing, collapsible steering columns. After the start of production the lower steering column bearing was revised, a groove in the steering shaft and retaining ring eliminated, and a clamp, nut, and bolt were added to retain the bearing in place. This is why we identify the steering shaft and lower bearing parts for the 1967 Corvette in this paper as being (Interim or Late) revisions. They are the same as the 1968 lower bearing parts.

1967 (INTERIM & LATE) AND 1968

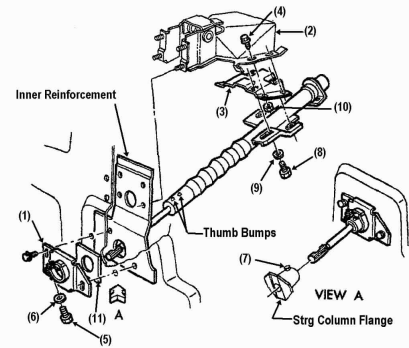
1967 STEERING COLUMN MOUNTING

Remove the clamp bolt (5) and washer (6) from the support assembly (1) on the engine compartment side of the lower dash panel. You should be able to pry the clamp open sufficiently to be able to clear the thumb bumps on the lower end of the steering column.

Use a crayon or piece of chalk to mark the orientation of the steering column shaft to the steering column flange.

Remove pinch bolt (7) from the steering column flange and spring the flange open with a large screwdriver.

If previously removed, loosely secure the seal (11) and support plate (1) to the engine side of the dash panel with two screws. Otherwise loosen the two screws that hold the support plate to the dash.

Feed the lower end of the steering column through the dash. Make sure that the clamp part of the support assembly is between the two thumb bumps on the lower end of the steering column jacket. Insert the steering shaft into the flange on the flexible coupling assembly. Make sure that you align the paint or chalk marks on the flange and steering column shaft for correct orientation of the parts. Loosely install the pinch bolt (7) into the flange.

Slide the escutcheon into position on the instrument cluster. Allow the lower dash panel attachment to float as you secure the steering column into the dash with the three vertical bolts (8) and washers (9). Torque the bolts to 20 ft-lbs.

Secure the seal and support assembly to the dash panel on the engine compartment side by tightening the two screws to 13 ft-lbs.

Tighten the bolt and washer to clamp the lower end of the steering column to the support assembly. Tighten the bolt to 13 ft-lbs. Tighten the pinch bolt to 30 ft-lbs on the steering column flange that is part of the flexible coupling assembly.

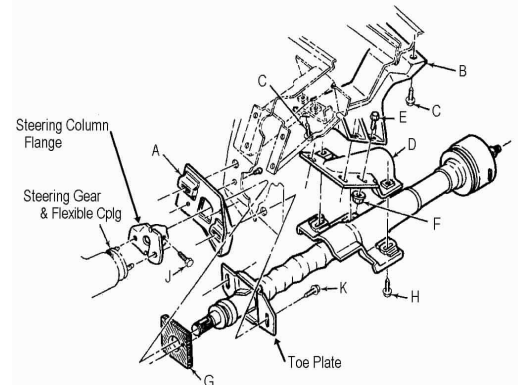
1968 STEERING COLUMN MOUNTING

If you have a manual transmission, you may find a fairly heavy clutch pedal spring attached to support (A) and to the Z-bar. You should detach one end of the spring at this time. **Hint!** Detach the clutch pedal rod from the Z-bar. This will allow the Z-bar to rotate rearward and take some tension off the spring.

Use a crayon or piece of chalk to mark the orientation of the steering column shaft to the steering column flange. Remove pinch bolt (J) from the steering column flange. Spring the flange open with a large screwdriver. Go back inside the car and remove two screws (K).

Install gasket (G) into toe plate on the steering column.

Hold support assembly (A) to dash panel on the engine side of the dash panel. Carefully insert the steering column through the hole in the dash panel and the support assembly.

Insert the steering shaft into the flange on the flexible coupling assembly. Make sure that you align the paint or chalk marks on the flange and steering column shaft for correct orientation of the parts. Loosely install the pinch bolt (J) into the column flange.

Loosely install bolts (K) through the steering column toe plate and thread them into the floating nuts that are part of the support assembly.

Allow the support assembly to float as you secure the steering column into the dash with the three vertical bolts (H). Torque them to 20 ft-lbs. Secure the support assembly to the dash panel by tightening the two screws (K) that are inside the car. Torque them to 13 ft-lbs. Tighten the pinch bolt (J) on the flexible coupling flange to 30 ft-lbs.

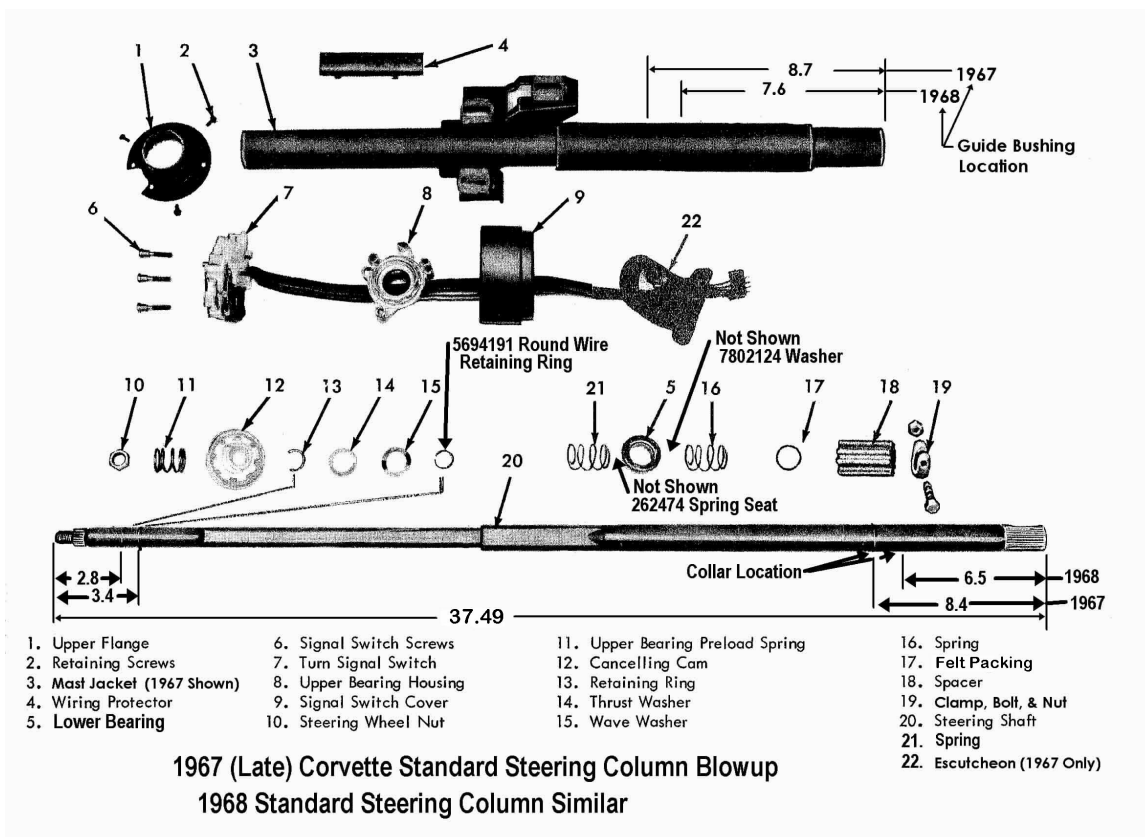
Note: The steering column flange is shown loose from the flexible coupling in both of the above mounting pictures. However, I do not think that it needs to be detached from the flexible coupling in order to remove the steering column. Also, I am quite sure that the steering column flange is too large to fit through the holes in support plates 1967 (1) or 1968 (A). Therefore my removal procedure calls for detaching the steering column shaft directly from that flange (leaving the flange attached to the flexible coupling assembly.)

Unfasten the three vertical bolts & washers 1967 (8 & 9) or bolts 1968 (H) that hold the column up into the dash. **NEVER** just remove the three vertical main mounting bolts that hold the steering column up into the dash and let the column “hang” by the attachments at the flexible coupling and the plates and fasteners on the lower dash panel. Pull the column straight back, disconnecting the column shaft from the steering column flange.

The Chassis Service Manuals are unclear as to exactly how to remove the lower column bearing #5 for service. The bearing case is a press fit to the mast jacket #3. It is possible that just removing the lower bolt, nut, and clamp #19, the spacer #18, packing #17, spring #16 and washer 7802124 may allow sufficient access to be able to pull the bearing from the lower end of the mast jacket and slide it off the steering shaft #20. So I would suggest trying this approach first. Note there is a spring seat 262141 and spring #21 behind the seal. Do not lose them. Also note the orientation of the spring seat.

Remove the nut, bolt, & clamp #19, the spacer #18, packing #17, spring #16, washer 7802124, and the lower bearing #5. Behind the lower bearing will be the spring seat 262474 and another spring #21. Make note of the orientation of the spring seat.

There is reference on the blowup picture to a plastic guide bushing that is up inside the mast jacket. While the lower bearing and steering shaft are out of the mast jacket, now is a good time to lubricate that bushing. It should be a light press fit and located about 8.7 inches (1967) or 7.6 inches (1968) up inside the mesh section of the mast jacket from the lower end. You want to apply some lithium based chassis grease to the bushing.

Slide a new bearing up the steering shaft and lightly tap it into the mast jacket. It is a press fit. Install washer (7802124), spring #16, packing #17, spacer #18, and clamp, bolt, & nut #19 on the end of the steering shaft. Press the clamp up against washer 7802124 or until spring #16 is compressed to its solid height. Tighten clamp nut to 30 ft-lbs.

Slide the steering shaft up into the mast jacket until the round wire retaining ring 5694191 on the shaft stops against the upper bearing. Slide the spring #21 and the spring seat (262474) onto the steering shaft. Did you remember the orientation of the spring seat? (The end of the seat that rides on the steering shaft must be seated against the inner race of the bearing assembly.) Slide the lower bearing onto the steering shaft and tap it into place. Install the washer (7802124), spring #16, packing #17, spacer #18, and clamp, bolt, & nut #19 on the end of the steering shaft. Loosely tighten the nut to hold the parts in place.
