Lubricating Midyear Windshield Wiper Transmissions

by Joe Randolph

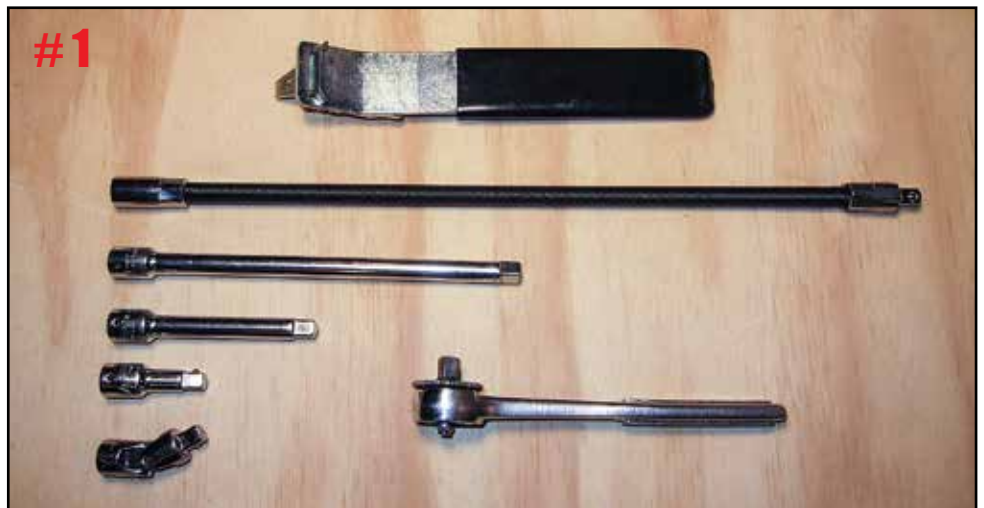
Photo 1 shows some tools that are helpful for removing and reinstalling the wiper transmissions. The tool at the top is an inexpensive wiper arm removal tool that allows release of the spring tension so the wiper arm can then be gently lifted off without damaging anything. It is far preferable to fumbling around with a screwdriver and yanking on the wiper arm. The remaining items are a collection of quarter-inch-drive extensions that help get at the transmission bolts under the dash on the driver's side. The long black extension at the top is a flexible shaft that is very helpful for reaching a bolt from an odd angle. The small universal joint at the bottom provides almost as much flexibility for dealing with odd angles.

of socket extensions similar to what is shown in **Photo 1**. This is where it really helps to be comfortable so that you can be patient while removing the three bolts that retain the transmission in the firewall.

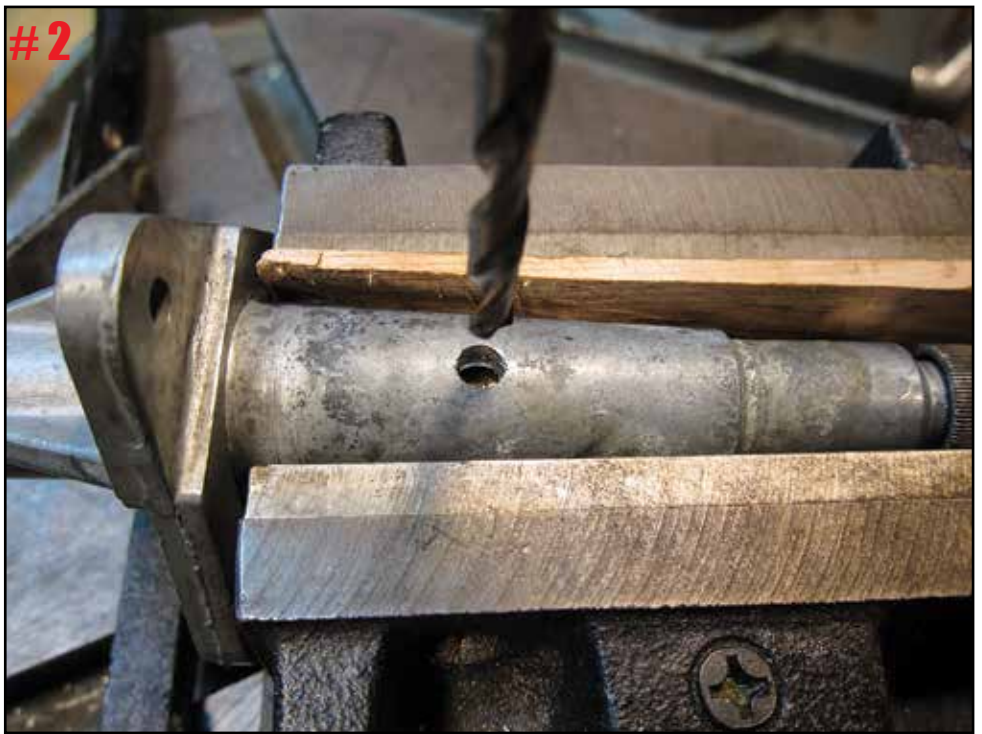
Photo 2 shows the transmission supported in a drill press for boring the

hole. I chose to thread the hole with a 1/4-20 tap so that I could use a short 1/4-20 hex-head setscrew to plug the hole. The setscrew needs to be fairly short because it must only plug the hole in the casting without contacting the shaft inside. I intentionally used only the tapered portion of the tap so that the setscrew would have a slight interference fit in the soft casting material and I also put some sealant on the threads.

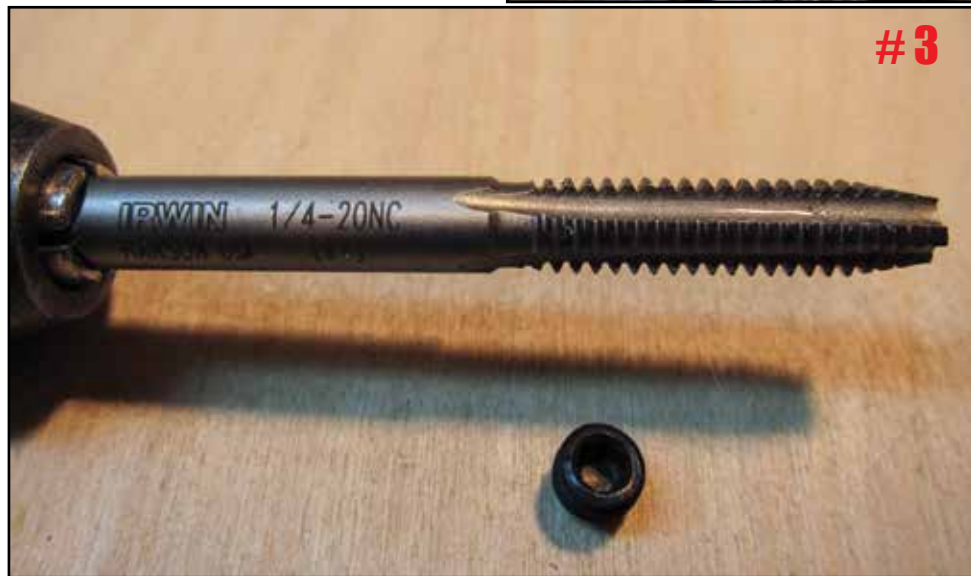
Photo 3 shows the parts involved. Note that simpler solutions could be

used, such as drilling a smaller hole and plugging it with a bit of JB Weld.

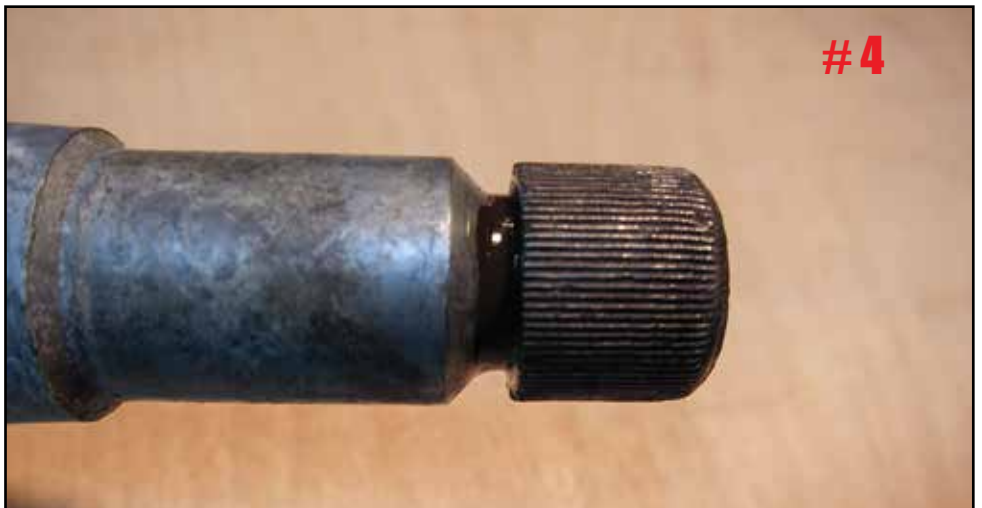
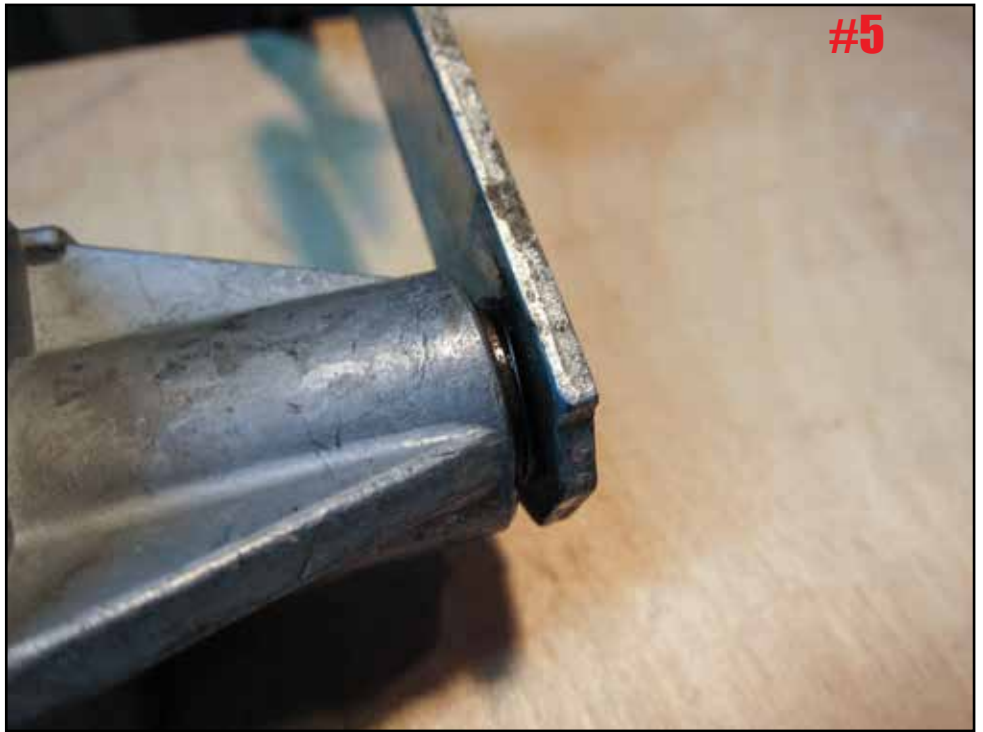
The hole provides access to the cavity containing the inside ends of the two bushings. I added some motor oil to the cavity and rotated the shaft in the bushings until some of the oil appeared at the outside end of each bushing as shown in **Photos 4 and 5**. Warming the casting with some light heat from a heat gun helped to accelerate this process. I then filled the cavity with oil and left the transmission sitting overnight to allow the oil to soak into the bushings.

Prior to closing the oil hole, it is important to drain any excess oil from the cavity. Otherwise, the excess oil will eventually work its way out of the lower end of the installed wiper transmission and drip on the floor inside the car. (Do not ask how I know this!)

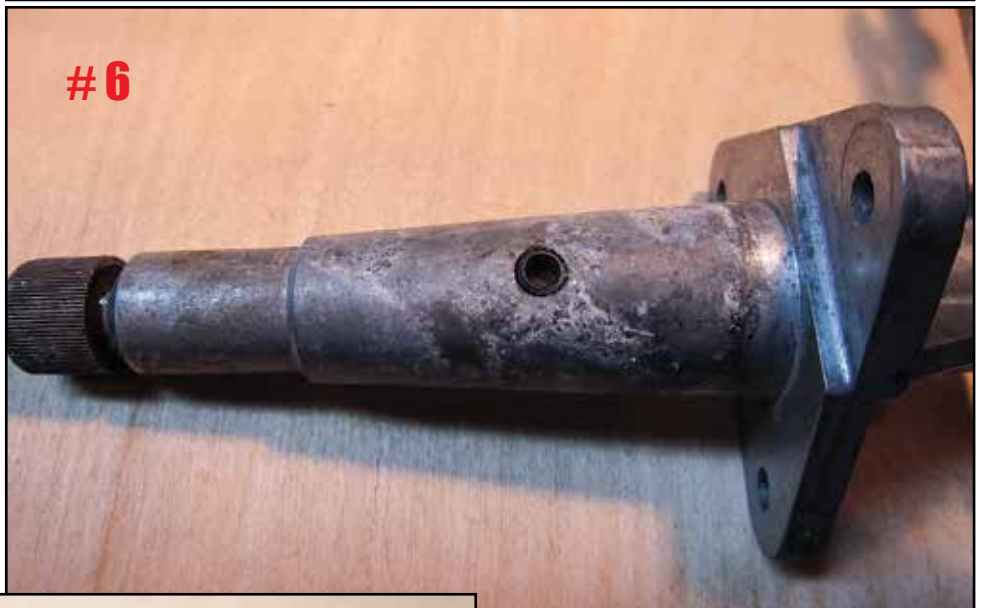
Photo 6 shows the hole plugged with the setscrew and **Photo 7** shows the new plastic cover installed on the transmission. I found that a small amount of heat from a heat gun allowed the new cover to stretch over the wiper mount and snap back into shape under the shoulder. In my case the original plastic covers were damaged from people prying off the wiper arm without using the proper tool, so I simply cut off the originals and discarded them. If you want to remove original covers and reuse them, that is probably possible but it would be challenging.
