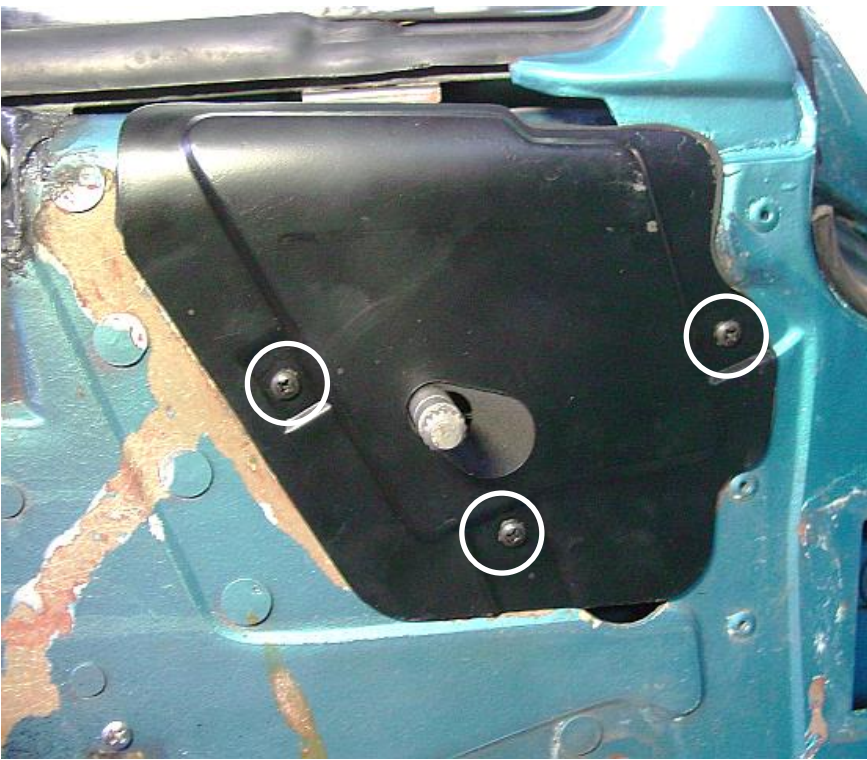
Remove this cover plate to expose the vent-window regulator assembly. Check to see if there are any issues with the insertion of the T-Post into the regulator at the point shown below. My '65 had a snapped t-post on the psgr side when I got it.

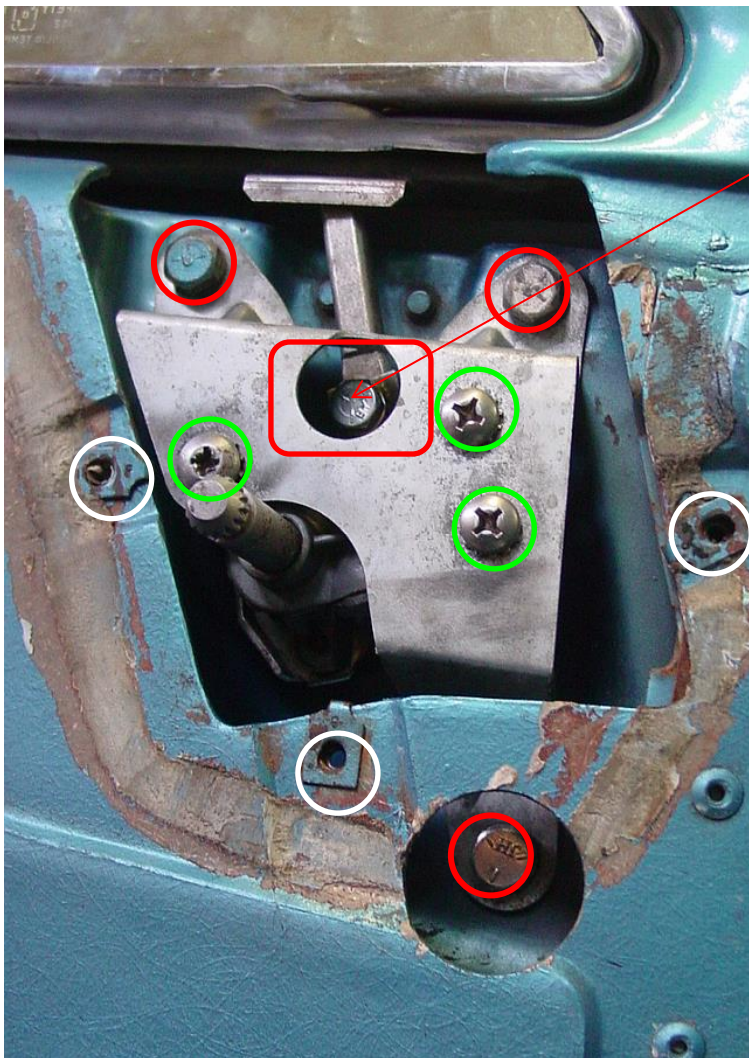
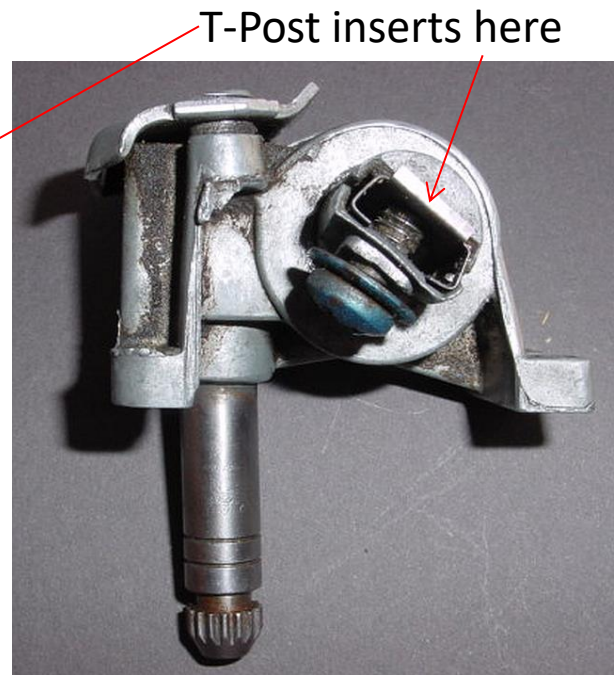
The regulator assembly can be removed, if necessary, by removing the 3 bolts circled in red and the one attaching the post into the regulator (rectangle). It is attached to the bracket by the 3 screws (green circles).

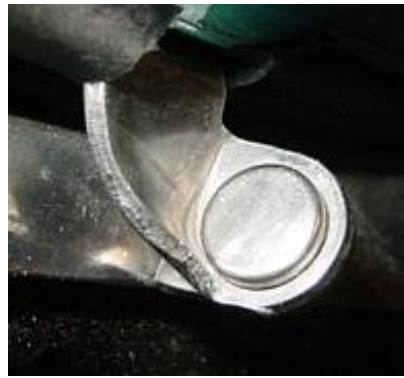
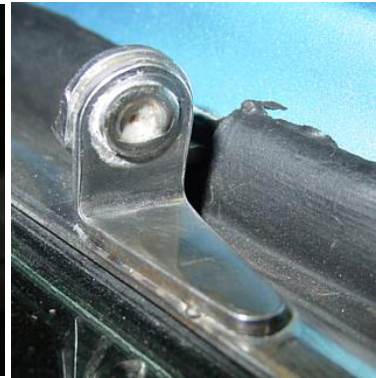
Hinge pivot and rivet on vent-window frame

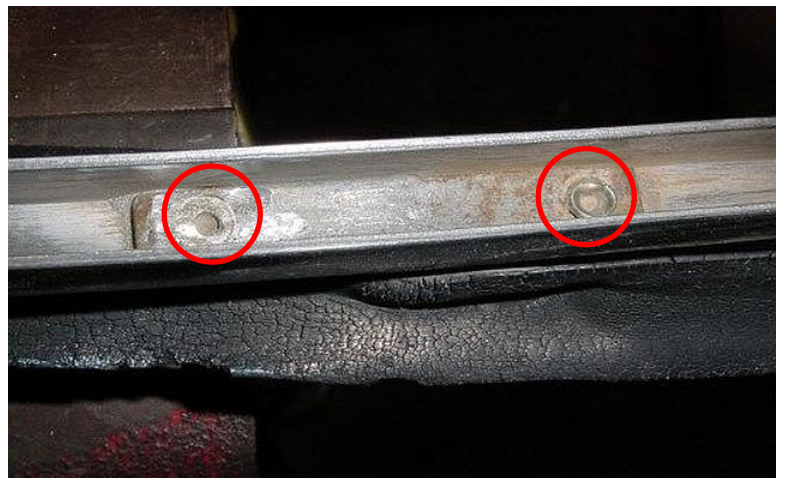
T-Post is riveted to the vent-glass frame.
