■ TECHNICAL GETTING THE SMELL OUT!

Getting The Smell Out!

RIDDING YOUR STRAIGHT-AXLE OF ITS STINKING GAS

BY JOHN HINCKLEY

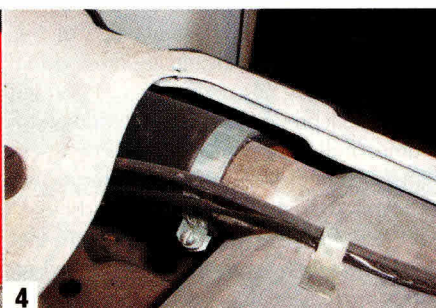
4 The often-neglected and frequently dry-rotted special fuel filler neck hose. "Bubba" occasionally replaced it with radiator hose.

FUEL FILLER NECK HOSE: The short section of special rubber hose from the fuel tank to the filler neck with the cap on the end is almost always dry-rotted

or deteriorated. Its barrier qualities are history, and both raw fuel and odors permeate it easily. Inspect it and replace it if necessary, using only "fuel filler hose" that's laminated with a barrier material; NAPA sells it by the foot. DO NOT use a section of radiator hose – that's Bubba's favorite substitute, and it's both unsatisfactory and dangerous.

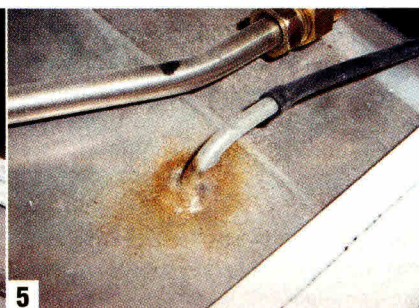
5 This is the vent fitting on the passenger side of

the fuel tank. It entered production early in the '57 model year, and was retrofitted to many earlier cars by dealers per a Chevrolet Service Letter.

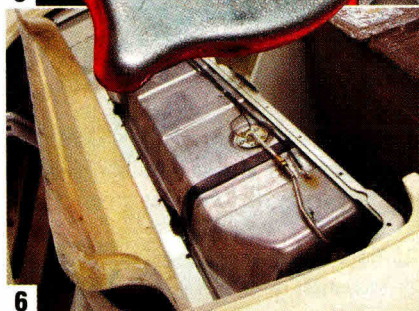
6 Typical C1 fuel tank – note the rubber vent hose routed across the tank toward the fuel filler opening.

FUEL TANK VENT LINE: A piece of rubber hose about three feet long runs from the vent fitting on top of the tank into the fuel filler cavity through a grommet, and the downward-pointing end is secured with a clip. Hardly anyone ever looks at this either, as it requires removal of the tank cover panel in order to inspect it and as a result, it's usually dry-rotted or has separated, and becomes a source of raw fuel or fuel vapors in the tank compartment. If there's any question about its condition, just replace it. While you have the tank cover panel off, check the fitting between the main fuel line and the sending unit and make sure it's tight and dry.

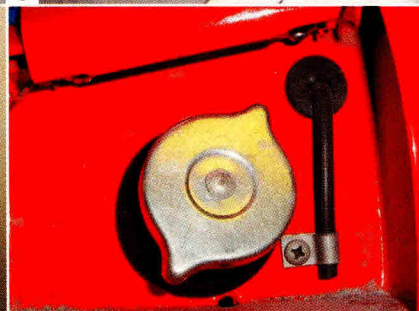
8 A correct mid-'57-up NON-VENTED gas cap and filler cavity with vent hose and clip, grommet, drain hole and nipple. A drain hose runs from the bottom of the nipple out through the underbody.

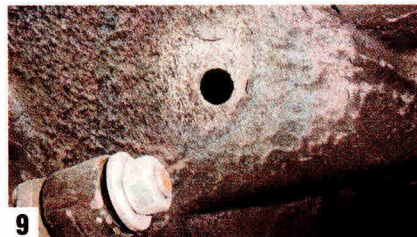
9 This is the underbody hole for the drain hose and grommet, both of which are usually missing. It's directly above the front of the rear spring.

This drain hose (and usually the grommet) is missing on probably 90 percent of C1s, as most folks don't know it's supposed to be there. When it's missing, the fuel spillage from the filler cavity drains through the nipple and pools INSIDE the underbody, and really stinks up the cockpit, especially when the top is up. The fix is simple – add the hose and grommet after removing the tank cover panel so spilled fuel dribbles on the pavement, not inside the underbody. I've also seen cars set up with the end of the fuel tank vent hose stuffed into the nipple. Don't do that, as it won't allow fuel spillage in the filler cavity to drain – it'll just pool in the cavity and "stink," and bubble the paint.
