JOHN HINCKLEY

RESOURCEFUL RIV-NUTTING

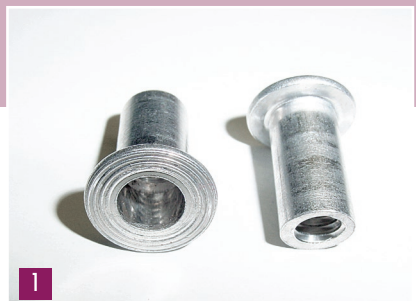
1 The 5/16"-18 aluminum Riv-Nut. They clinch themselves in place permanently when the installation bolt draws the threaded barrel down against the back side of the hole in the sheet metal.

A PERMANENT, ONE-TIME-ONLY METHOD: Use aluminum "Riv-Nuts," which are designed to replace stripped threads in blind holes in sheet metal with strong, permanent-threaded inserts that clinch themselves solidly in place. "Riv-Nuts" are commonly available at industrial supply houses like McMaster-Carr and through aviation supply houses. Get aluminum ones, not the steel ones – the steel ones require expensive installation tools – but the aluminum ones can be installed with home tools. The ones you need are 5/16"-18 x 1", Riv-Nut part number A31-125.

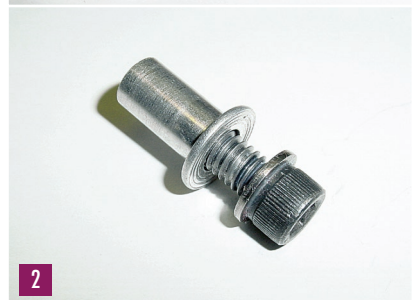
2 Here's the home-made Riv-Nut installation tool. When the bolt bottoms out on the flange, it distorts the "barrel" to clinch the Riv-Nut in place. Oil the threads and the washer to simplify the installation.

You can make an installation tool by using a 5/16"-18 x 1-1/4" Allen-head cap screw and a small-diameter AN flat washer (see photo); this will

allow you to hold the flange on the Riv-Nut stationary with Channel locks while you drive the cap screw in with an Allen-head bit. When the screw bottoms out, it continues to pull the threaded barrel portion of the Riv-Nut toward the flange and the barrel distorts (like a pop rivet) and clinches the Riv-Nut in place from the back side of the hole. If you oil the threads and both sides of the washer and drive it with an impact wrench, starting with the screw only engaged two or three threads, it will install and clinch instantly. Install the tub with 1/2" hex 5/16"-18 washer head screws, and nobody will ever know the difference – and the repair is permanent. ■

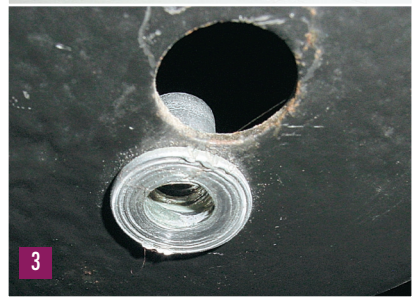
3 Riv-Nut installed in one of the holes in the frame crossmember. This is a permanent repair, and stays in place even with repeated disassembly.
