Ignorance Is Not Always Bliss!

Installing Air Conditioning in My Solid Axle Corvette

by Tom Blount

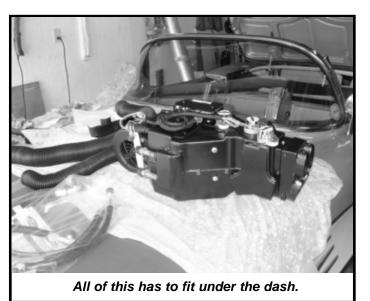
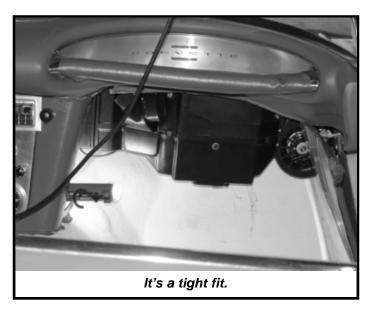
This is the time to reroute refrigerant hoses towards fender sides to facilitate future battery removals. A better alternative is to relocate the battery to the trunk.

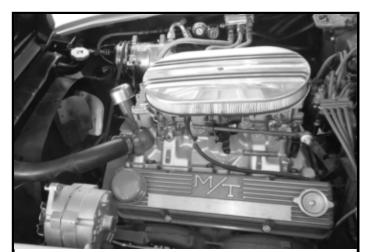
Fabrication is needed to solve hood strut clearance problems.

Charging unit, now an alternator, is relocated to to the left side. Compressor is located to the right.

Getting the hood to open and close was a good two week project, ably assisted by Monte and his ingenuity, note he had to make a special bracket for the hood support rod. I ended up dropping the 13" electrical fan about 3" lower than the condenser coil due to hood lip issues. I also had to adjust belt lengths in 1/2 increments to get them to fit, ended up with a 54 and a 58 inch belt

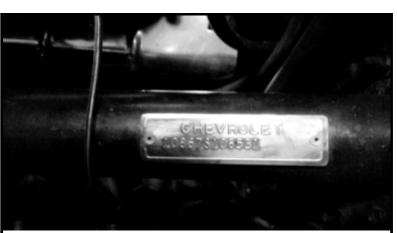
Reunited: The original VIN tag was re-installed by Paragon Corvette

About a week later I returned to Paragon's and had them spot weld the tag on the steering column. Mission accomplished! Total cost: a couple months of sleepless nights, \$200 charge from Paragon to access the proper spot on the frame and do the "rubbing", another \$25 to spot weld the tag back on the steering column and another \$25 to the nefarious chap that had my tag. Total: \$250.

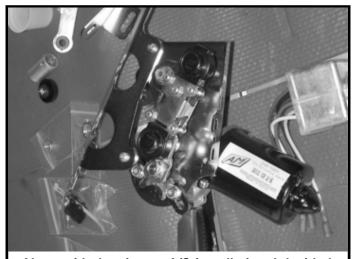
Along with the vintage A/C installation, I decided to install a new Raingear electric wiper system.

- A. Don't install raingear wipers and vintage air systems together. The raingear motor and drive contacted the vintage air vent distributor as well as the cowl vent. Get another wiper system unless you are prepared to do a lot of tweaking.

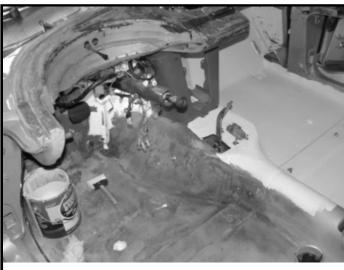
Beginning of the interior insulating process.

Insulation is very important, as you have to not only worry about engine/exhaust heat, but you have to contend with air flow through the car at higher speeds. Roger Lester reported his car would freeze your knees at 55, but you wouldn't know it was on at 80! Mike Coletta taped up his first restomod driver's door and windshield, and then blocked off hot air coming from behind the seats and the glove box. He also put a WHITE towel on the rear

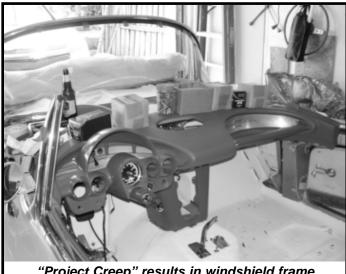
"Project Creep" results in windshield frame being removed for new dash pad.

Project Creep - My "while you're at it list" includes electric fan, conversion to alternator, changing out both exhaust manifolds with Por manifold dressing, new brackets, pulleys, raingear wipers, new Al Knock padded dash, replacing original Wonderbar radio and speaker with aftermarket units, electronic tach, insulation coating and fabric and installing Stewart Warner vacuum gauge in space previously occupied by the clock. Monte Hagerman's assistance in materials, technical expertise and encouragement has been invaluable.

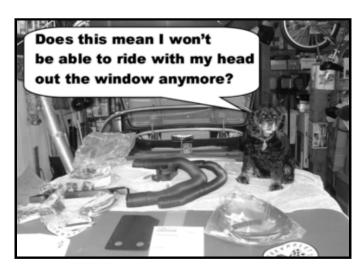
Monte Hagerman and I recently decided to upgrade our rides via Vintage Air so we could enjoy our cars throughout the year. There are many considerations involved when making that decision. Monte and I went on slightly different directions, but it has been an interesting journey. Special thanks to Roger Lester, Mike Coletta and Bill Fleckenstein for their advice. I, hopefully, have quoted them correctly. My original one month journey, unfortunately, evolved into a four month saga. But as Monte says, "The fun is in the journey." And, as some like to say, "Are we having fun yet?" My '60 went down on Memorial Day, but Monte's '61 hasn't been on the road in 20 years and he is rebuilding the drive train. As luck would have it, my '60 had cold air on the first day in autumn. How's that for timing? Just one season off!

BASIC - A bare installation requires removal of the heater and associated controls. The new unit will require mounting the evaporator assembly, new controls, hoses, compressor and the new condenser. You will also need to replace the crankshaft and water pump pulley with a dual pulley. It is also advisable/neater to mount the compressor on the driver's side, thereby requiring the relocation of the generator to the driver's side. These installations required extensive tweaking due to closed hood clearances.

Lessons Learned – Keeping in mind my skills are Bubba level and Monte is a skilled fabricator, we learned that a lot of things didn't fit or work as planned, which extended the "journey" accordingly. A skilled professional like Mike Coletta can make anything work and makes it look easy. But for the rest of us, if I had to do it again, here are some recommendations:
