Midyear Corvette Auxiliary Hardtop

Exterior Configuration

Midyear Hardtop Plexiglas Window Date Codes

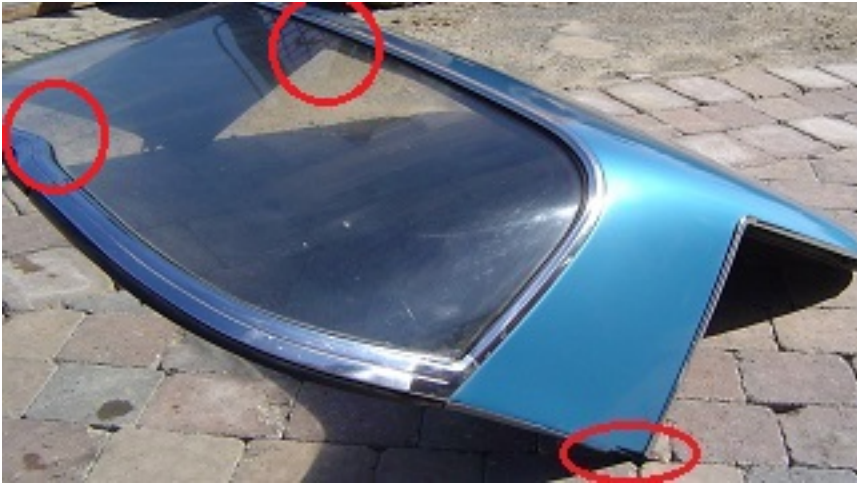
Pictured is an early '63 hardtop with side notches and no Plexiglas window reinforcements:

There were at least three different hardtop configurations in '63. Early '63's had a slight notch cut in the bottom, on each side, above the rear edge of the door to give greater clearance above the door. This design ran to about March '63.

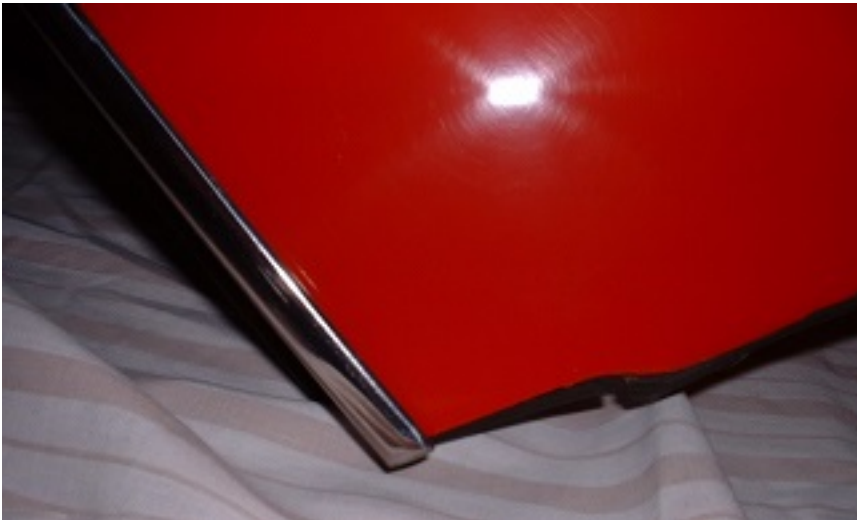
This picture is a close-up of the early '63 side notch (Plexiglas date February '63):

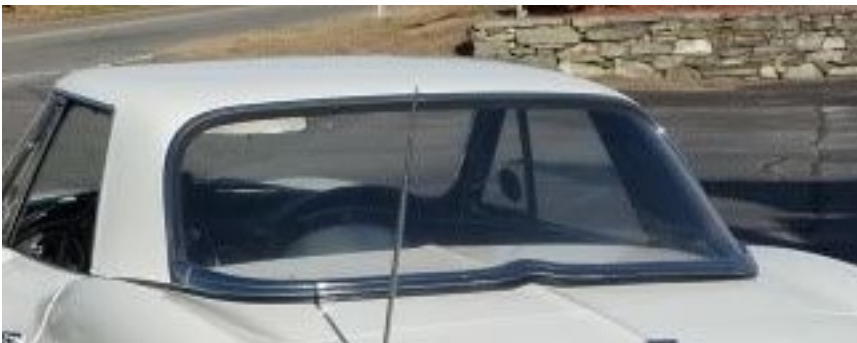
Pictured is a '63 hardtop (Plexiglas date May '63) without the door notches and without Plexiglas window reinforcements:

Tops from approximately April through June '63 did not have the notch. The notch was eliminated because it wasn't necessary.

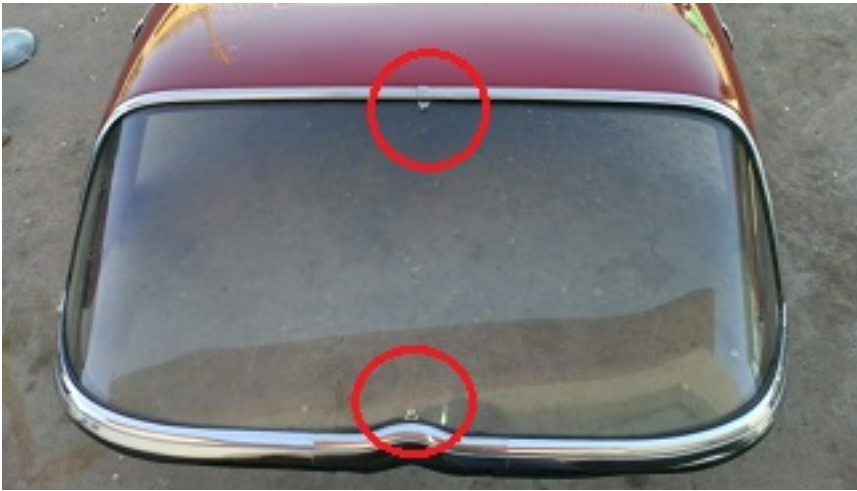
This picture shows the upper and lower Plexiglas reinforcements:

Tops after about June '63 have reinforcing brackets at the top and bottom center of the Plexiglas. Very late '63 through '67 tops were essentially the same.

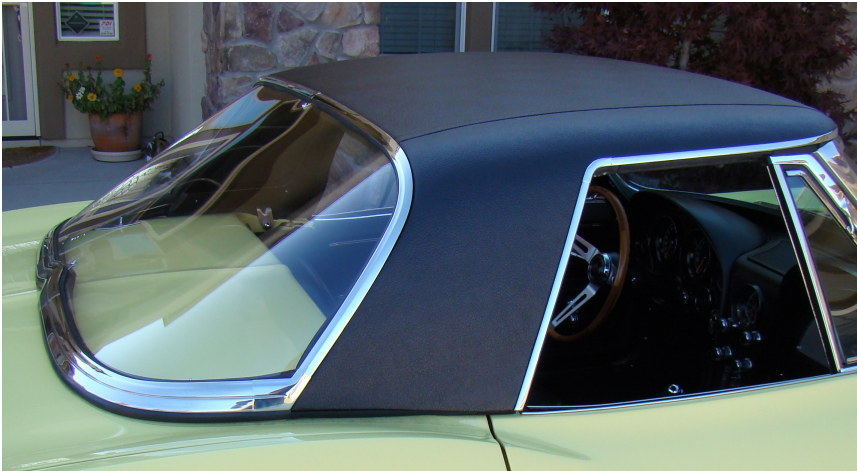
Then there was the '67 only black vinyl exterior covered hardtop with two faux sewn seams running from front to back.

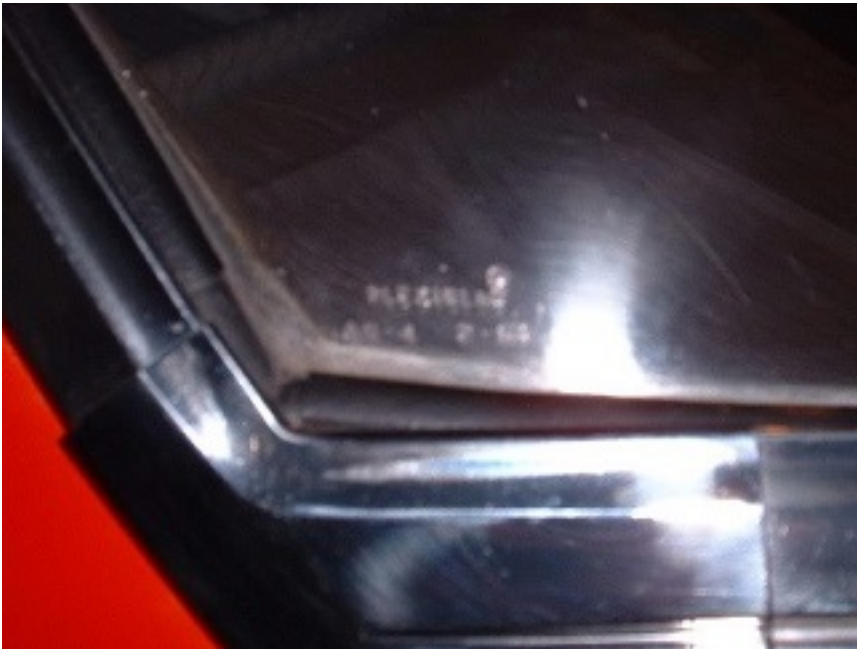
Example: 2 - 63 (February 1963)

(date on same line as AS4) Plexiglas
AS4 MM YY

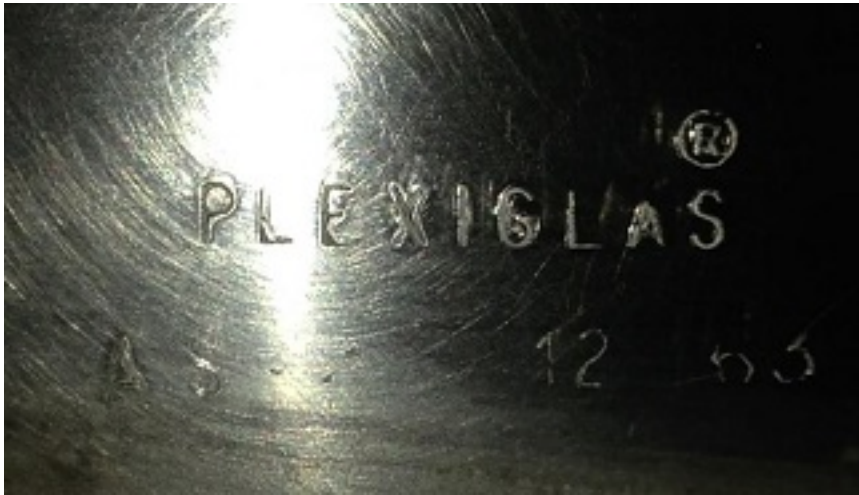
Example: 12 - 63 (December 1963)

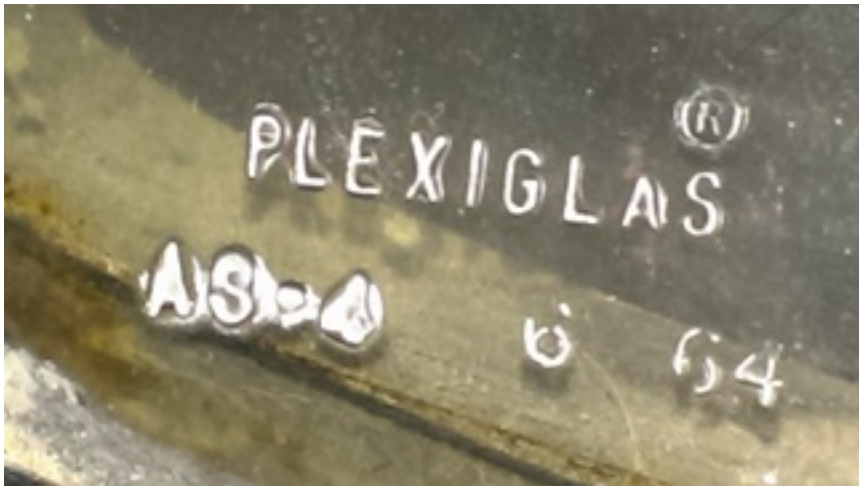
Example: 6 - 64 (June 1964 found on a very early '65 model year)

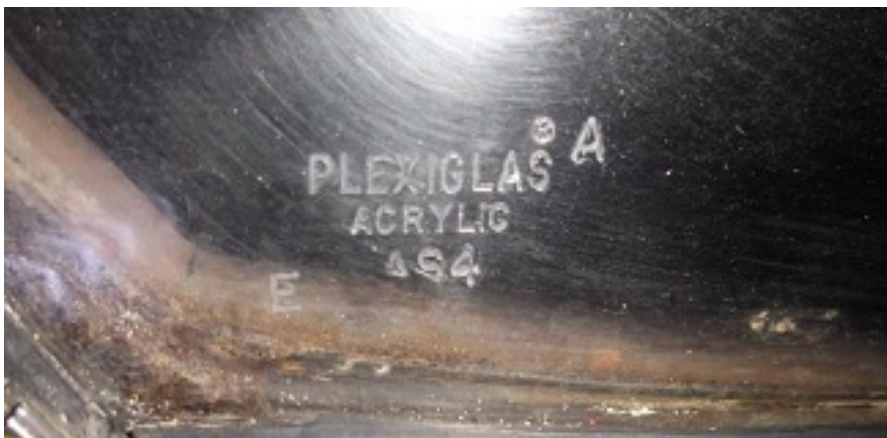
Example: E A (January 1965)

Aug 1964: 64 8
Sept 1964: 64 9
Oct 1964: 64 10
Nov 1964: D K, (also) 64-11
Dec 1964: D L, (also) 64-12
Jan 1965: E A
Feb 1965: E B
Mar 1965: E C
Apr 1965: E D
May 1965: E E
Jun 1965: E F
Jul 1965: E G
Aug 1965: E H

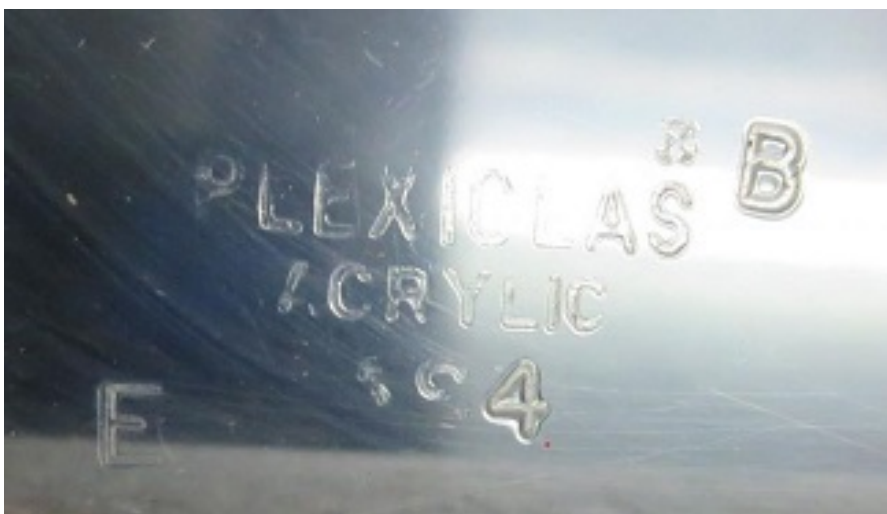
Example: E B (February 1965)

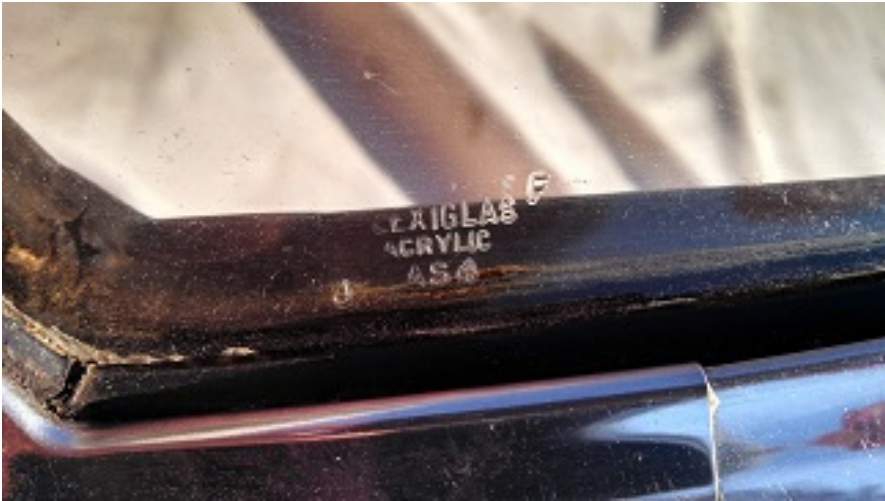
Example: J F (October 1966)

E-65, F-66, G-67

A-Jan thru L-Dec

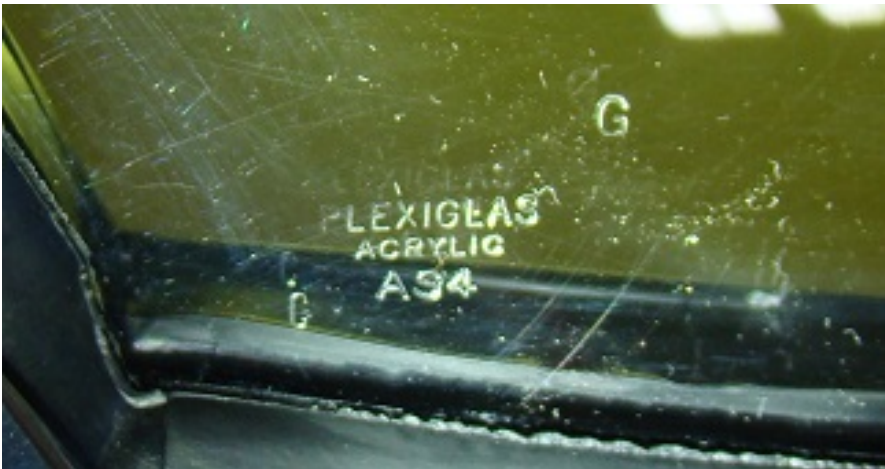
Example: C G (March 1967) (known reproduction)
