Evidence that Dex-Cool Harms the LT5 Cylinder Head Gasket

Marc Haibeck

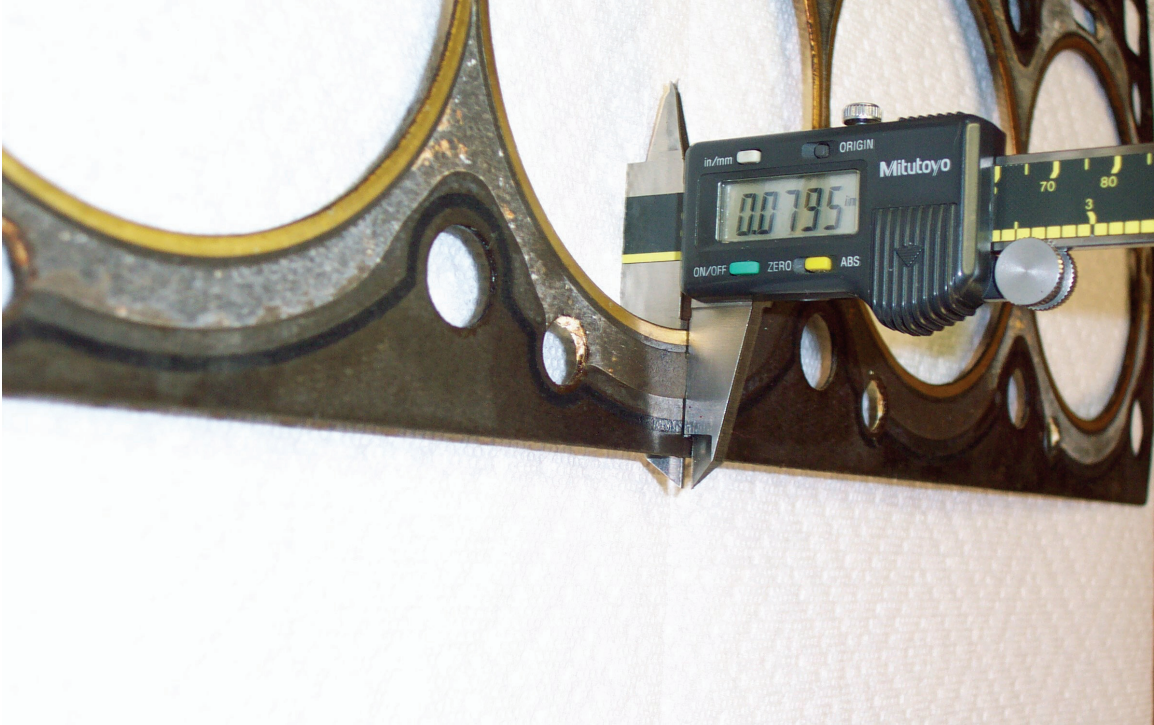
I have observed that coolant with an organic corrosion inhibitor causes the fiber material in the head gasket to swell more than with silicate corrosion inhibitor. Dex-Cool has an organic corrosion inhibitor and is color-coded orange. Conventional coolant has a silicate based corrosion inhibitor and is color-coded green. The head gasket is not compressed in the areas outside of the cylinder liners, so that area normally can swell. Engines that use the green silicate corrosion inhibitor are found to have gasket swelling of about .010". The thickness of a new gasket is .070". When installed the gasket is compressed to .065". A removed gasket is normally .068" thick in the compressed areas. The uncompressed areas are about .079" thick. This gasket was removed from a factory assembled engine with 10k miles.

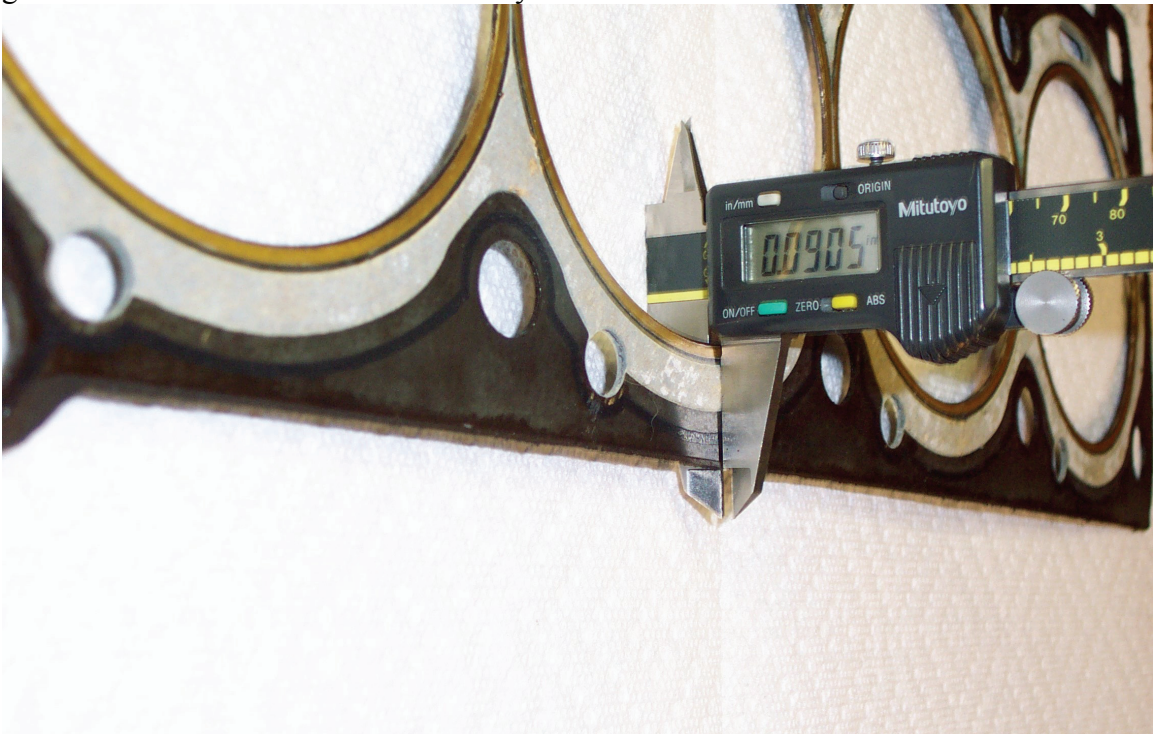
A gasket exposed to coolant with organic corrosion inhibitor swells much more. This gasket was used with Dex-Cool for one year.

I believe that this is evidence that the fiber material is softened by coolant with an organic corrosion inhibitor. If the fiber is softened, it is possible that the sealing ring around the cylinder can loosen because it is crimped over the fiber.

Since it is possible that the head gasket material is softened by organic corrosion inhibitor, coolant containing organic corrosion protection should not be used in the LT5 engine. The possible values of using organic corrosion protection are small. Dex-Cool claims extended service interval and possible longer water pump seal life. It is not worth taking even a small risk since the consequences of head gasket damage are huge.

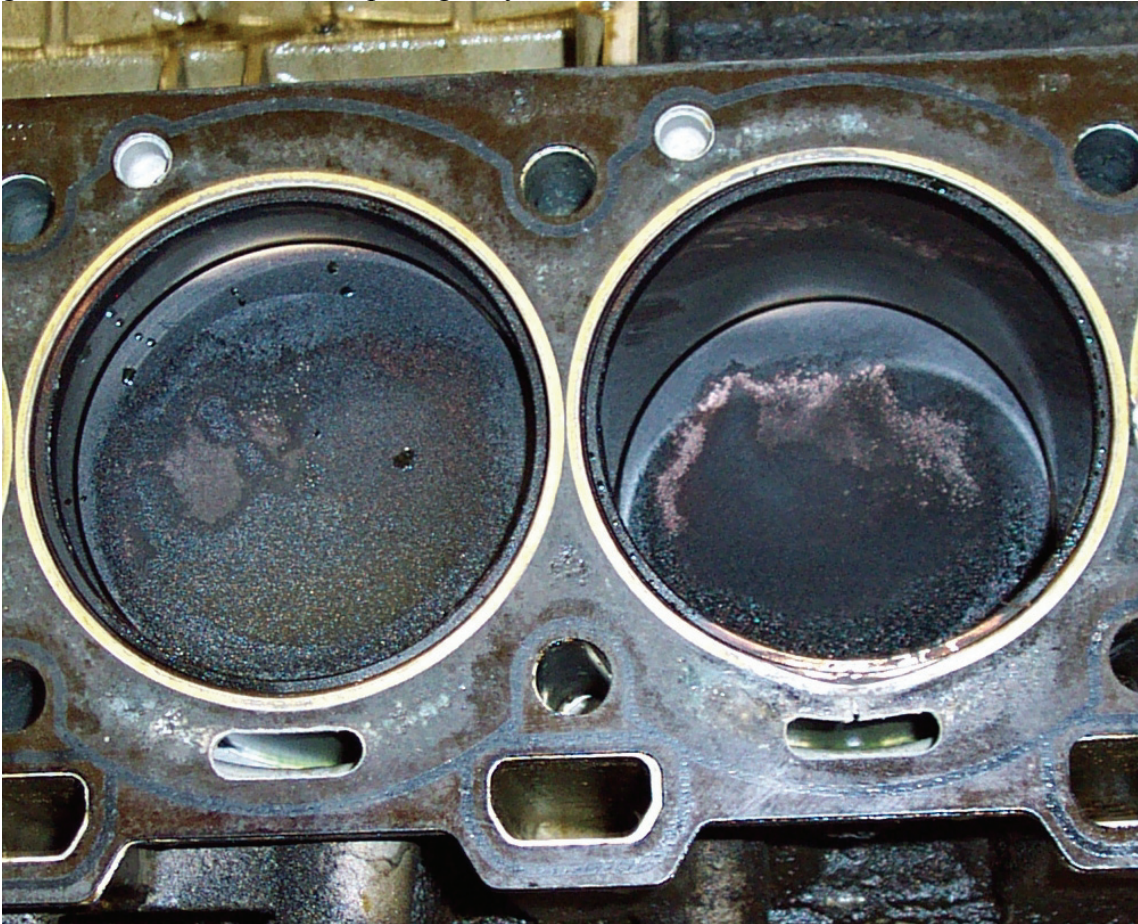
This is a picture of a typical head gasket failure. Pressure in the cylinder has pushed the gasket back into the coolant passageway.
