C6 2005-2013 -Automatic Transmission - Stuck in Neutral or Drive or won't shift out of Park.

How to Release Auto Shifter Stuck in Park or Unable to Get back to Park

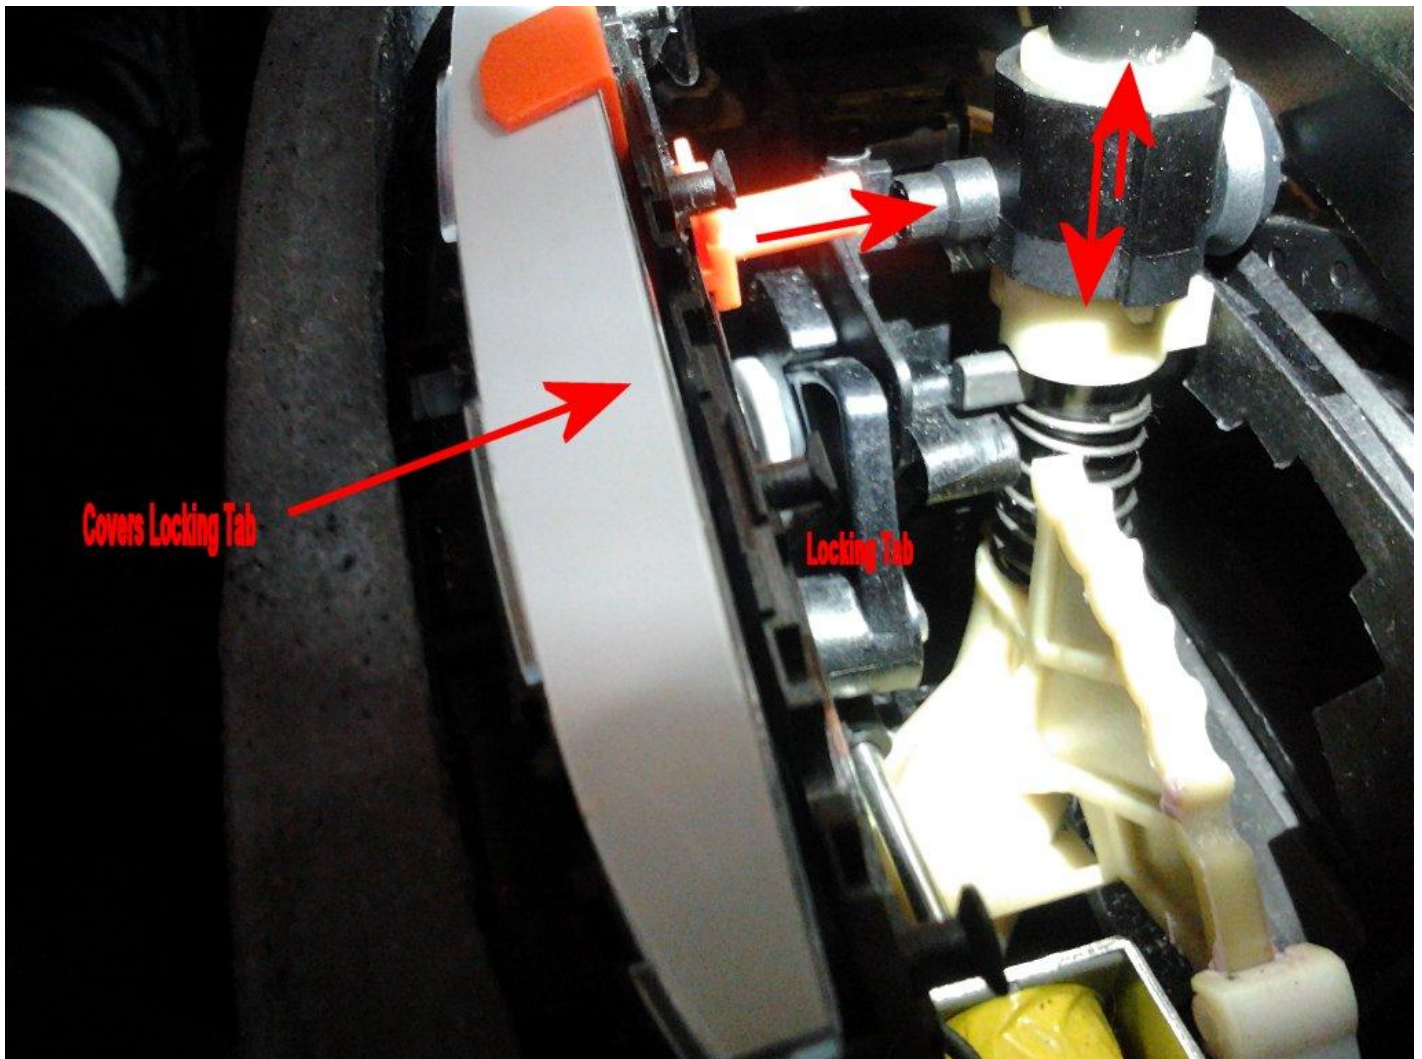
- 8) With the removal of the top section, all the parts that incorporate the shifter mechanism are now in plane view.

The above pics have: the shifter shaft (with black coupling), a solenoid contact limit switch in front of the shifter. This contact limit switch is made when the shifter is in Park. The contact has to be closed in order for the signal to be sent to energize the Transmission Lock Out Solenoid.

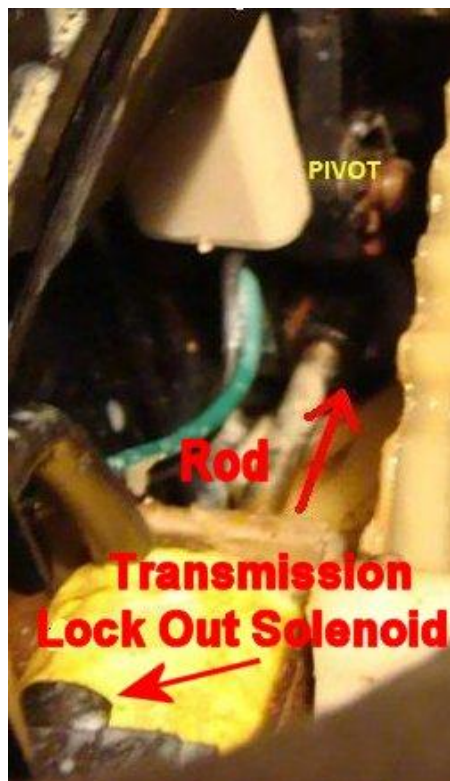
- 9) If the shifter contact limit switch is open, and the Transmission lock out solenoid is not energized, then the shifter will be very stiff to shift out of Park, and will likely not be able to be moved past Drive. For sure, it will be extremely difficult to move back into Park, if not impossible. If the TLO solenoid is not energized, the rod will not move forward to pivot and release the locking pawl (tab).
- 10) The picture below shows a close-up of the Transmission Lock Out Solenoid and rod. When the solenoid is properly energized, it moves the rod forward moving the pivot to release the locking pawl so the shifter button can be depressed and easily moved from Park into gear.

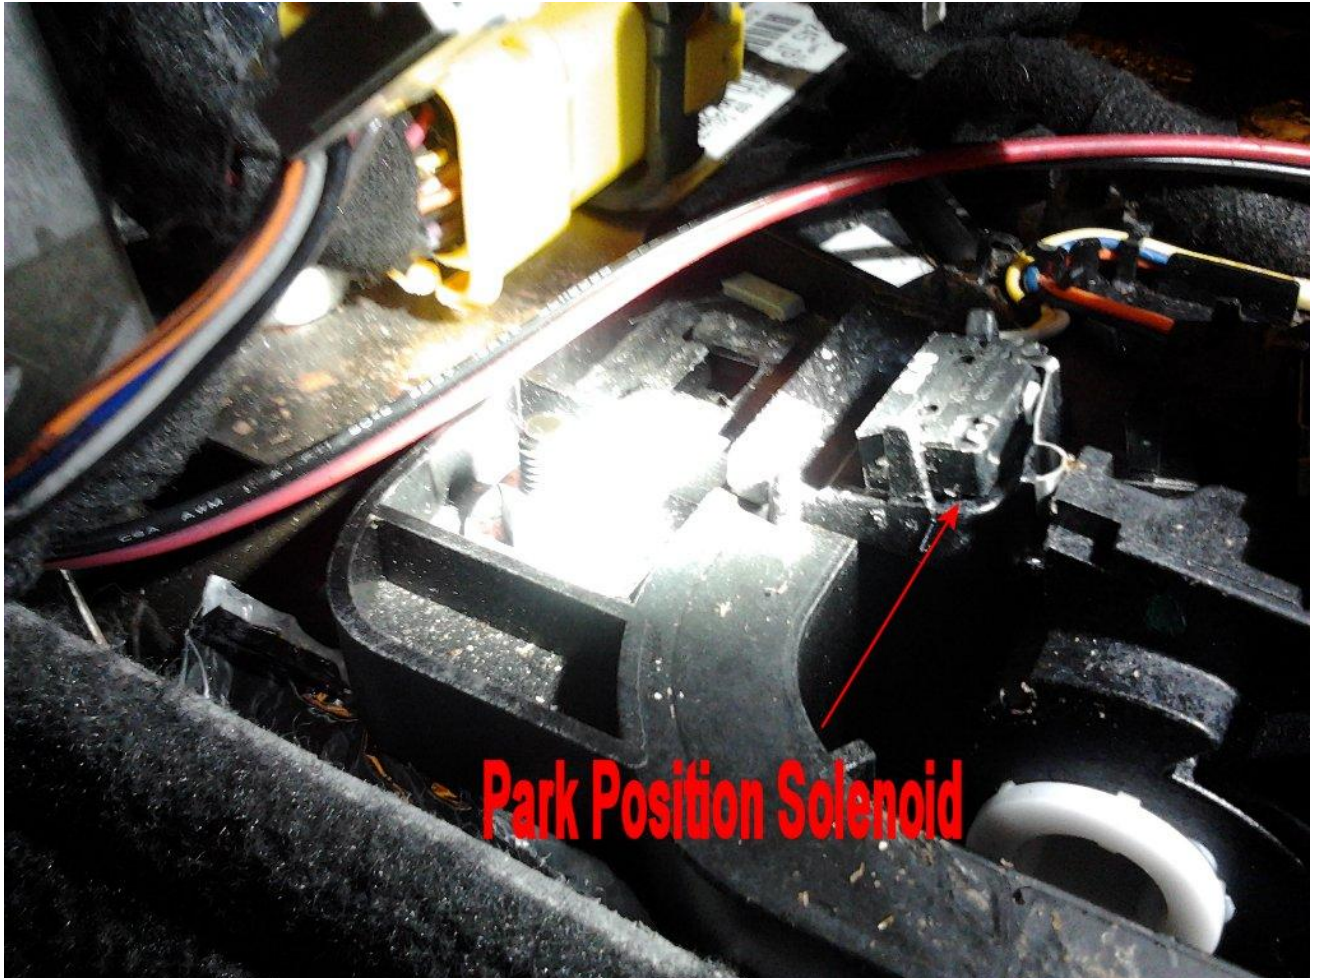
12) Assuming that your transmission is out of Park and stuck somewhere around Drive or Neutral. In order to release the Locking Pawl (tab), a small flat screwdriver can be inserted between the locking pawl and the catch, and pried up to get it released. Once this tab is released, then the shifter finger button can be pushed in, and easily moved into the Park position.

13) The locking pawl (tab) can also be pried and released if the shifter is stuck in Park.
