Rear Hatch button repair - DIY Many pictures

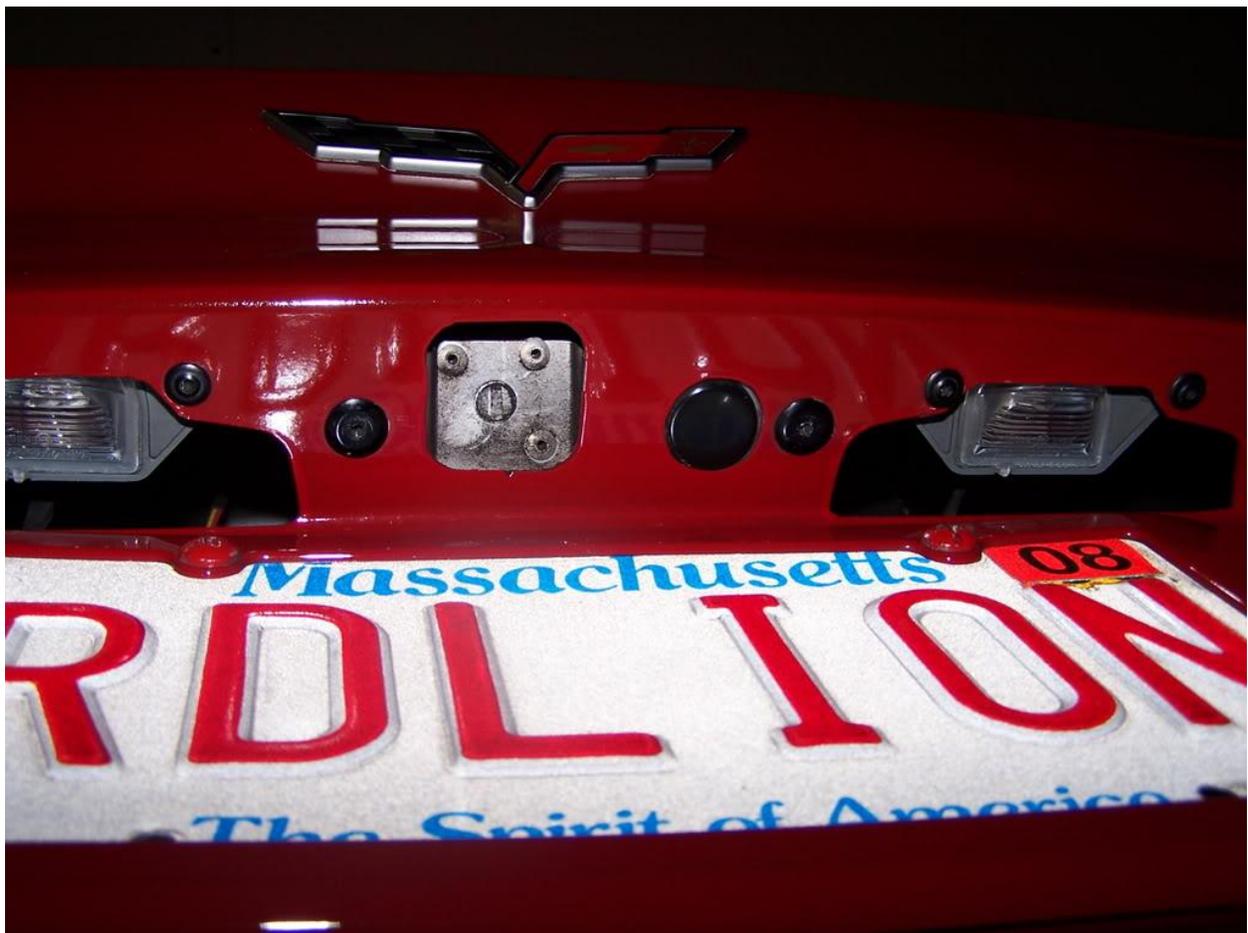
The switch is located above the license plate on the rear fascia.

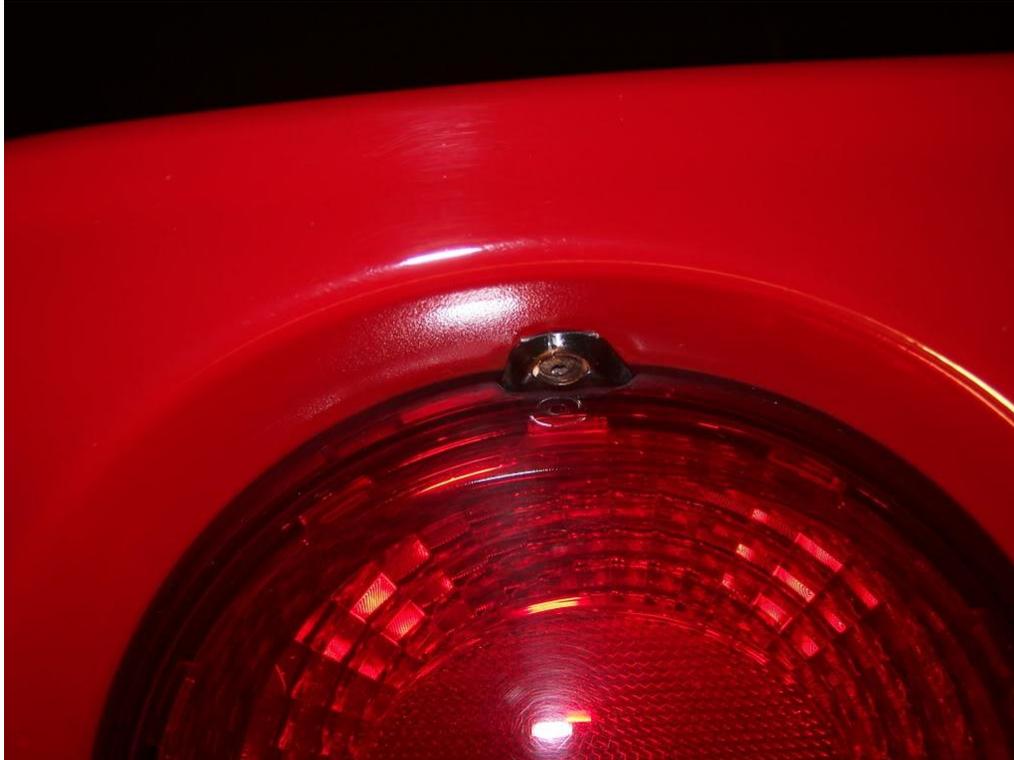
The switch can be accessed by removing the passenger side inner most tail light.

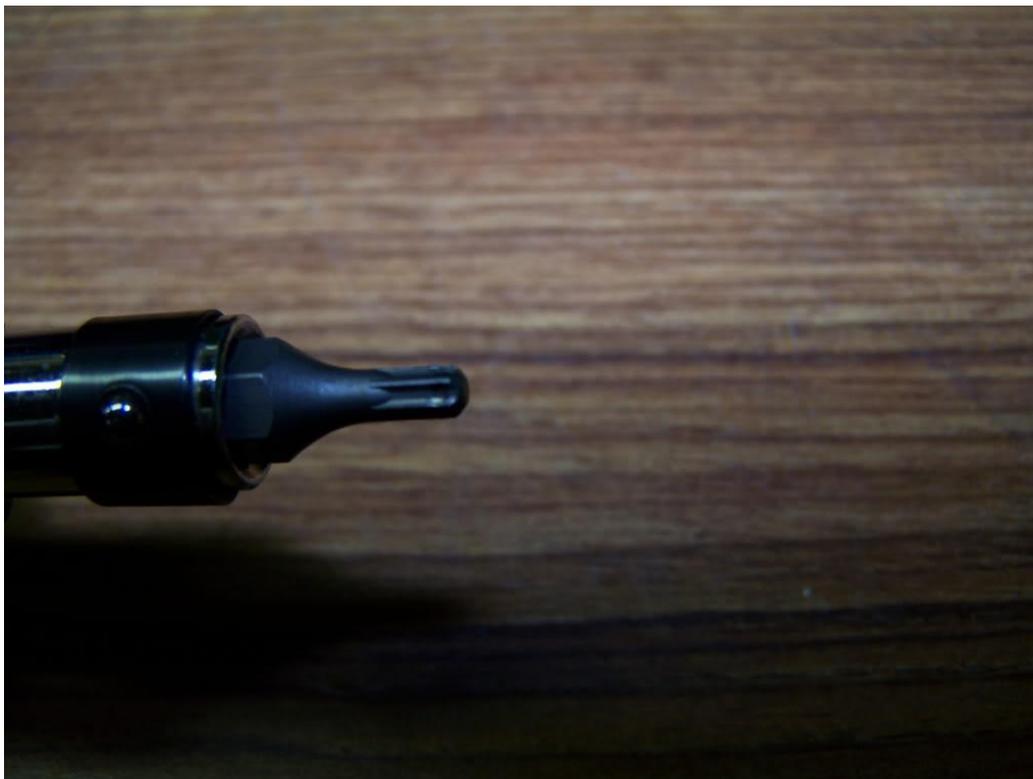
The light is held in place by one T15 Torx screw.

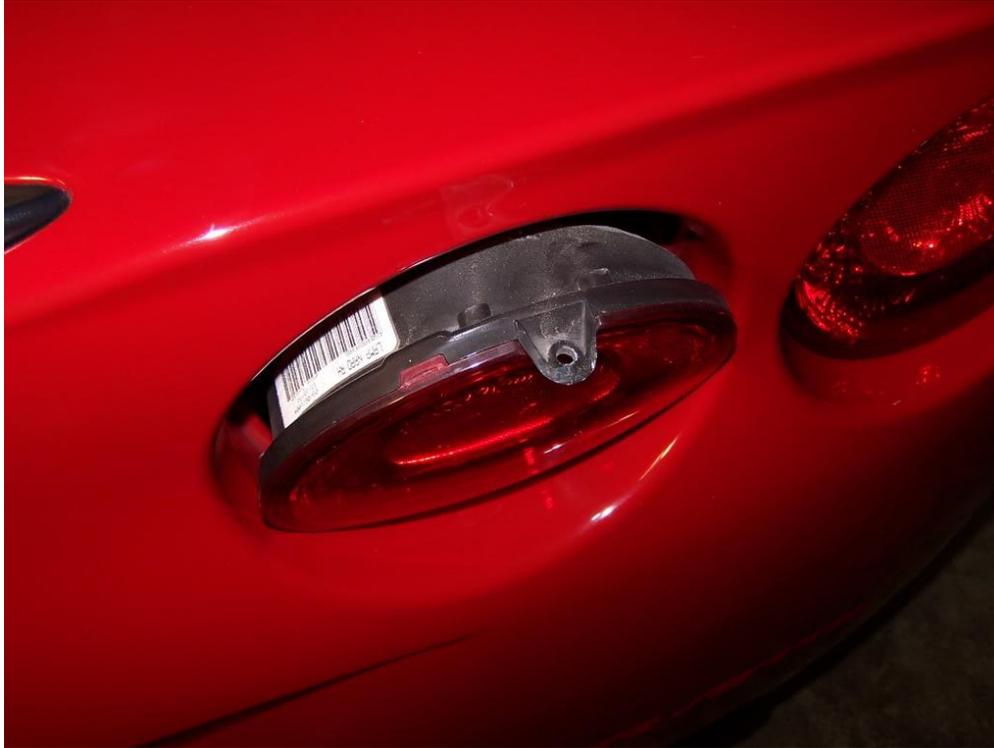
Once the screw is out, tip the tail light forward and remove it.

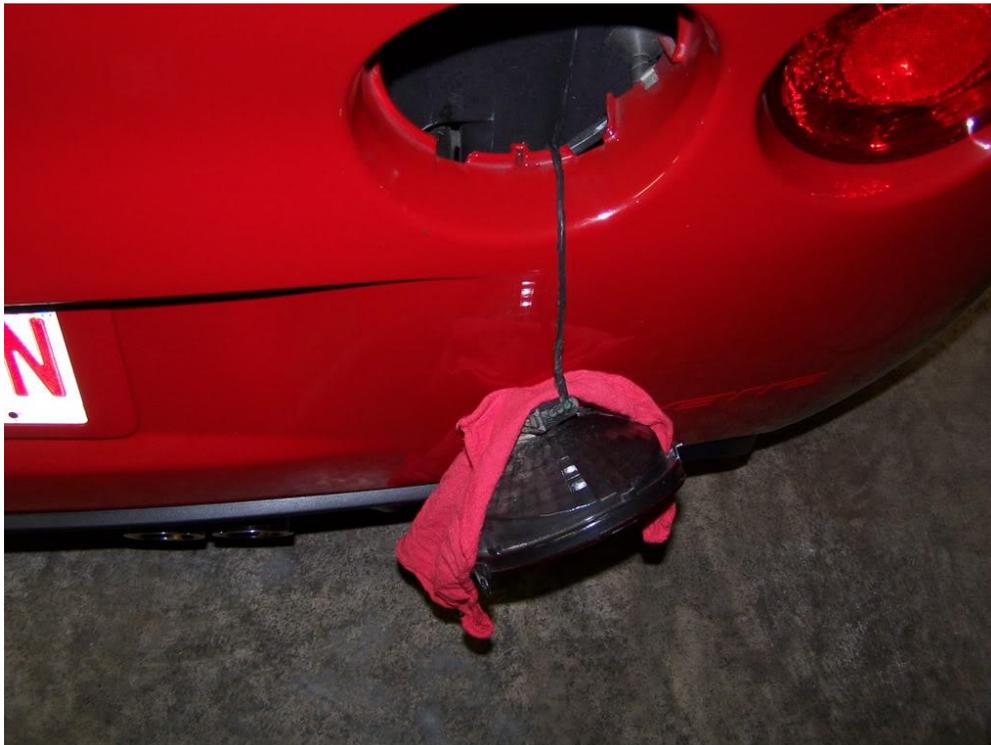
Let the tail light hang down by the harness. I prefer to drape a shop rag over the tail light and rest it against the rear fascia.

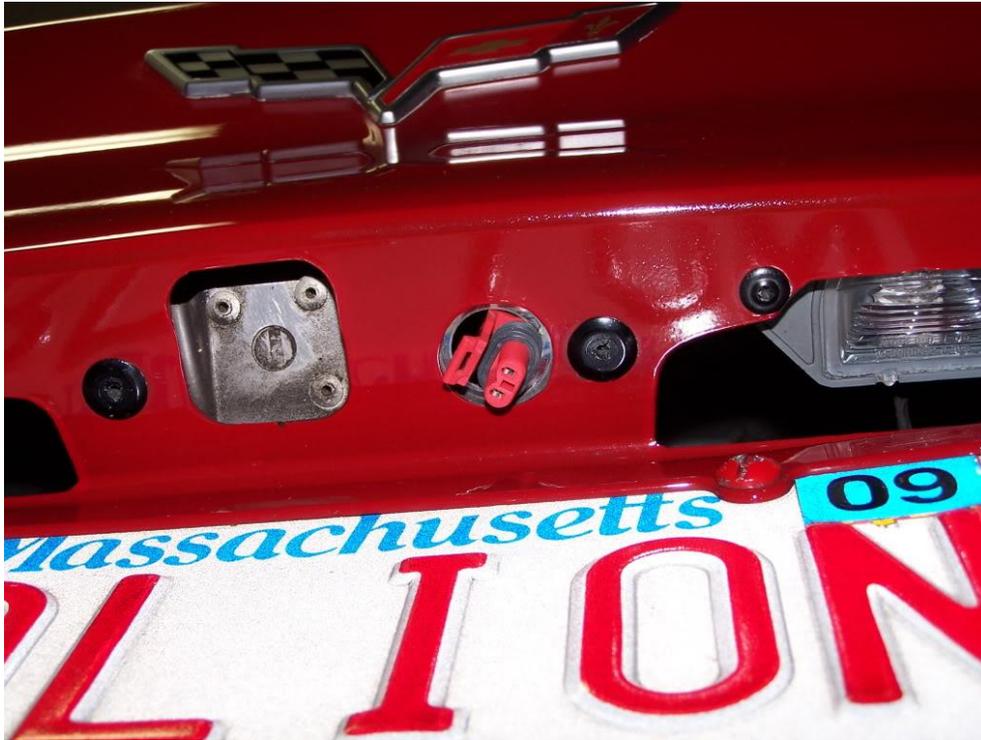
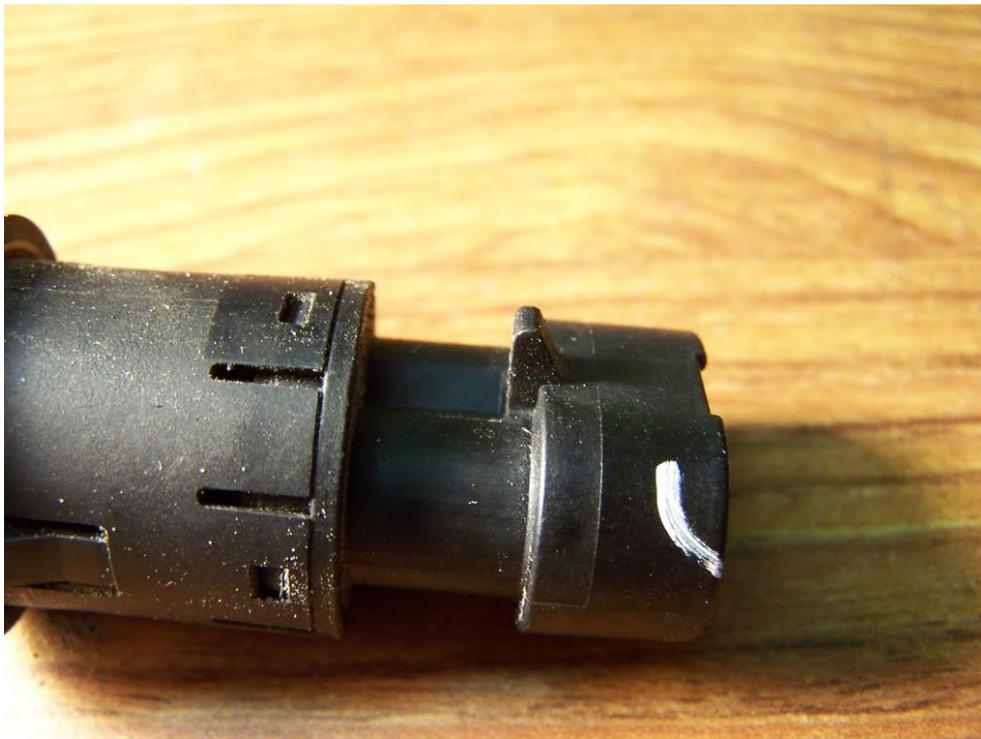
Reach in through the tail light opening and disconnect the wire harness connector from the top of the switch. There is a tab on the side of the connector that must be released to remove it from the switch. You can see the tab in this next photo and the mating detent on the switch housing in the following photo.

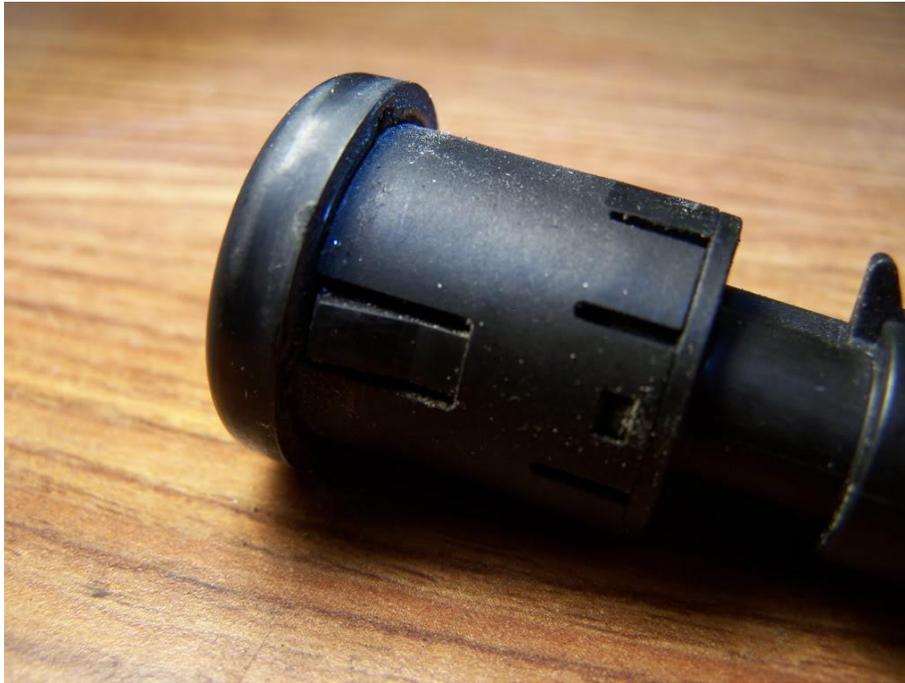
The connector will not fit through the switch opening so you must disconnect it to remove the switch. Once the connector is free there are two press tabs that lock the switch housing in place. You must press these in and the switch housing will drop down out of the rear fascia. You can see the detent in the following picture.

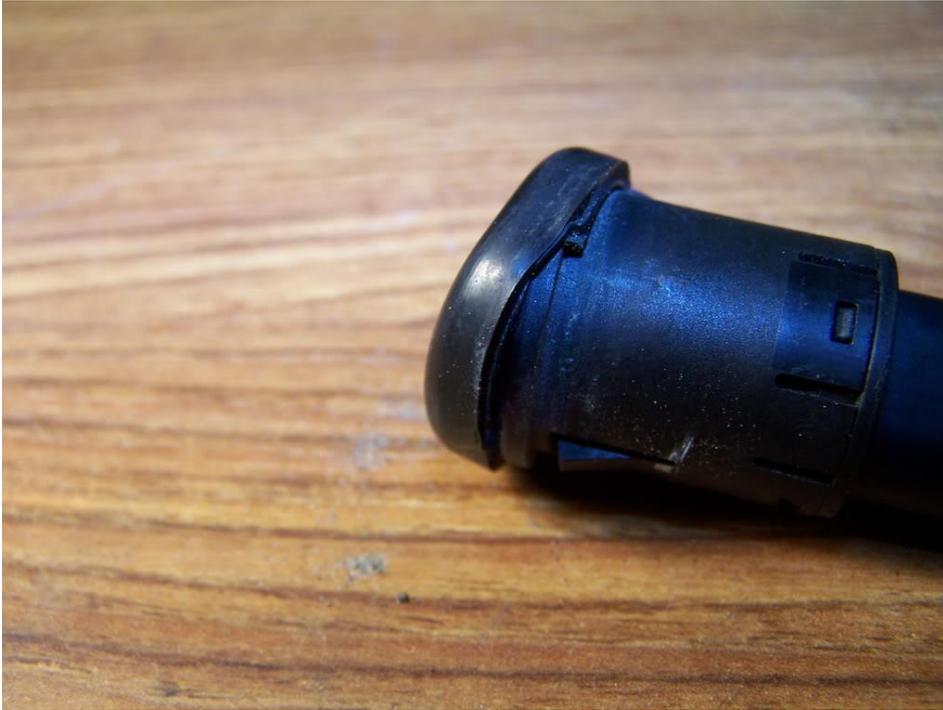
You must remove the rubber cover which is used as a protective cover for the switch. The rubber cover simply peels back.

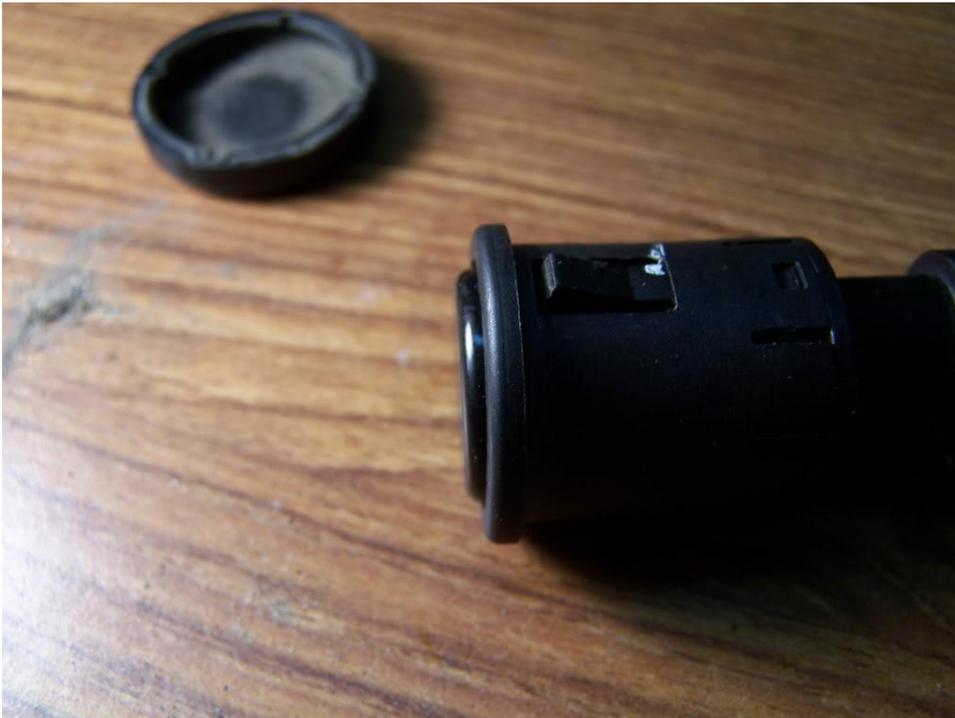
This next picture is how a button should look that will function normally. The plunger should be raised above the switch housing and the plunger should move freely up and down.

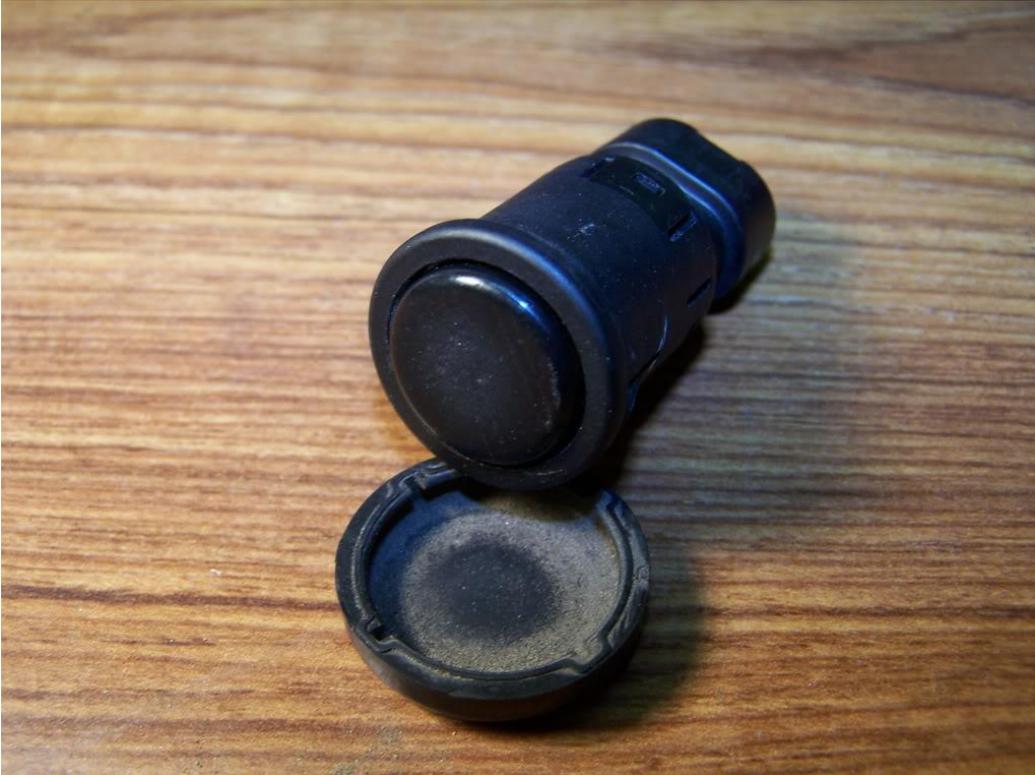
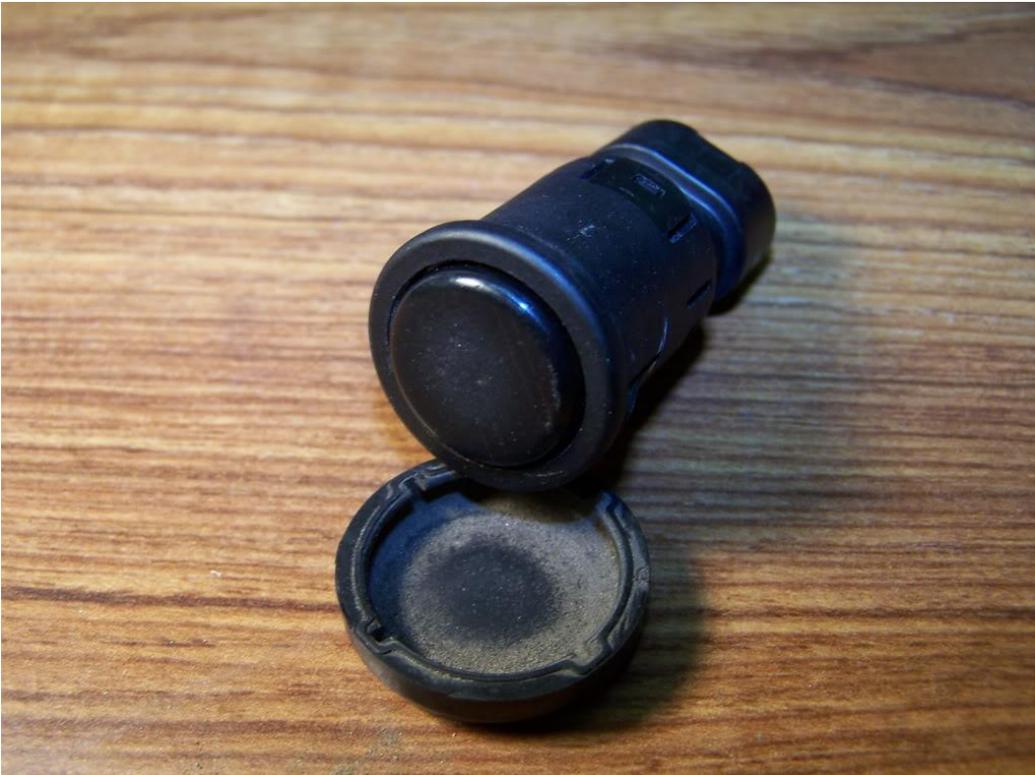
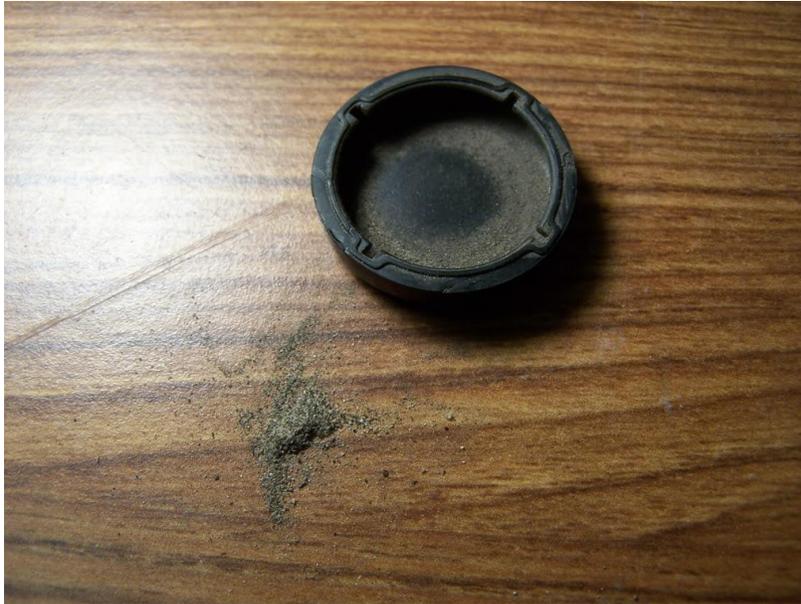
Take a look at what I found in my switch.

This sand and silt is the cause of your switch problems. This was just under the rubber cover. Expect to find more inside.

If your plunger is flush with the surface of the switch it is stuck in the down position and that will be a source of problems. This sand and silt can move around and cause the switch to work intermittently.

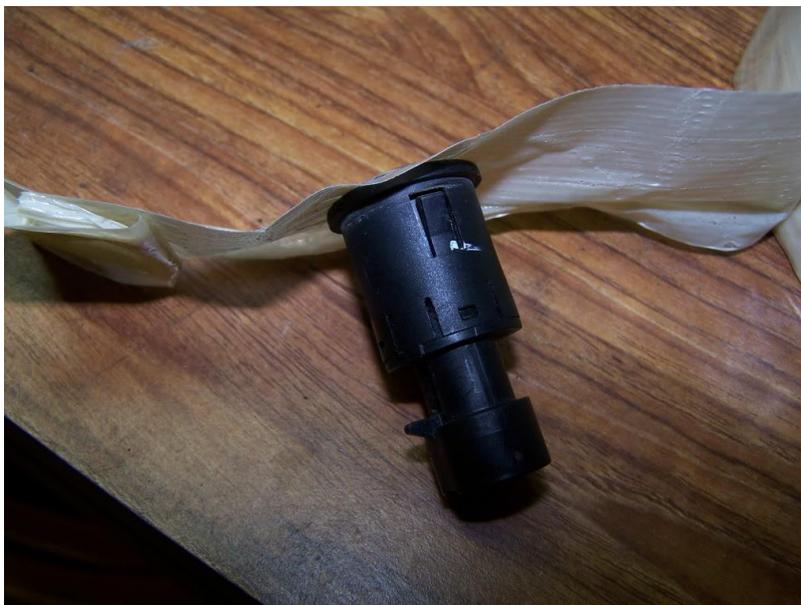
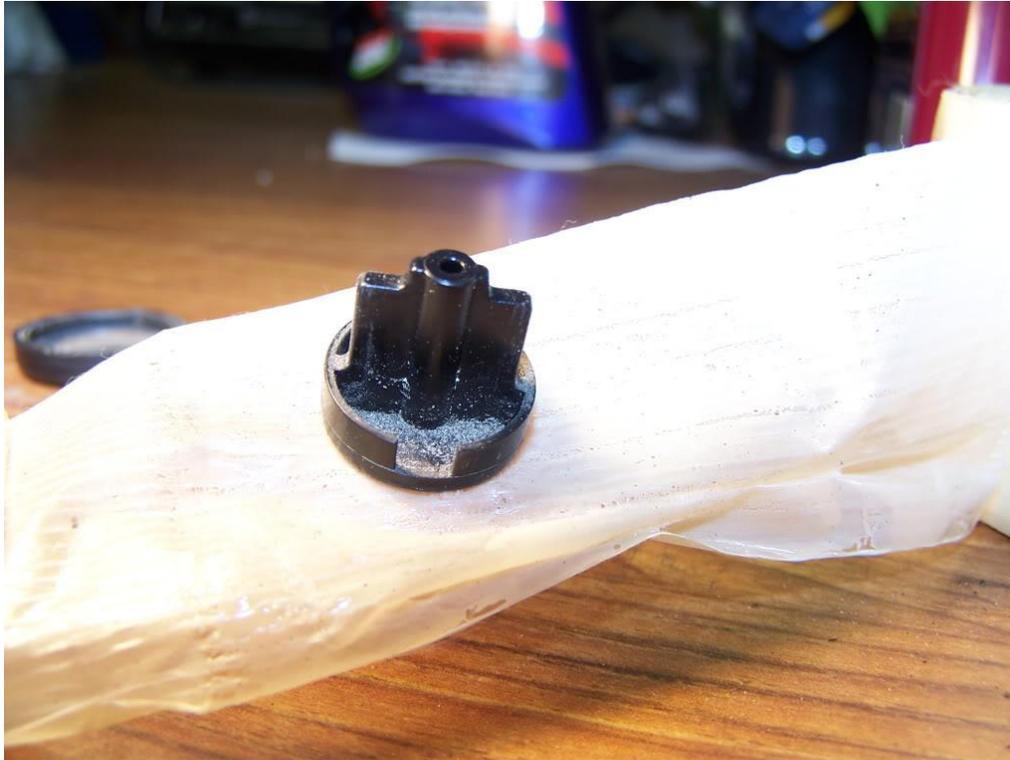
In order to get the plunger out, use a piece of strong tape like duct tape or packing tape. Press the plunger to the sticky side of the tape and pull up on the tape while holding the switch base. This will pull the plunger out of the switch housing which is only a press fit.

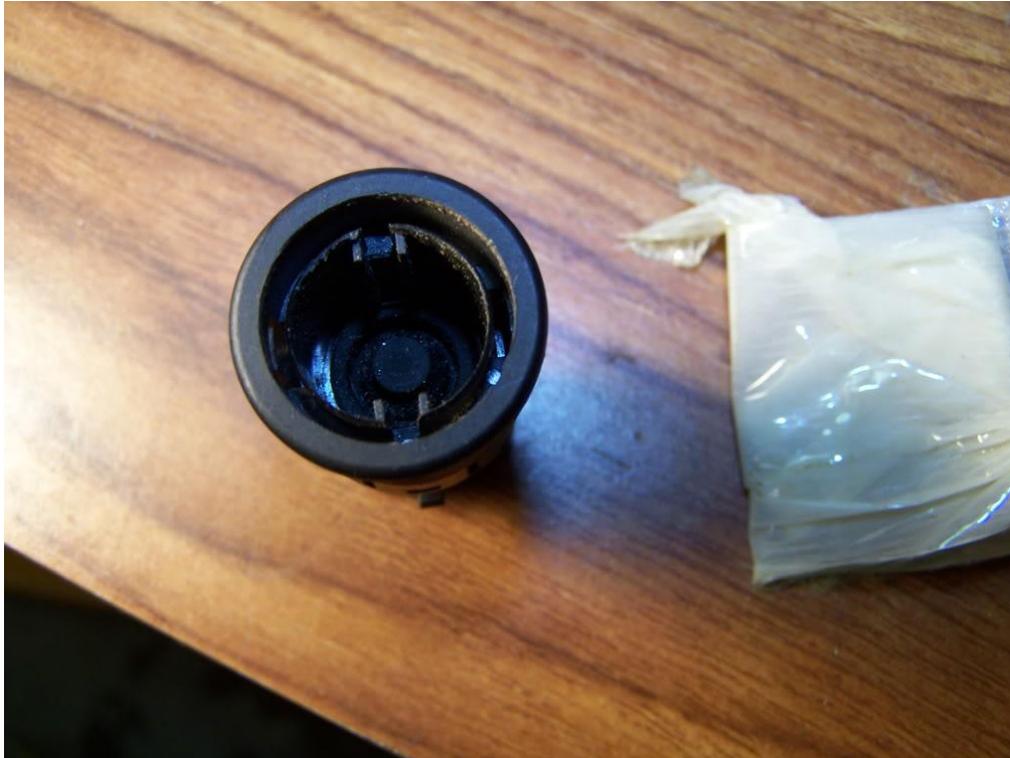
The switch plunger travels in two channels and uses the rubber switch at the bottom as its return spring. It is a sealed switch and there is no need to remove any other components of the assembly. The problem will be the plunger if there is one.
