DIY Fix for "Loose Gas Cap" indicator aka code P0449 w/Pics (member: JKBRIDE)

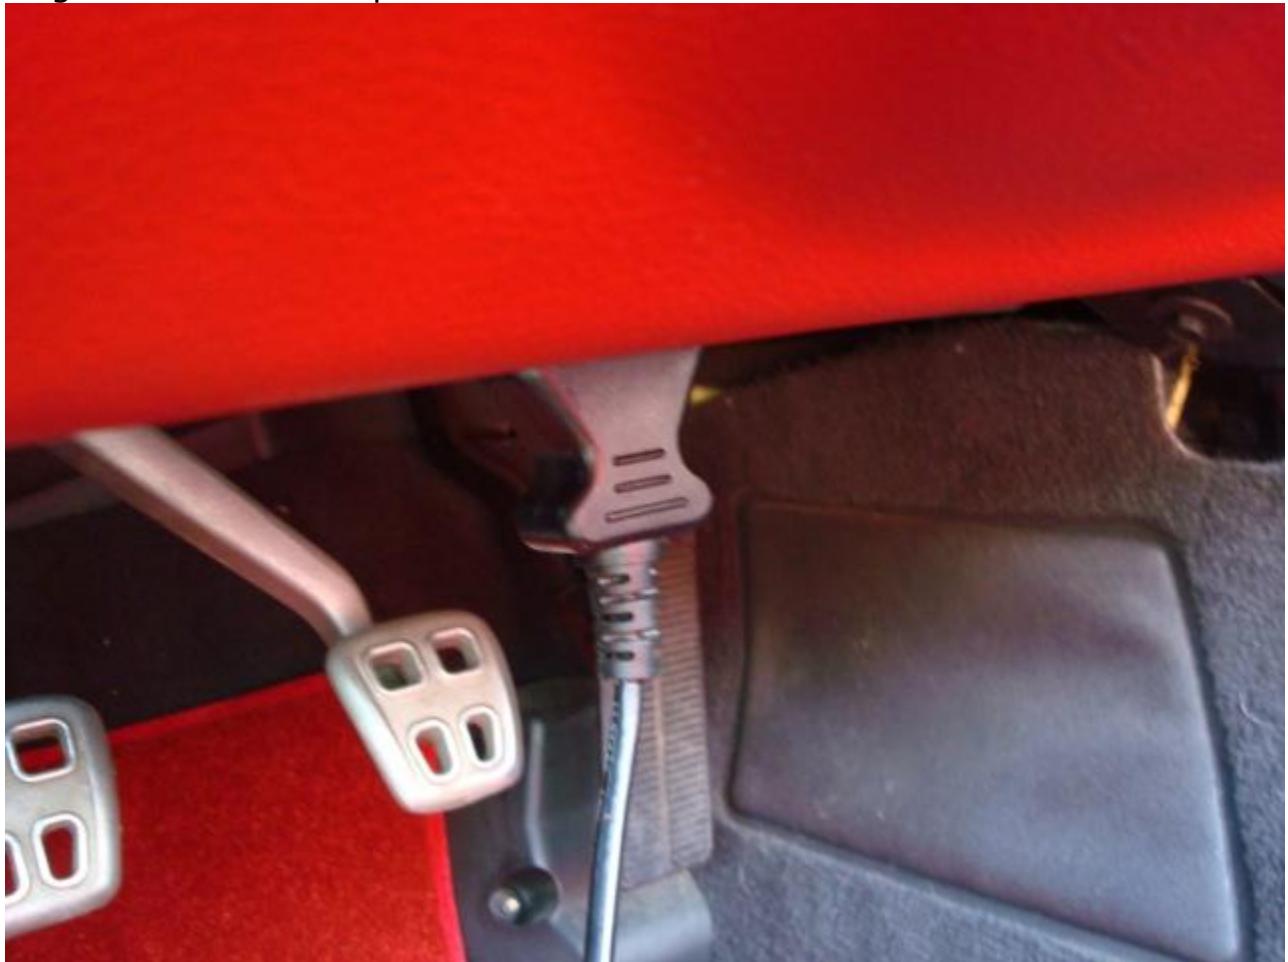
Plug it in the OBD adapter located under the driver's side dash.

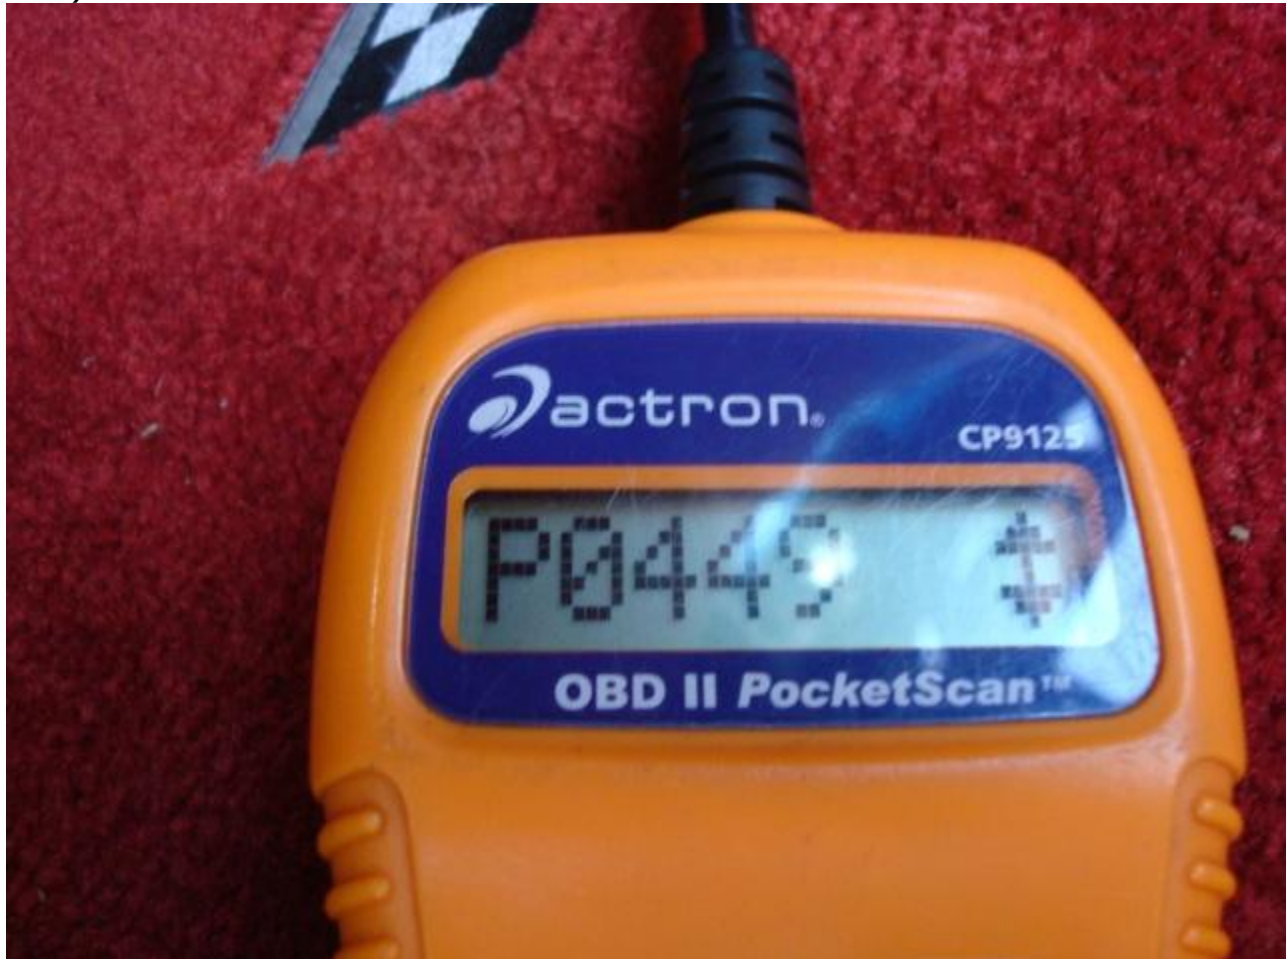
In my case I had a P0449 and a P0455. **P0449** Evaporative Emission Control System Vent Valve/Solenoid Circuit Malfunction and **P0455** Evaporative Emission Control System Leak Detected (gross leak)

I tried resetting my codes, but they would come back within seconds. The next step is purchase a new Fuel Vent Solenoid from your local dealer. In my case it was about \$25. GM also recommends an upgraded harness (\$30)...but it was not needed, so I will return it.

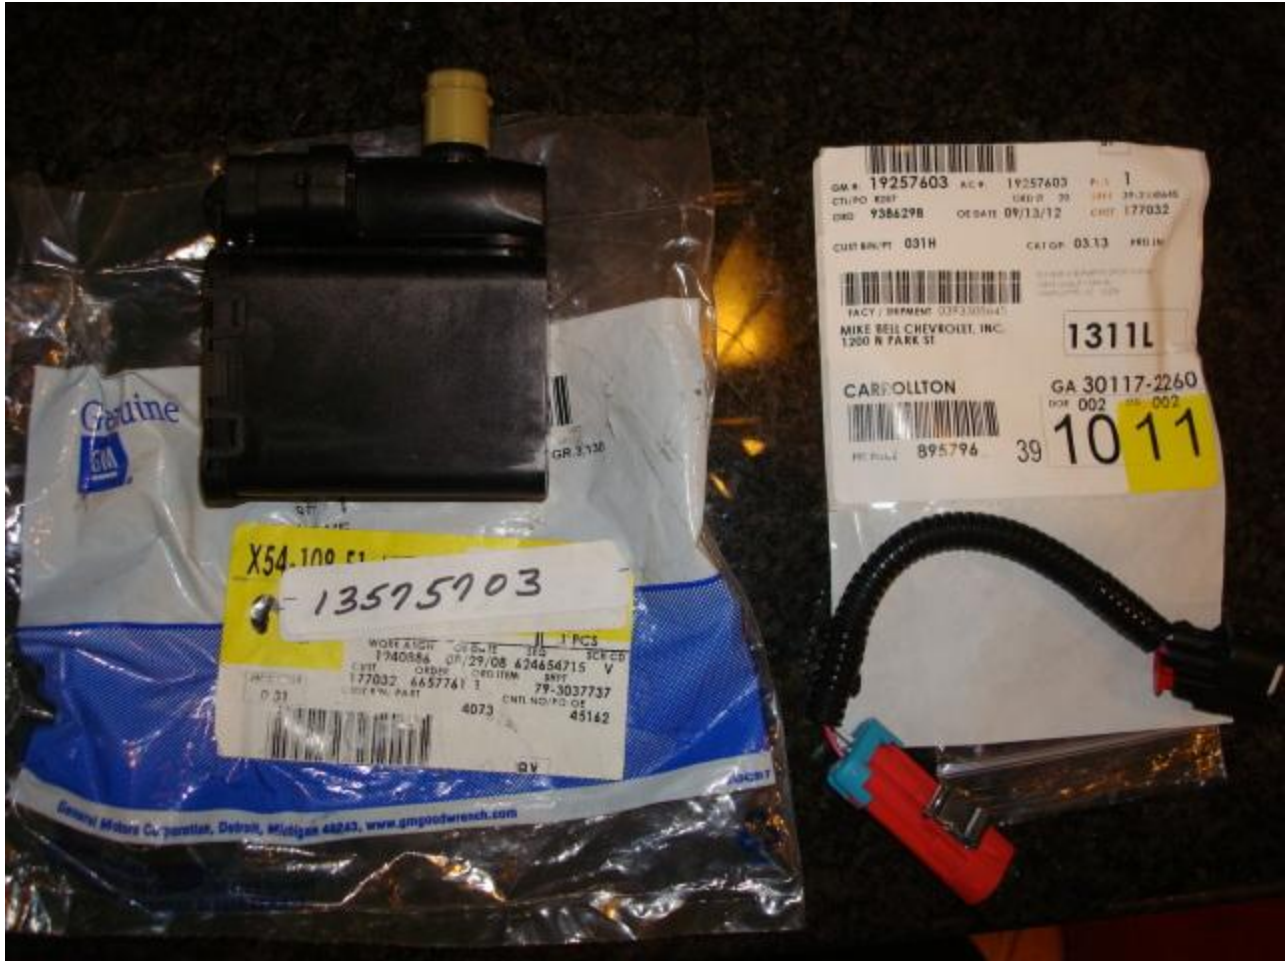
The Fuel Vent Solenoid is located on the passenger side tank near it's top and is easy to get to. I removed my rear tire, jacked up the car, placed jack stands and chocks (I'm super cautious under a car).

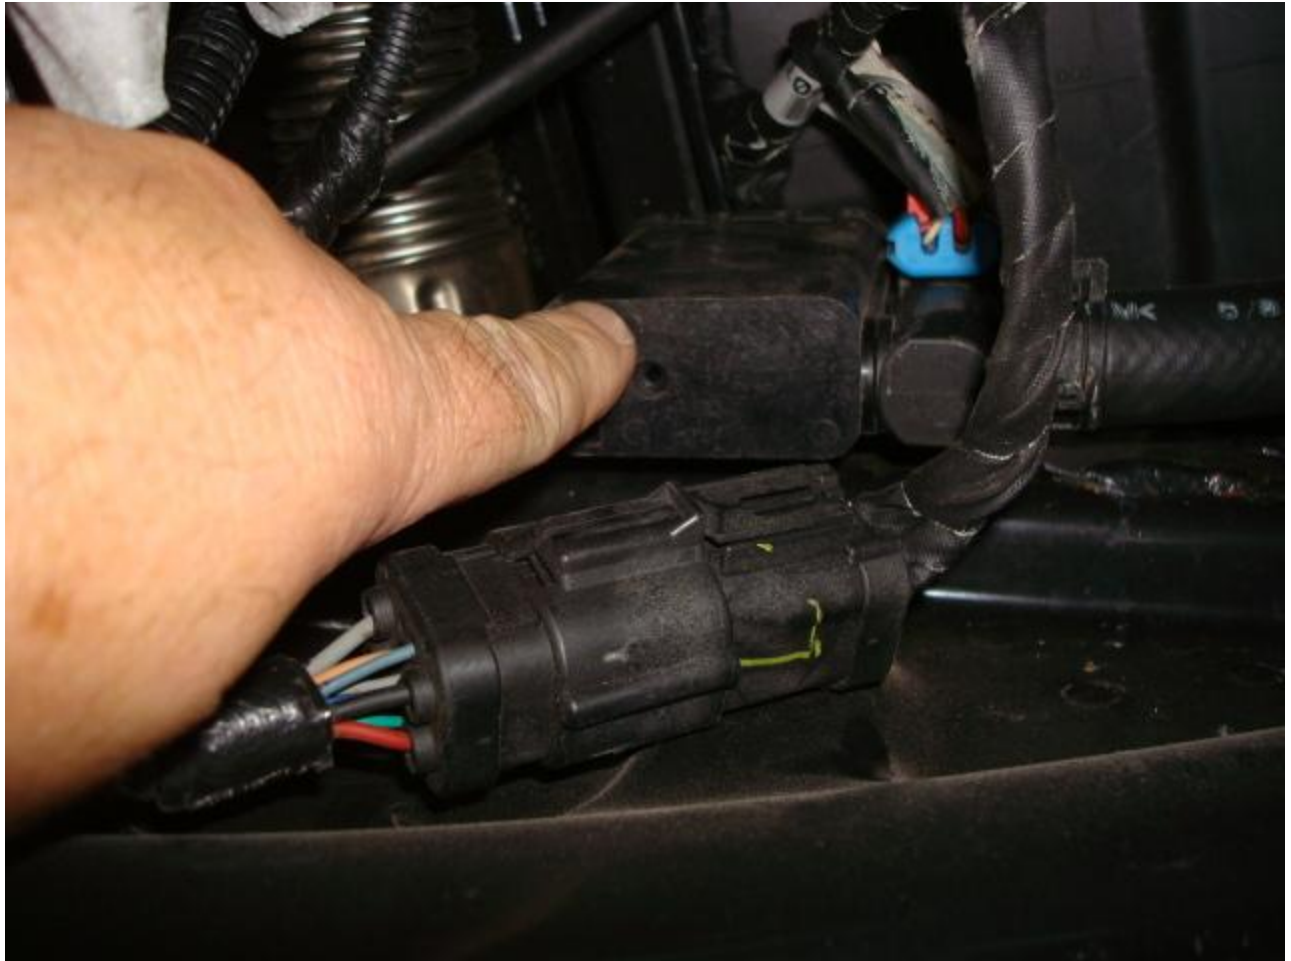
Once under the car this is what you will see, and I have my finger on the part:

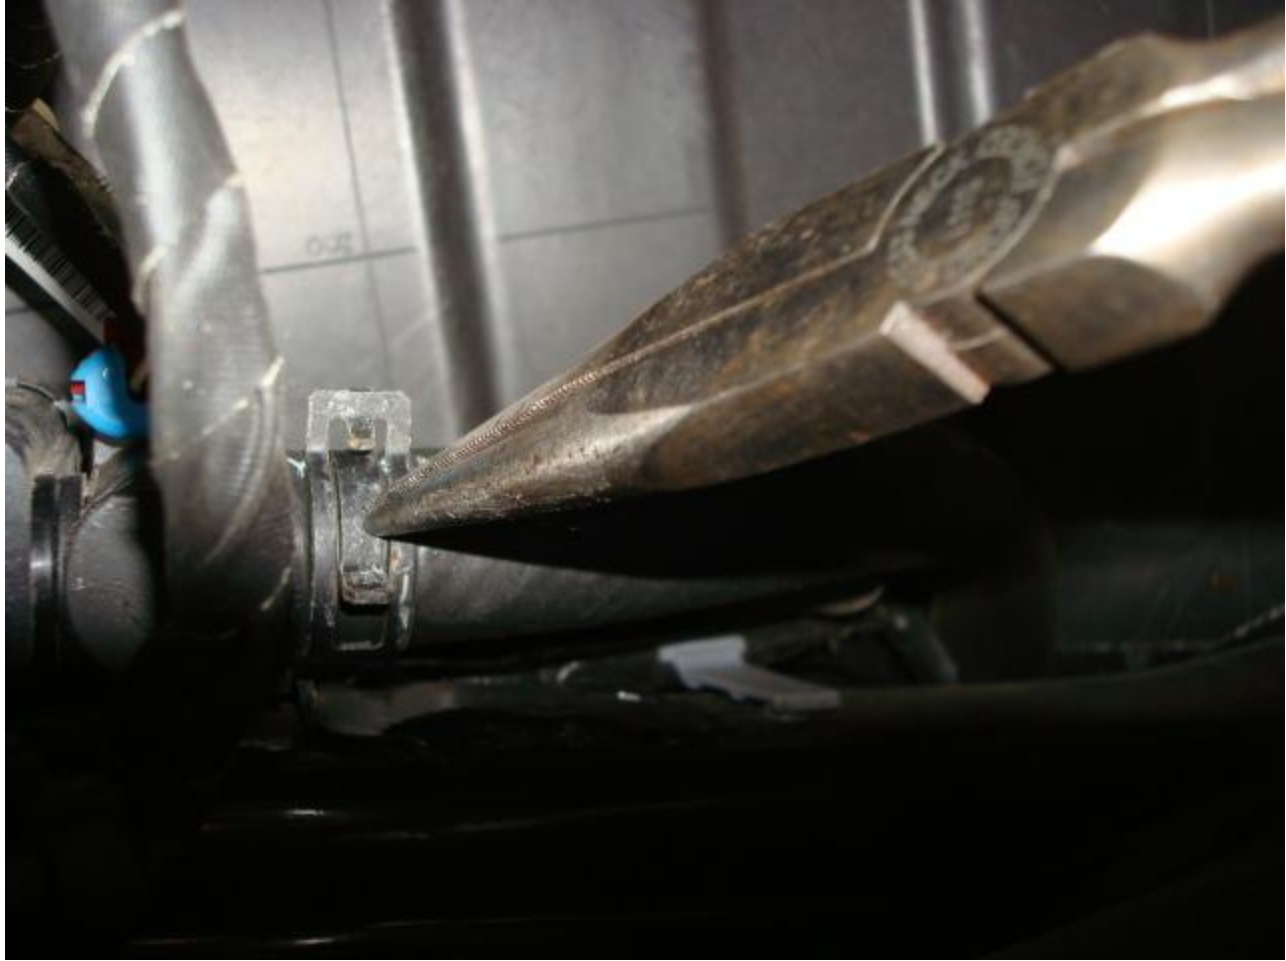
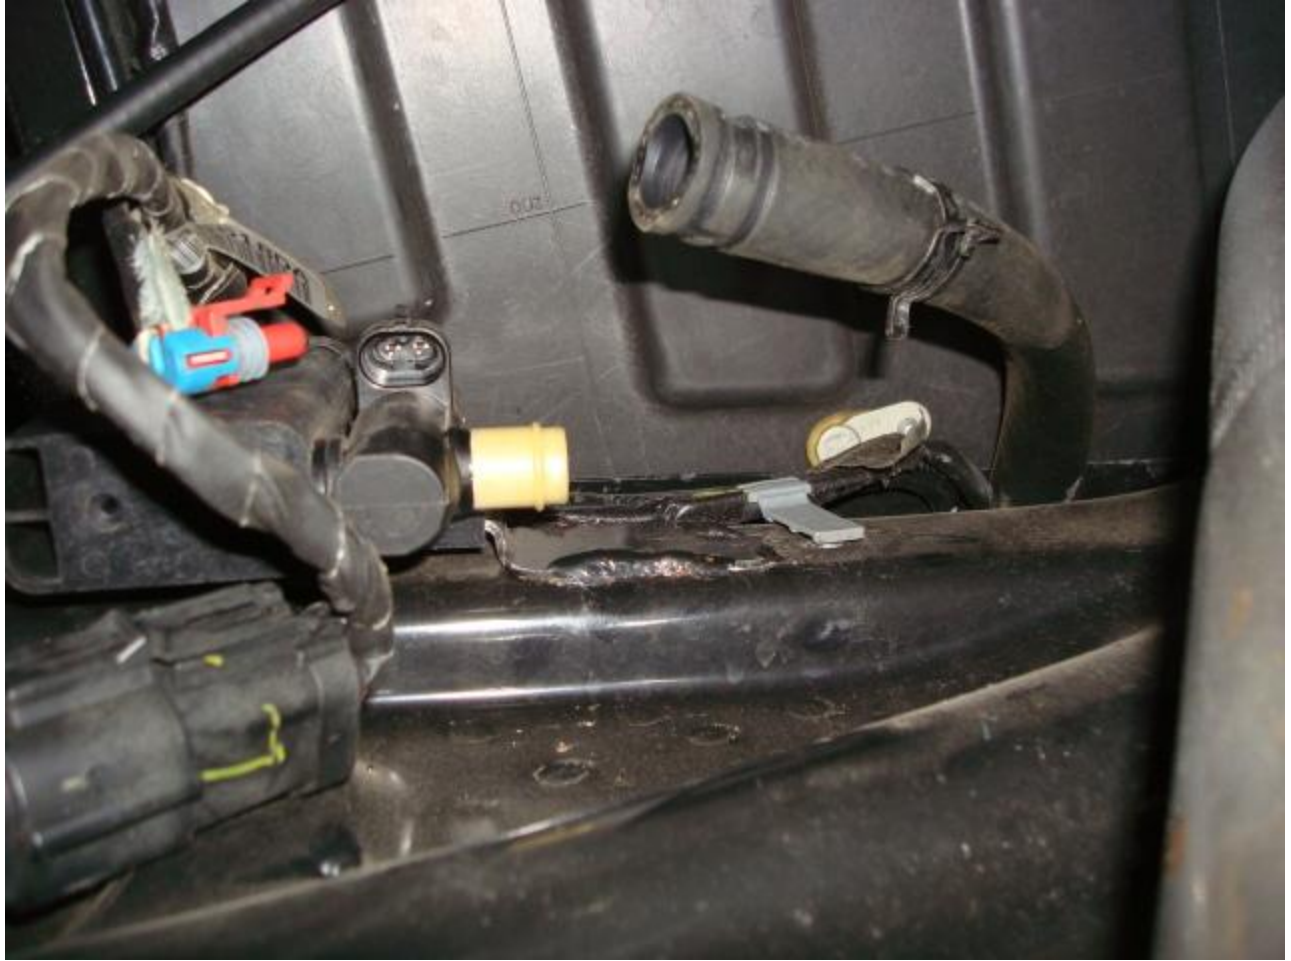
Remove the Vent Hose (it runs to your emissions canister) using a pair of pliers. You can rotate the clamp if needed to access the dog ears to open the clamp.

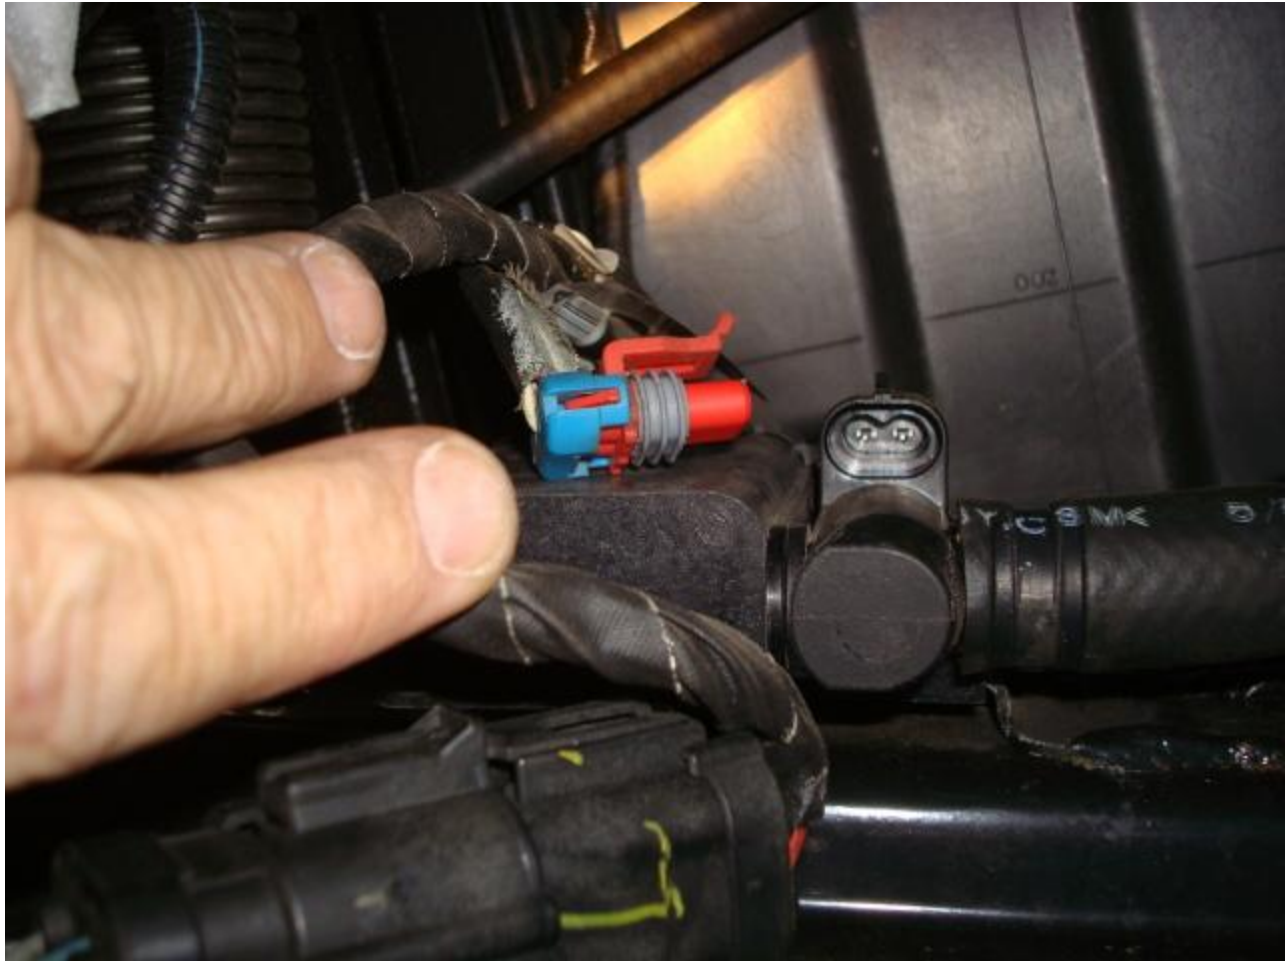
Unplug the power connection

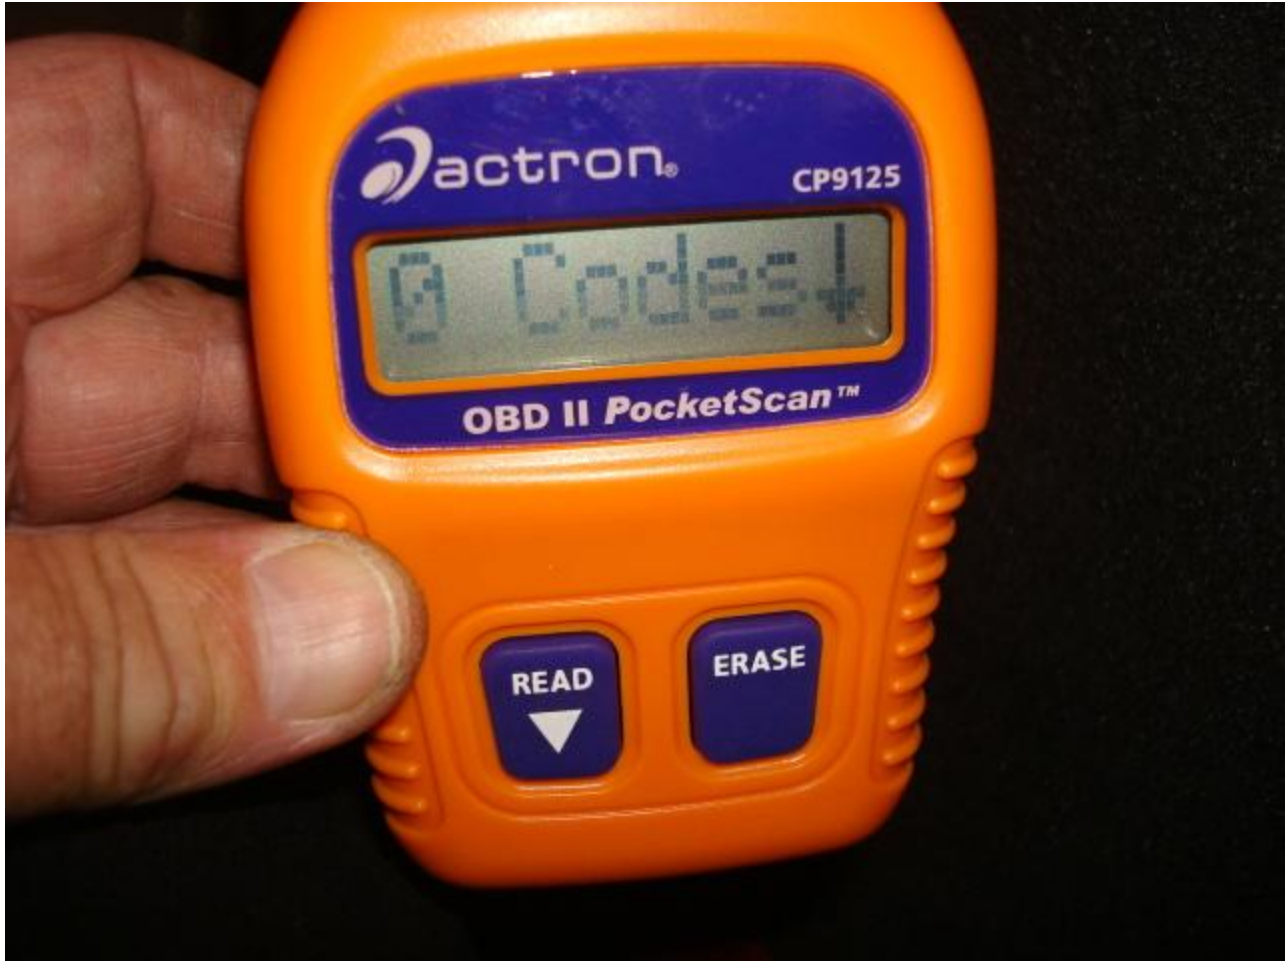
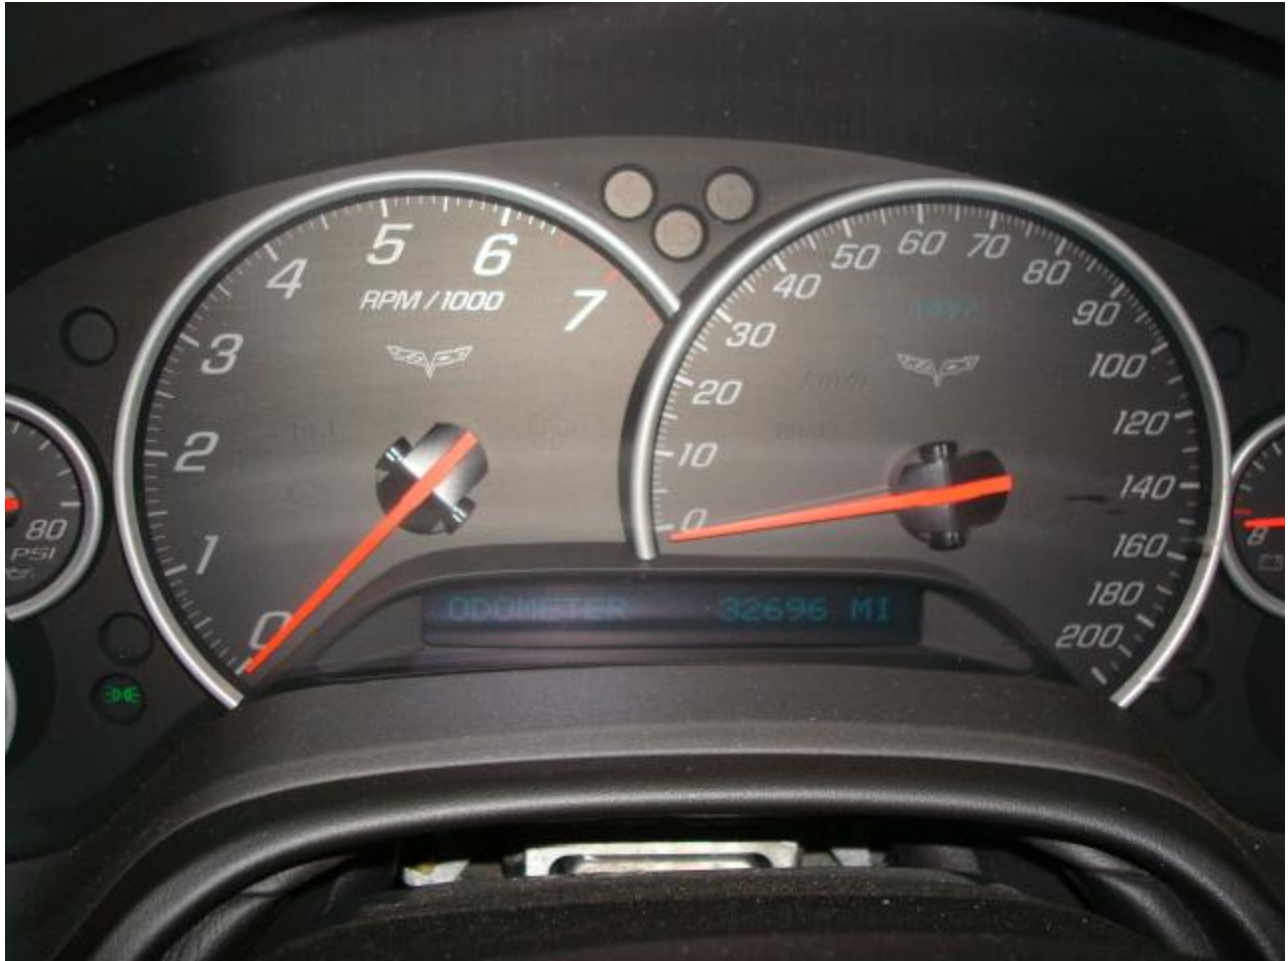
This is what you should now see on your code reader. No Codes and the DIC is clear with no check engine light or warnings.

Now plug your code reader back in and scan for codes. If they come up hit erase.
