C6 2005-2013 -Automatic Transmission - Stuck in Neutral or Drive or won't shift out of Park.

## **How to Release Auto Shifter Stuck in Park or Unable to Get back to Park**

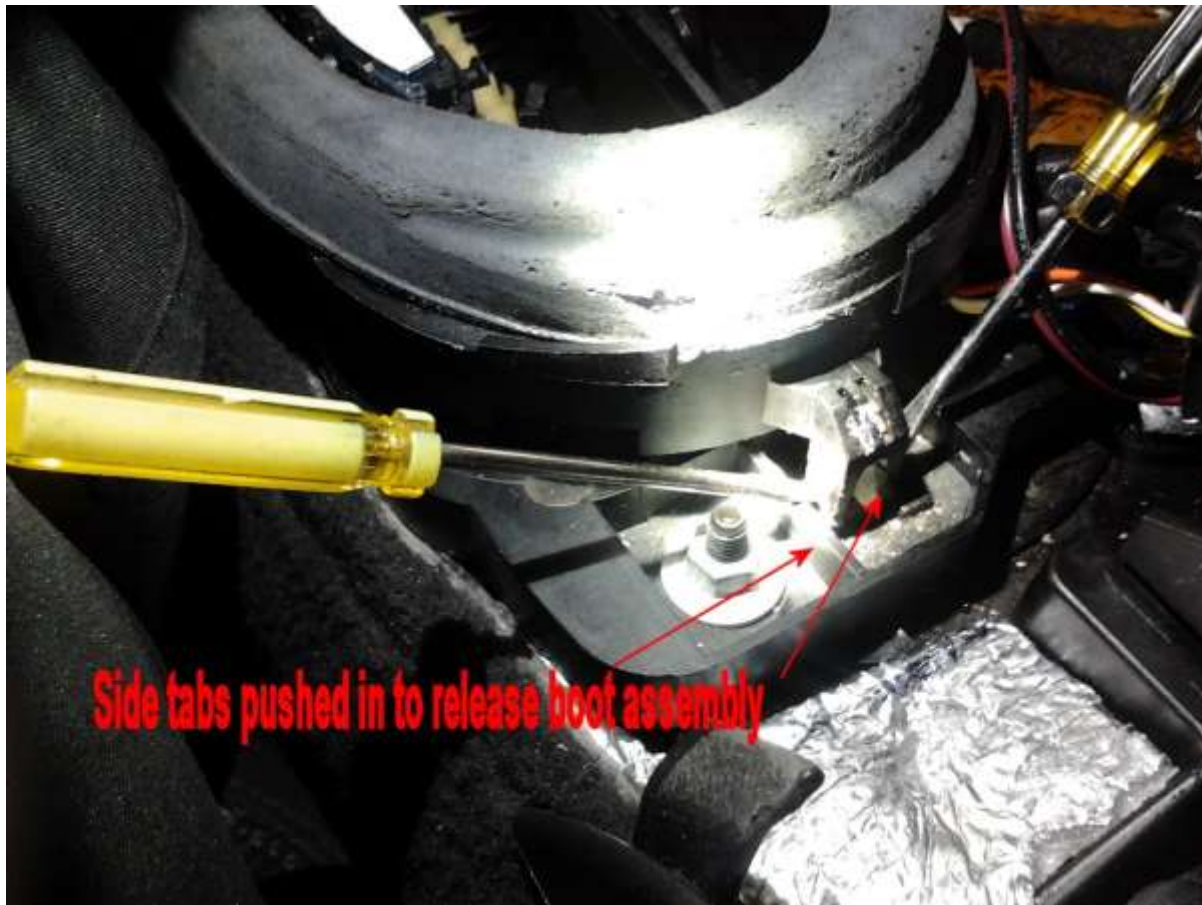
- 5) To remove this top section, which is held in place by (2) plastic locking tabs that fit in a square hole. There is one on the dash side (top) and one on the console side (bottom).

- 6) As per the above picture, with 2 small flat head screwdrivers, start with the bottom, and wedge a screwdriver on each side of the locking tab, prying the tab inwards until the tabs release and the section can be lifted up and out. Use the same technique for the top tab. The above picture only shows the bottom locking tab location.
- 7) With the tabs freed up, lift up the top plastic assembly. This will separate the (red) shift position pointer from the shifter position coupler (black piece). This will be returned to the proper position during re-assembly. The picture shows the red pointer and the black coupling that the pointer fits into, located on the shifter shaft over the white plastic.

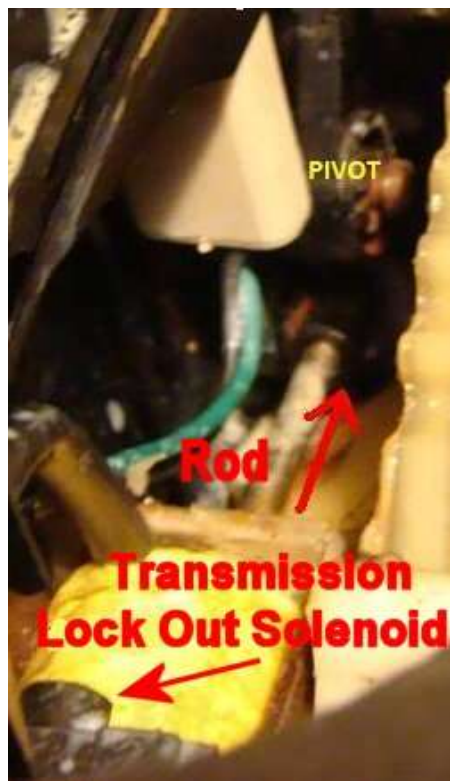
- 9) If the shifter contact limit switch is open, and the Transmission lock out solenoid is not energized, then the shifter will be very stiff to shift out of Park, and will likely not be able to be moved past Drive. For sure, it will be extremely difficult to move back into Park, if not impossible. If the TLO solenoid is not energized, the rod will not move forward to pivot and release the locking pawl (tab).
- 10) The picture below shows a close-up of the Transmission Lock Out Solenoid and rod. When the solenoid is properly energized, it moves the rod forward moving the pivot to release the locking pawl so the shifter button can be depressed and easily moved from Park into gear.

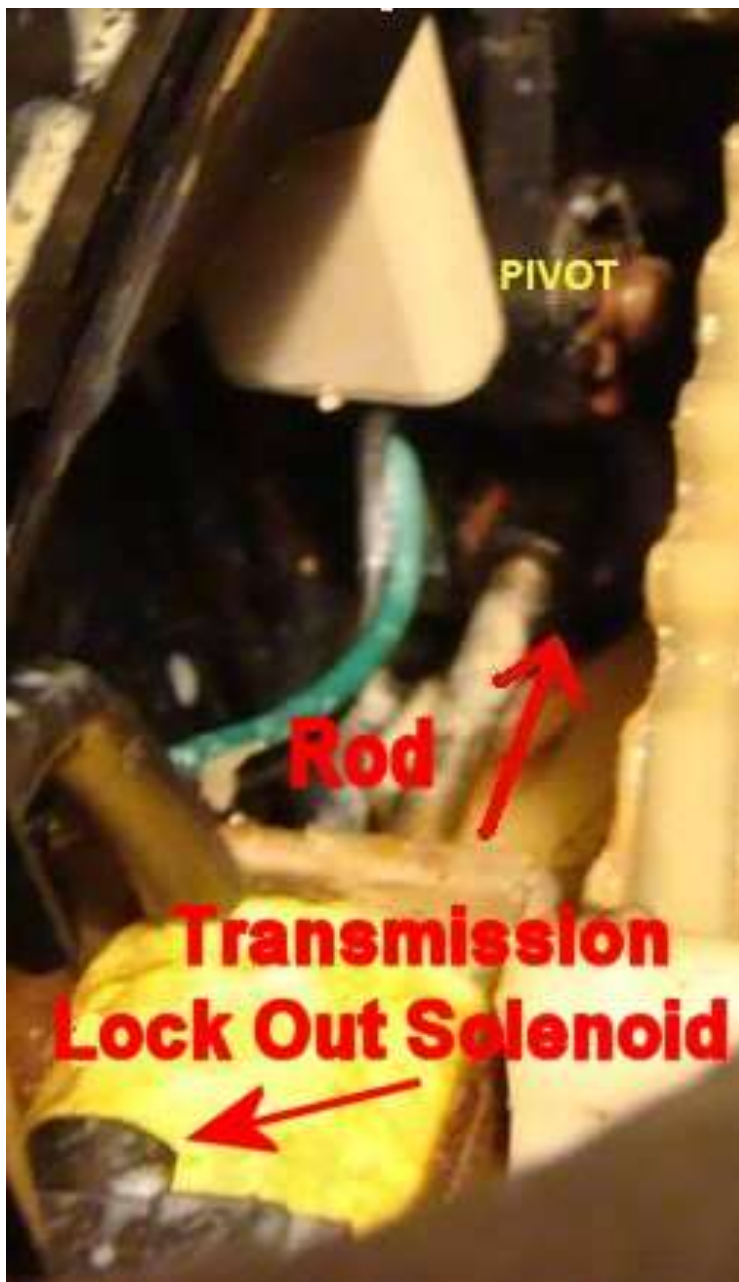
11) The other limit switch located just in front of the locking pawl (tab), is the Transmission In Park limit switch. This must be made for the car to be able to start. The car can also be started if the shifter position is in Neutral.

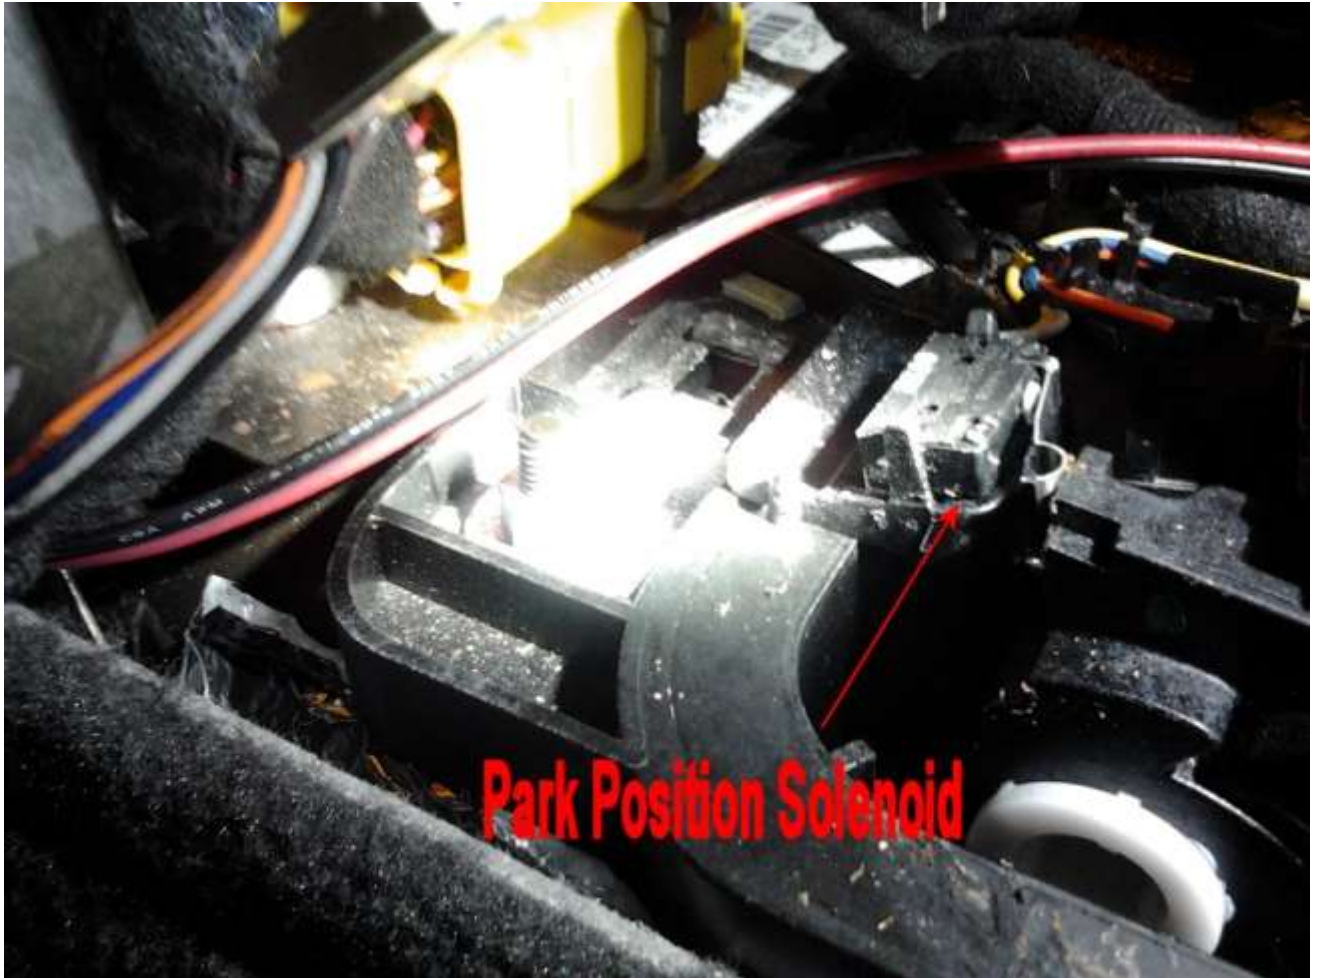
12) Assuming that your transmission was able to be forced out of Park and stuck somewhere around Drive or Neutral. In order to release the Locking Pawl (tab), a small flat screwdriver can be inserted between the locking pawl and the catch, and pried up to get it released. Once this tab is released, then the shifter finger button can be pushed in, and easily moved into the Park position.

13) The locking pawl (tab) can also be pried and released if the shifter is stuck in Park.

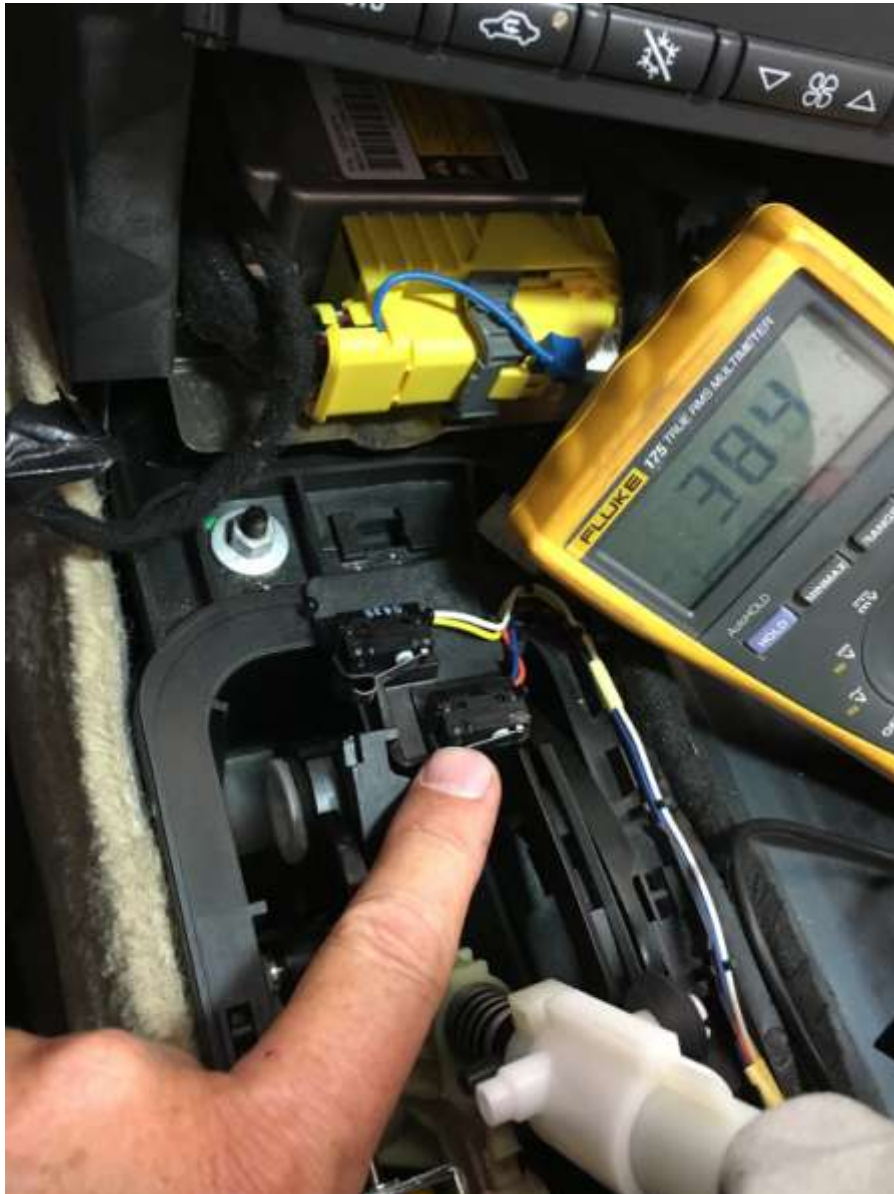
14) If the Transmission Lock Out Solenoid has not been powered, due to a faulty solenoid limit switch, this can be changed out by removing the old switch, and soldering the wires to a new micro switch. Micro switch can be purchased at radio shack or at an electronic store.

The Normally Open micro switch is 12V 5 amps at 125-250VAC and has a body size of 3/4x1/4x3/8"

A lever or roller will work.

Here is one type from Radio Shack

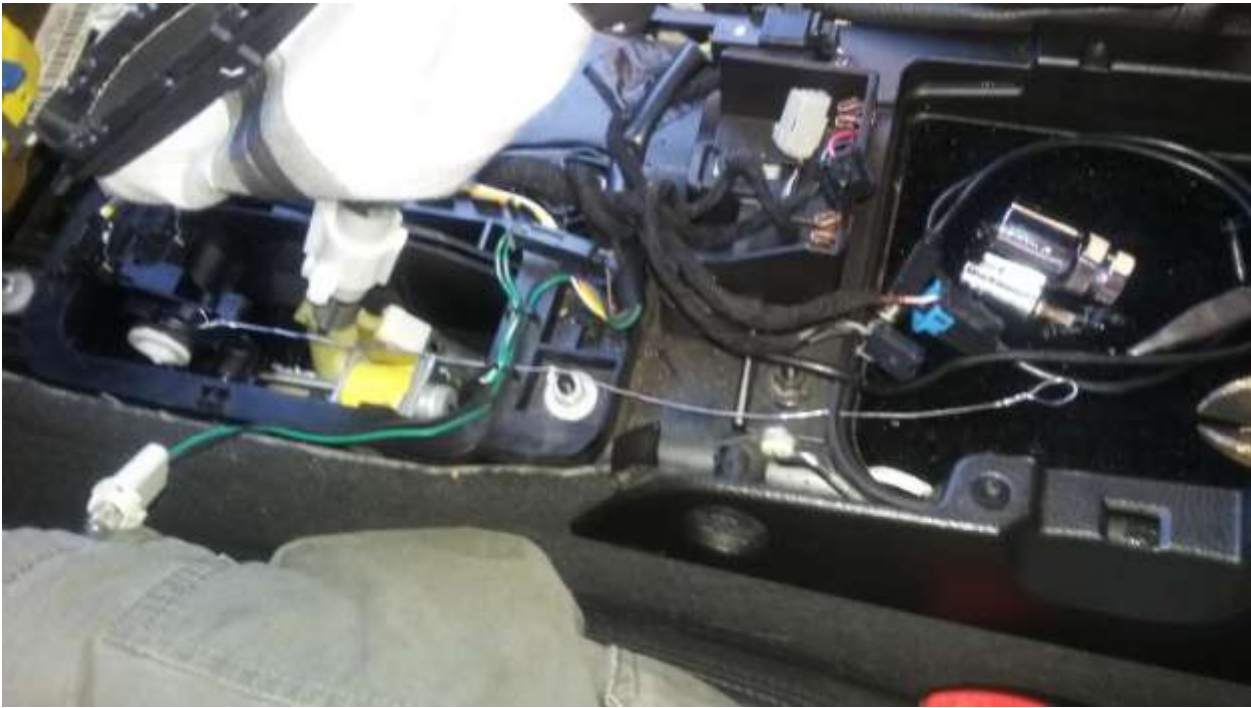
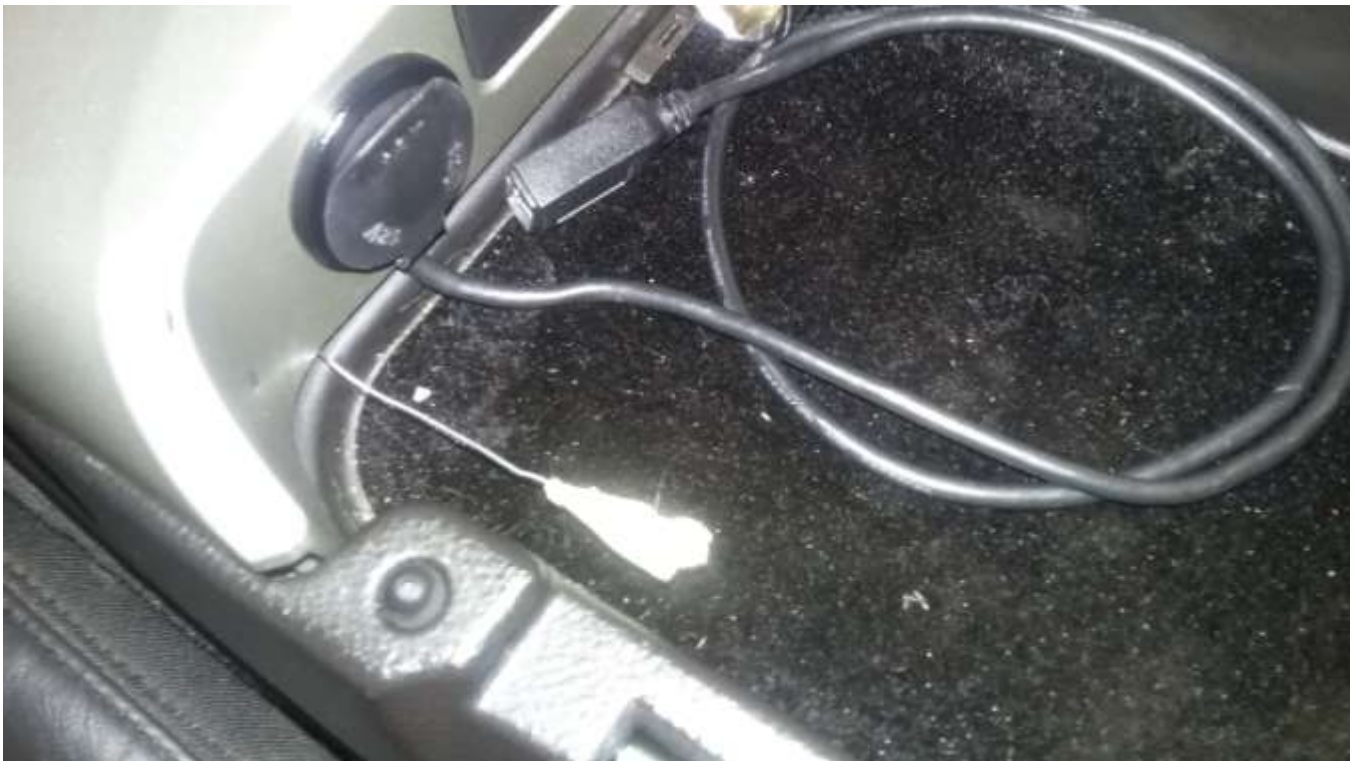
Here is an example pics.

17) Many members tie the pawl, and run the wire to the inside of the console, or on the side of the console so they can release it if the shifter gets stuck. That way, no safety systems are bypassed.
