A6 Shift Knob Removal

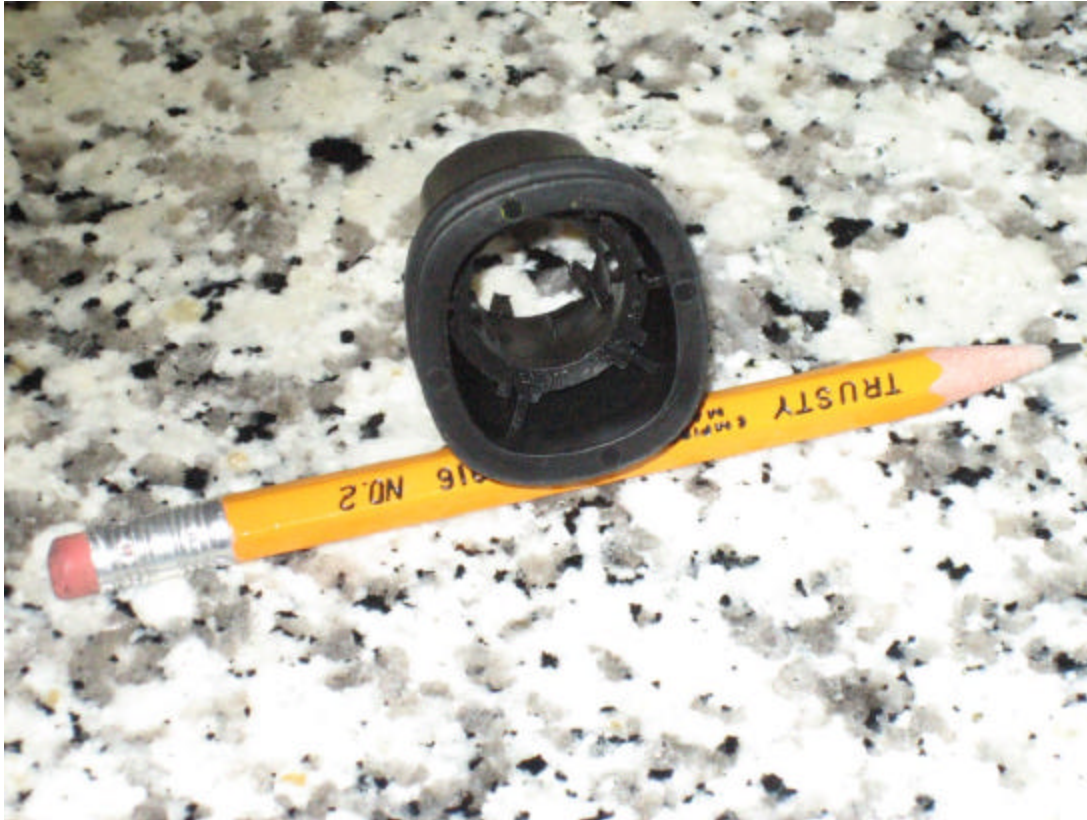
The first picture shows the top of the shift knob retaining ring (shift boot fits over this ring).

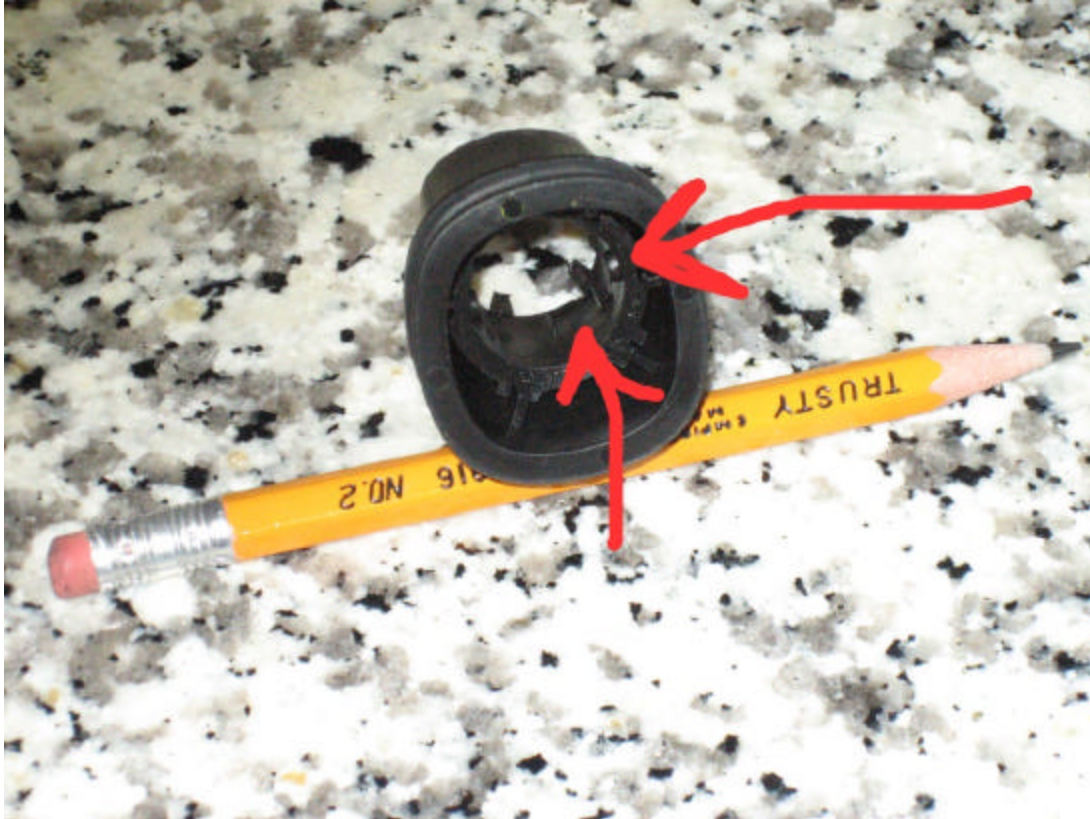
If you look carefully you can see the interior posts that align the ring and the channels that allow the shift knob to be removed.

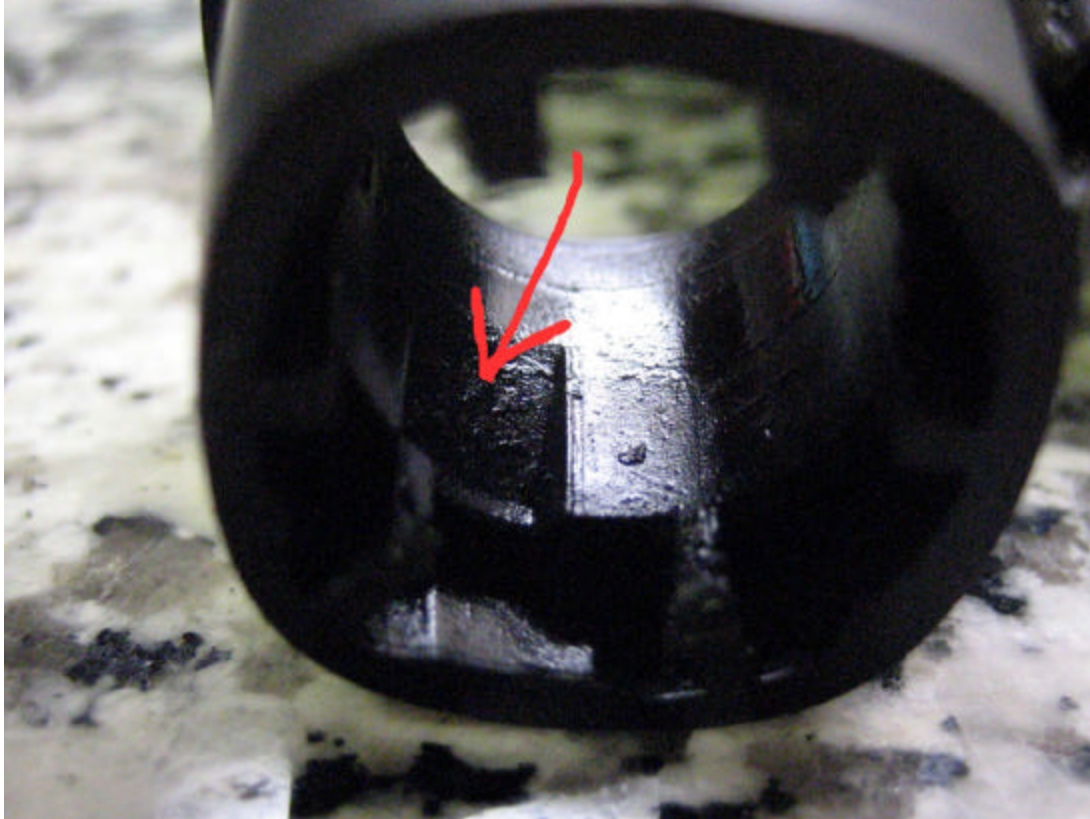
A close-up picture looking from the bottom of the ring shows the two tapered channels cut into the interior of the retaining ring in more detail. These channels allow the A6 shift knob to be removed when the ring is rotated to the 1:00 position. The deepest channel cut is at the bottom of the retaining ring.

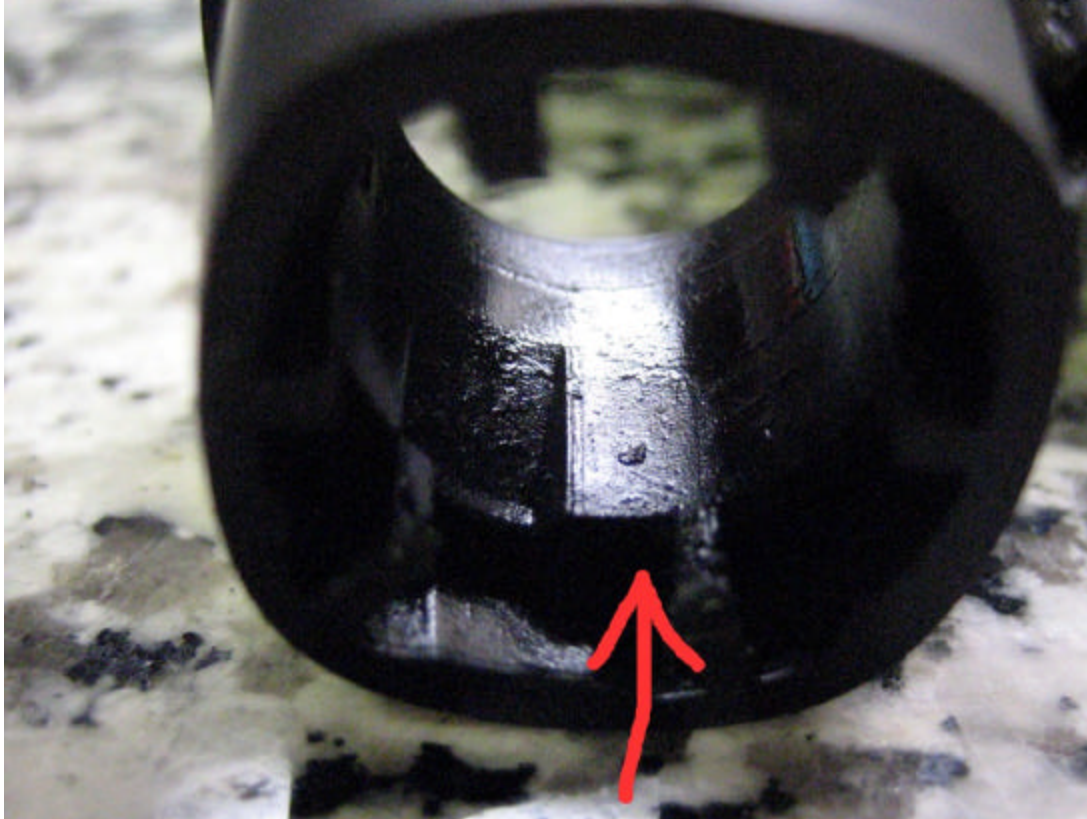
This picture shows deep indentations at the base of the retaining ring where the ends of the shifter prongs lock when rotated to the 12:00 position.

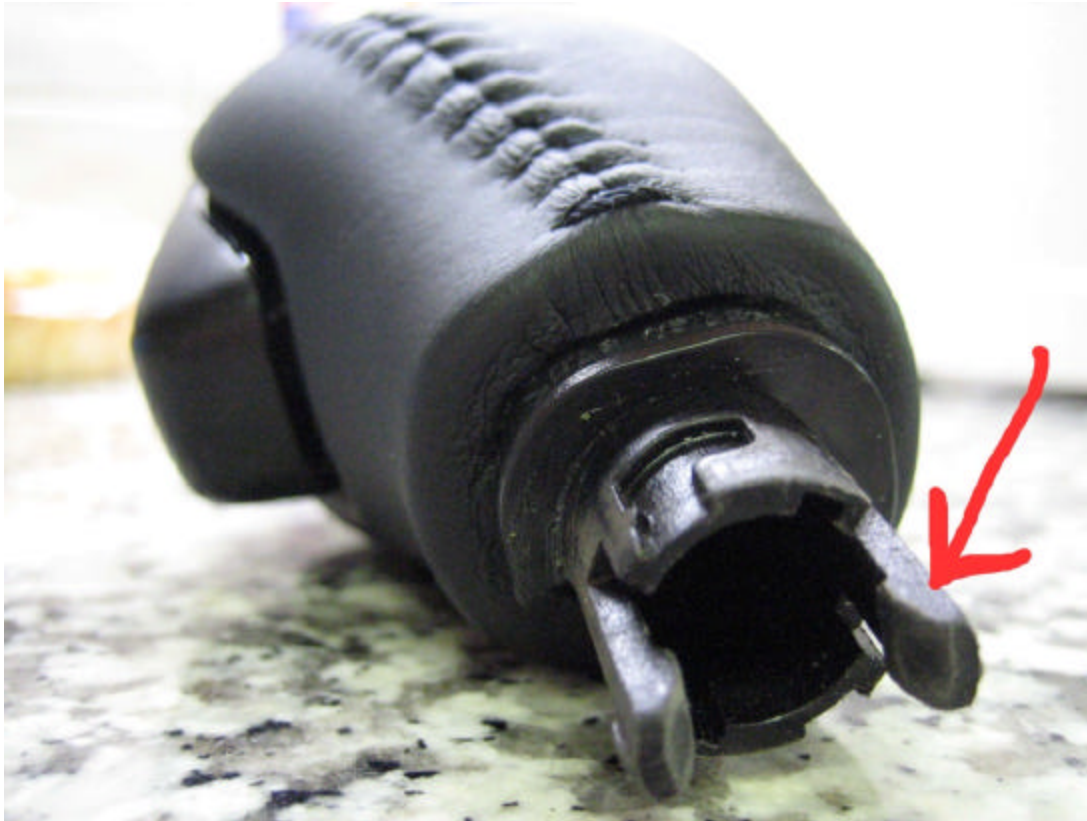
The next picture shows the two prongs on the shift knob that lock into the bottom indentations of the retaining ring when it is rotated to the 12:00 position. When the ring is rotated to the 1:00 position the prongs align with the channels and the channels provide clearance for the prongs to be pushed outward as the shift knob is removed by pulling upward. **If you pull down on the retaining ring the ends of the prongs are pulled from the deepest cut of the tapered channels to the shallower ramp and they will not be able to flex outward and will not release properly.**

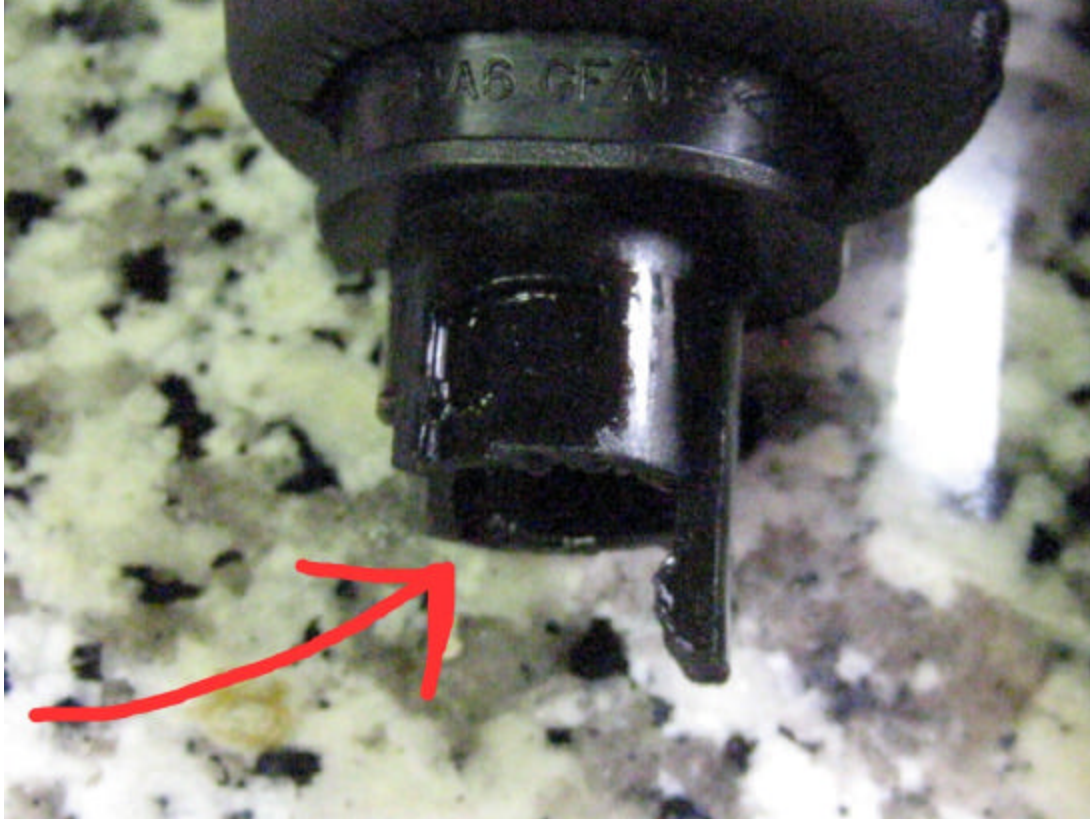
This picture shows what happens when you pull down on the shifter boot and retaining ring and apply "considerable effort" while pulling up on the shift knob as mentioned in the GM instructions. Time to find \$100 and call Gene Culley. 😊

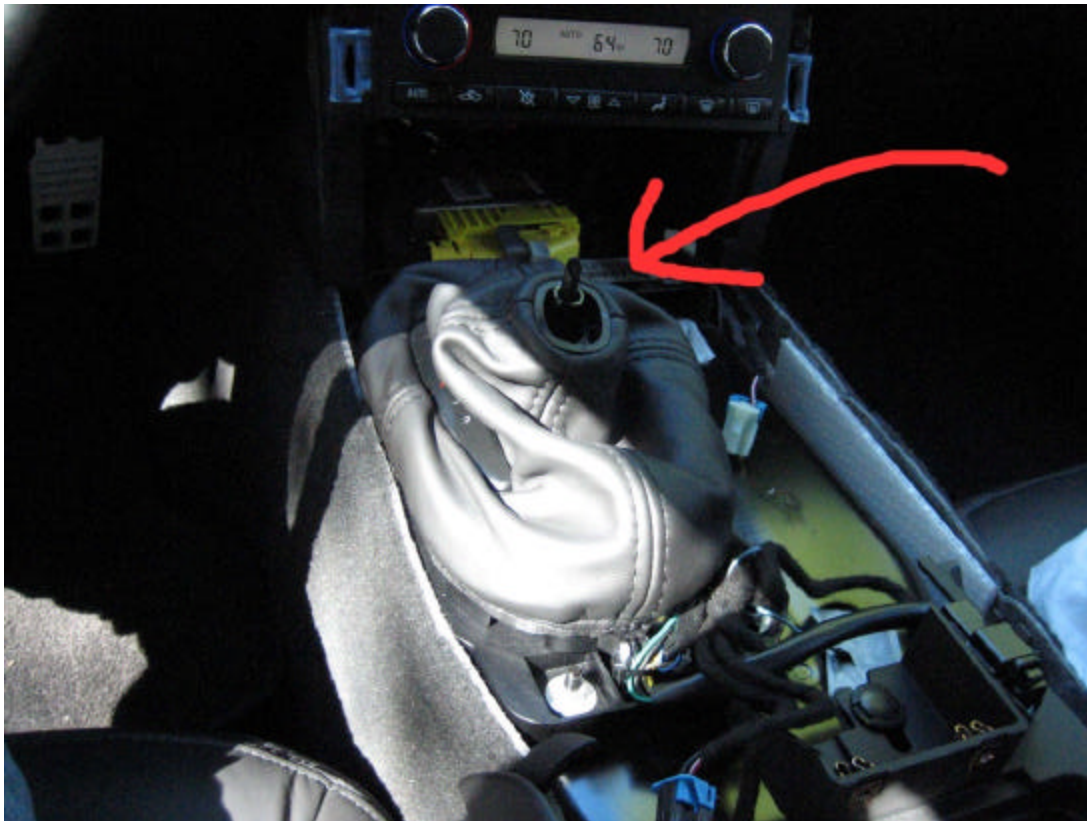
With the ring rotated to the 1:00 position and NOT PULLED DOWN, the shift knob can be removed by pulling up with reasonable force. You will be rewarded with the welcome sight of no A6 shift knob! Please note that you see the retaining ring installed in the shift boot in this picture only because I wanted to see how it fit into the new DownSouth boot before I installed the new knob.

Installation is easy if you push the retaining ring back onto the knob at the 1:00 position and push both down onto the shifter shaft. Rotate the ring back into the 12:00 position to lock the knob and replace the boot on the ring. **Be careful! The shift knob will also lock on the shaft when reversed (button to the rear). You won't like that although it will still operate.** 😊

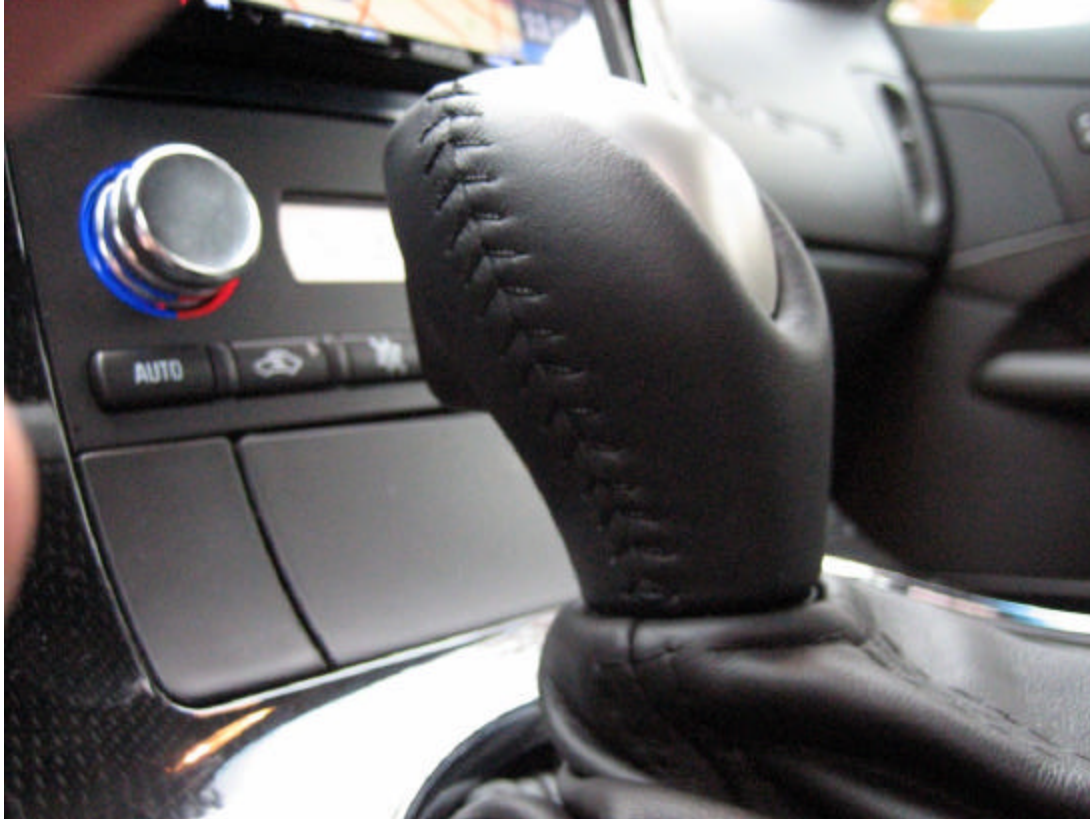
Installation completed. I will try to post a new picture that shows the quality of Gerardo's work better. He uses a heavy grade of leather as used by BMW and the quality and stitching are excellent.
