PRECISION ENGINE

The Story Behind LS7 Valve Guide Wear

Getting to the root of & correcting a high-performance problem.

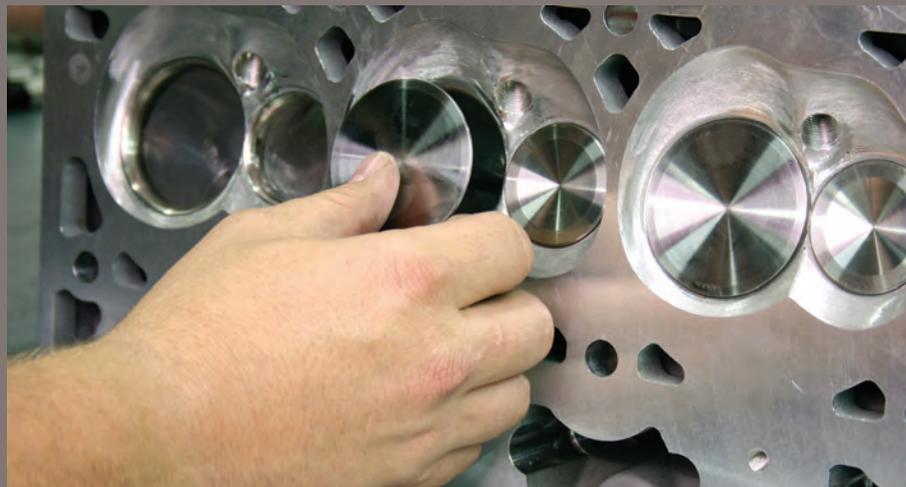
Katech's solution for the valve guide issue is installing manganese-bronze (simply referred to as *bronze*) valve guides and performing a valve job.

Katech's solution for the valve guide issue is installing manganese-bronze (simply referred to as *bronze*) valve guides and performing a valve job, which comes from our experience building engines for 24-hour endurance racing.

The valve seat cutter pilots in the valve guide, so the two are brought back into concentricity. We've been asked whether the new bronze guides are better than the original powdered metal guides, containing mostly iron, which is a harder metal.

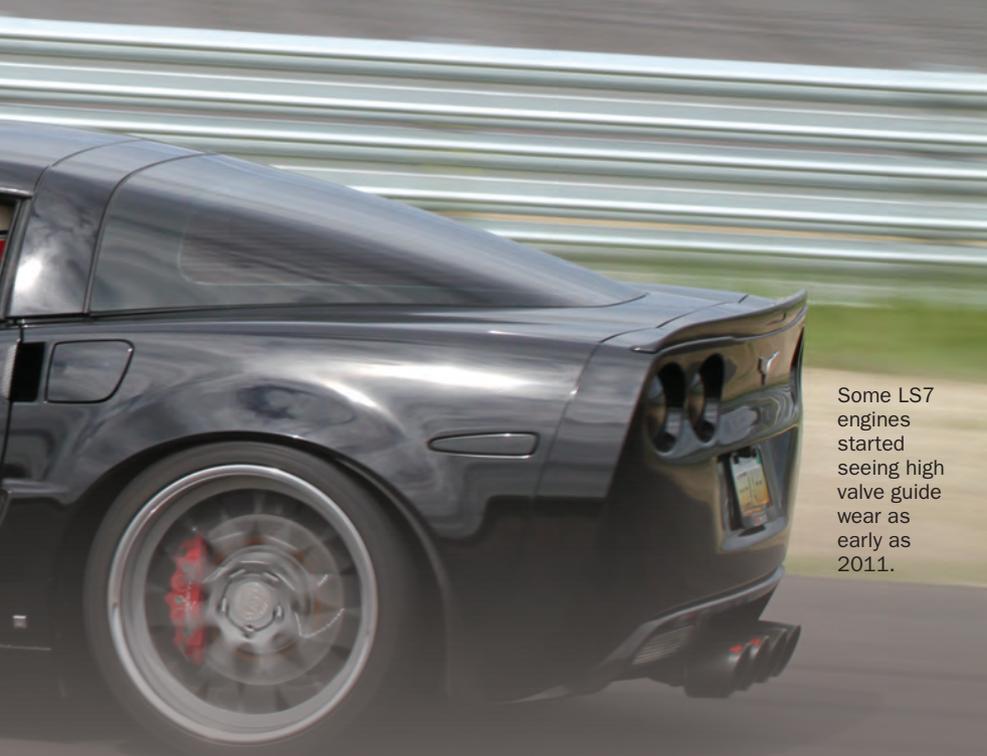
Some LS7 engines started seeing high valve guide wear as early as 2011.

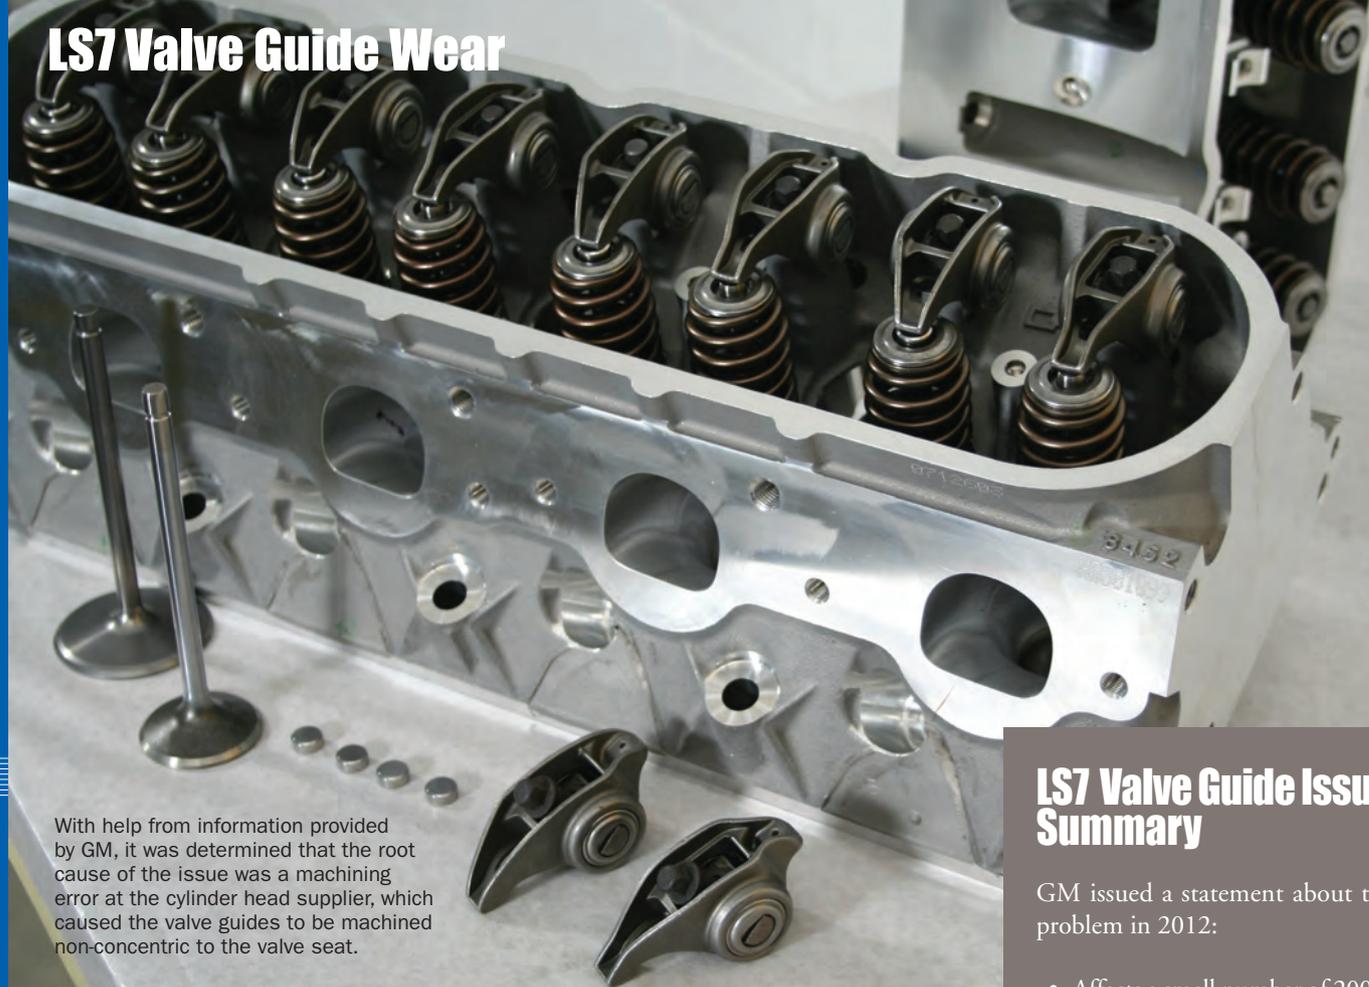
With help from information provided by GM, it was determined that the root cause of the issue was a machining error at the cylinder head supplier, which caused the valve guides to be machined non-concentric to the valve seat.

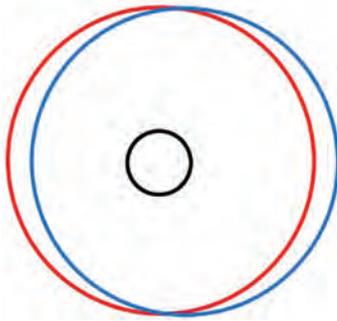
VALVE GUIDE
 VALVE SEAT - CONCENTRIC
 VALVE SEAT - ACTUAL
 Exaggerated for illustrative purposes

caused side pressure of the valve against the guide, which in turn caused an hourglass-shaped wear pattern on the valve guide.
