#17-NA-355: Front and/or Rear Fascia Peeling - (Nov 13, 2017)

Subject: Front and/or Rear Fascia Peeling

Brand:	Model:	Model Year:		VIN:		Engine:	Transmission:
		from	to	from	to		
Chevrolet	Corvette	2017	2018			All	All

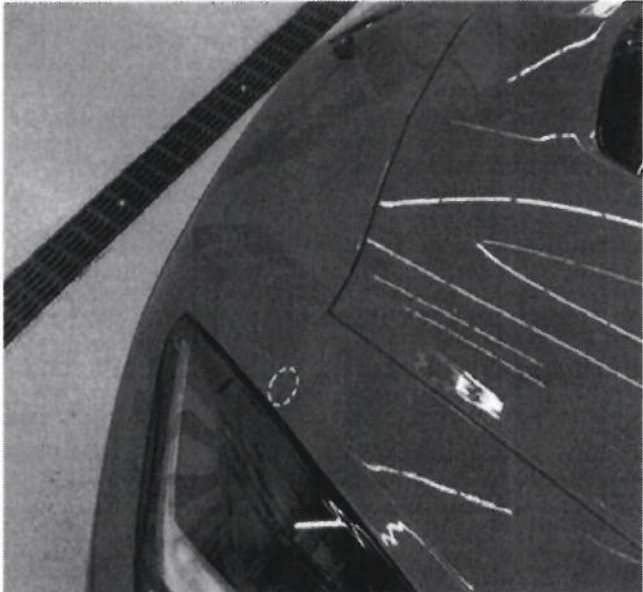
Some customers may comment that a front and/or rear upper fascia may be peeling at the interfacing edge to the fender or quarter panel. Some examples are shown circled in the graphics above.

The cause of the condition may be lack of paint adhesion due to improper surface preparation.

Refinish the front and/or rear upper fascia(s) following the Service Procedure below.
