Vehicle: All Technical Service Bulletins Aftermarket Radio May Set DTC'S 72 and 74 In CCM

Number: 93-68-9A

AFTERMARKET RADIO MAY SET DTC'S 72 AND 74 IN CCM

Model and Year: 1990-93 CORVETTE

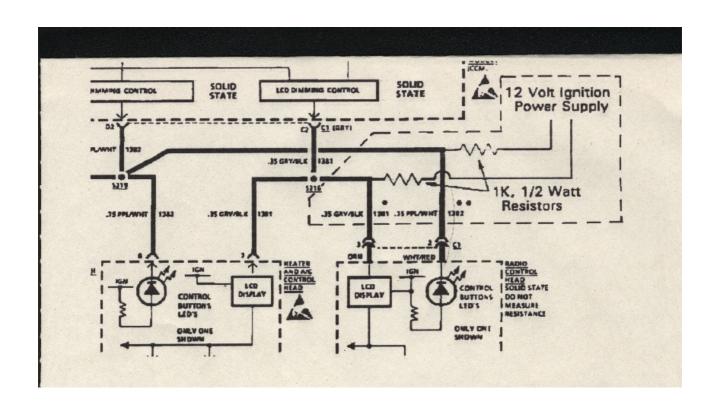
With an aftermarket radio installed, DTC's 72 and 74 are likely to be set because the LCD and LED dimming lines to the radio have gone to an open circuit, because these inputs do not exist in an aftermarket radio.

- 3. Add 1K ohm, 1/2 watt resistors as shown in the illustration. The resistors are available from a local electronics supply store, such as "Radio Shack. The resistors should be connected to a 12 volt ignition-switched circuit. For 1991 to 1993, there is an auxiliary power pickup in the console. For 1990, ignition circuit number 300 should be used. See Section 8A for wiring details.
- 4. Reinstall the radio, then reconnect negative battery cable. Clear the CCM DTC's as shown in Section 8D, and verify proper operation.
