Broken headlight-bezel attaching tabs: a “workable repair”?.

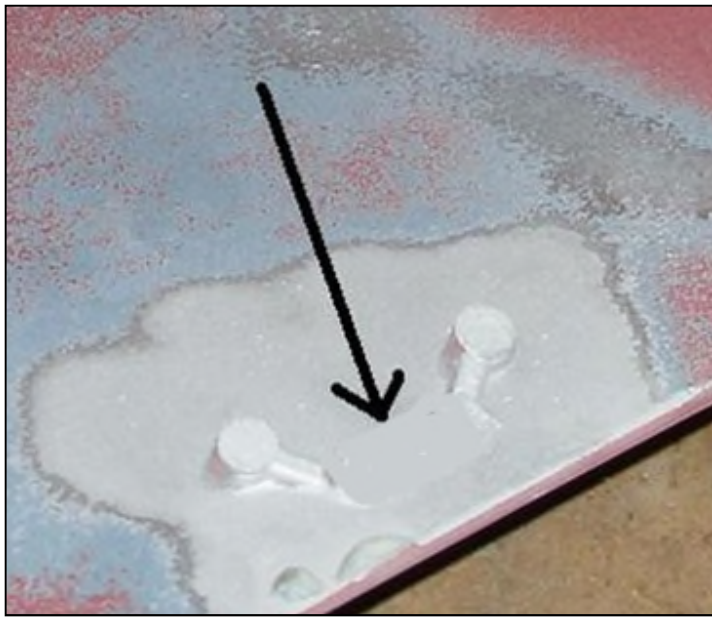
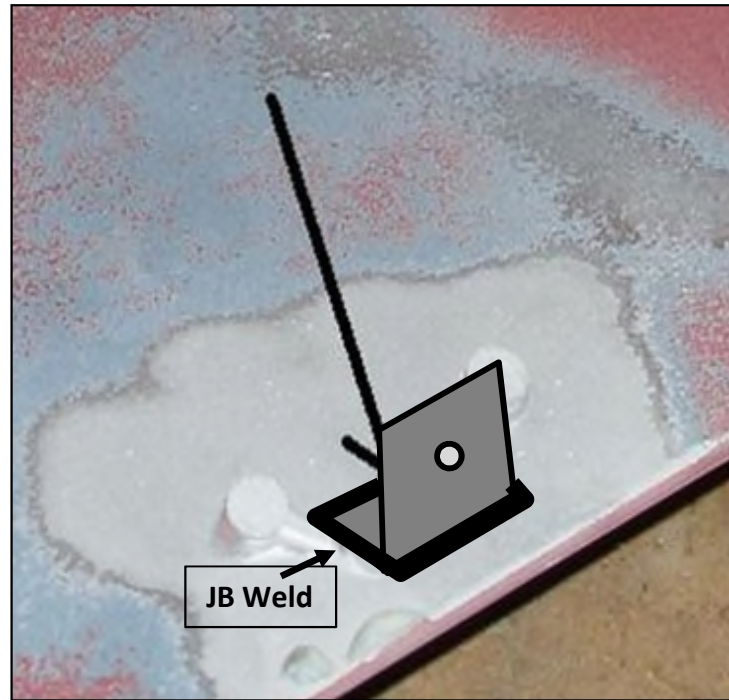
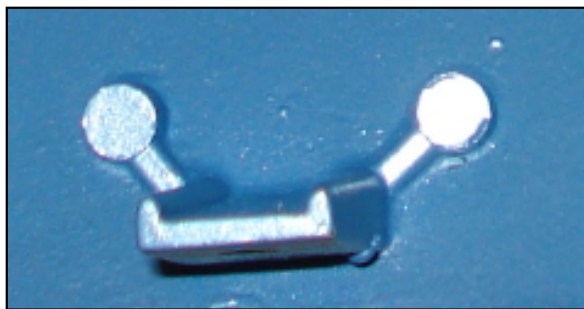
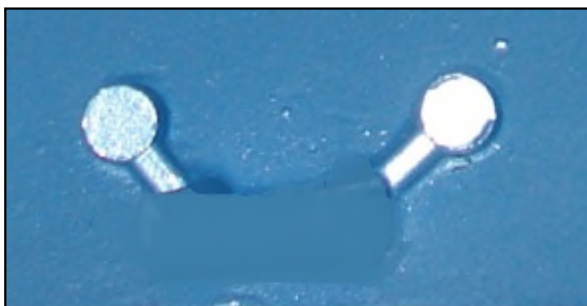
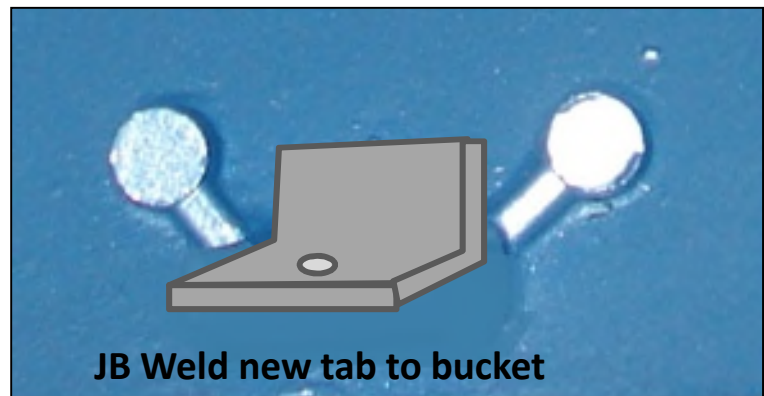
Suggestion for a possible repair of a broken lower bezel attachment tab.

Grind or file this area flat. Bend a right-angle tab out of 1/16th inch aluminum bar of appropriate width and JB weld it to the bucket. Drill the hole before attaching to the bucket. Build up the epoxy around and over the sides of the tab against the bucket to get a solid attachment.
