MOISTURE IN HEADLIGHTS

I've had moisture in my passenger headlight and how I fixed it.

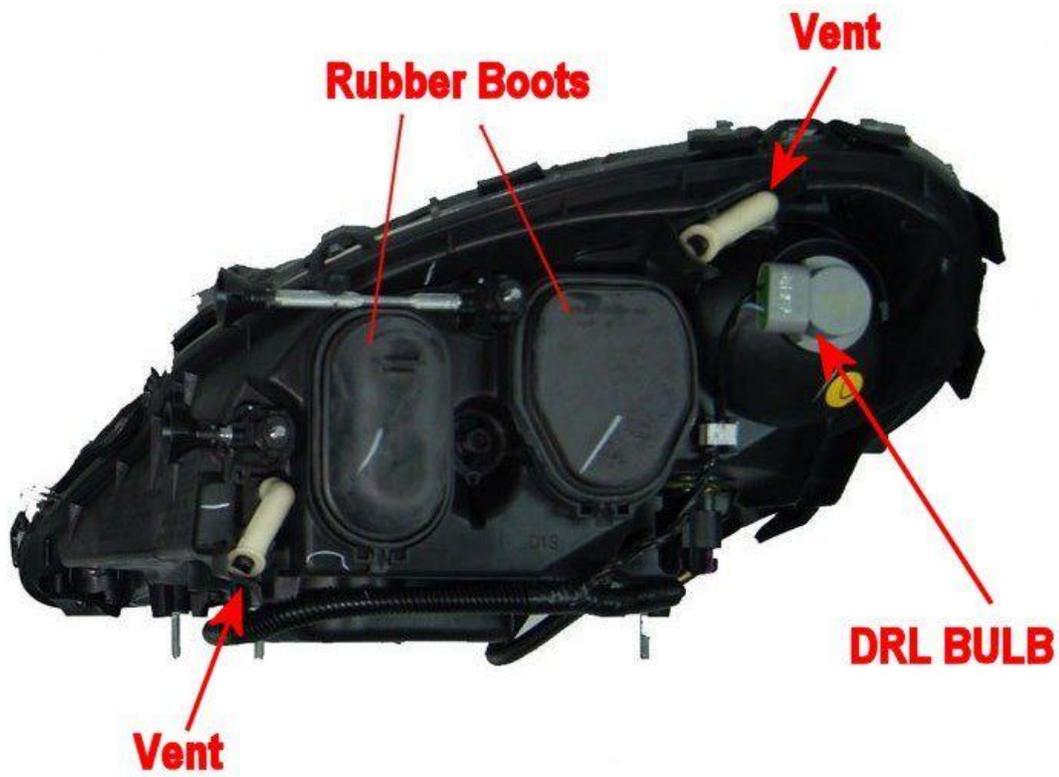
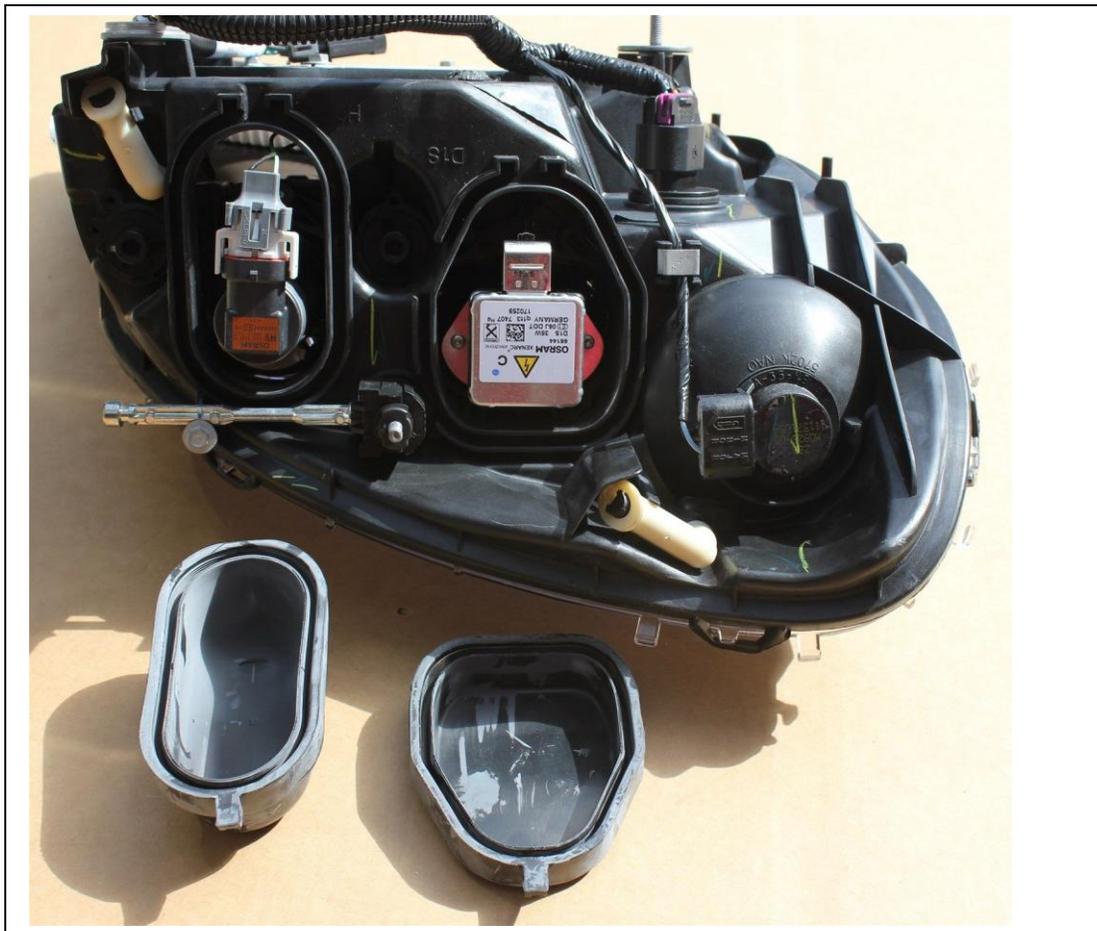
3) If those 2 things are OK, then the only other area water can get in, is between the assembly and the headlight lens.

It's possible that the glue that holds these 2 pieces together has failed, or was not done correctly from the factory. (that was my issue)

Water could work in there under heavy rain, or when I went through a car wash under pressure.

Headlight assembly gap that may be leaking

To fix the seal between the lens and assembly, you need to remove the headlight from the car, and may also need to remove the headlight gasket, in a few areas to get access to that gap, all the way around. I've enclosed a pic of the headlight assembly to show the different areas that could let water in.
