#16-NA-014: Delayed Engagement After Sitting With Engine Off - (Jun 28, 2016)

Subject: Delayed Engagement After Sitting With Engine Off

North America and N.A. Export Regions

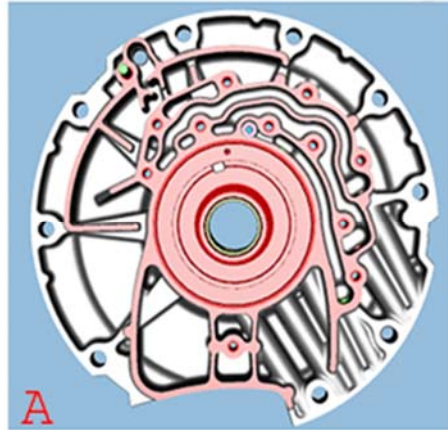
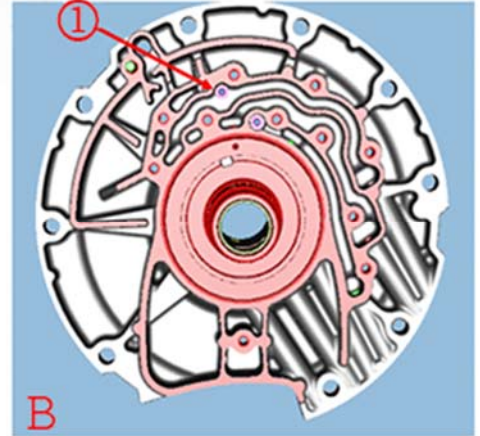
- (A) Old stator support asm
- (B) New stator support asm

Note: The new stator shaft support assembly has a second check ball (1) added (see illustrations).

12. Remove the turbine shaft O-ring seal (1). Discard the seal.

13. Remove the nine stator shaft support bolts (2).

14. Remove the stator shaft support assembly (3).
