DIRECTIONAL SIGNAL

DIRECTION SIGNAL DIAGNOSIS

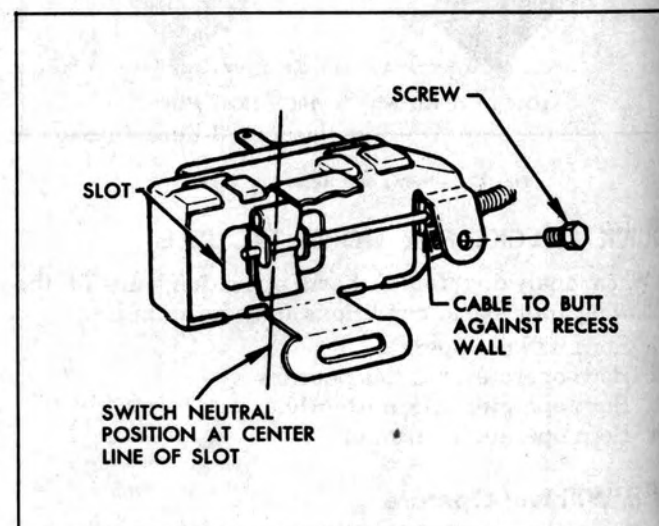
Fig. 125—Direction Signal Switch

The direction signal switch requires no adjustments

due to its simplicity of design. However, if any malfunction of this mechanism should occur, the steering wheel may be removed and the mechanism checked for defective parts. Any defective parts should be replaced.

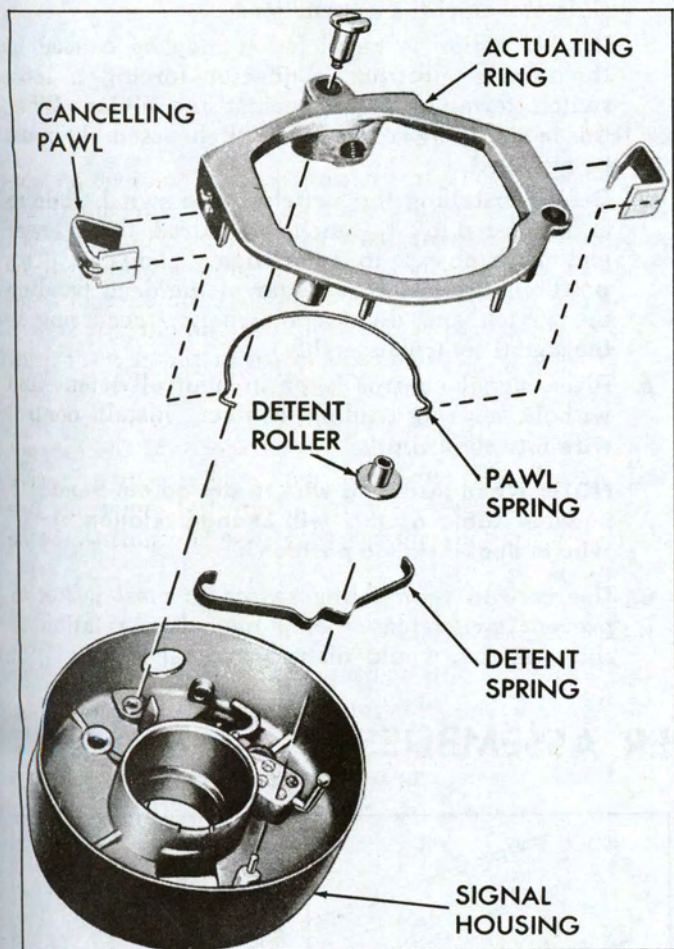
Fig. 126—Direction Signal Cancelling Mechanism Exploded

This condition is usually due to the actuating ring pivot pin becoming loose in the housing. The pin is screwed into the housing and if it loosens, the actuating ring is free to move out of the path of the cancelling cam prongs. If the pin is loose in the housing, check for lockwasher under actuating ring.

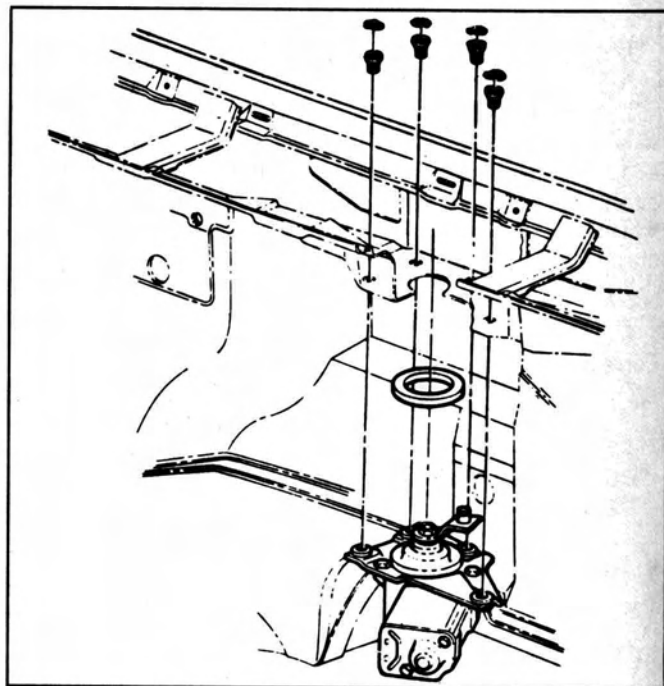
Fig. 127—Windshield Wiper Mounting

The single-speed wiper installation shown in Figure 127 is typical of both wipers.

5. Inside plenum chamber, remove retainer securing drive linkages to motor assembly and disengage drive linkages from motor.
6. Remove four (4) screws and lock washer assemblies, Figure 127, securing motor assembly

1. Make certain motor is in parked position.
2. Remove screw attaching each windshield washer nozzle, pull hose free from nozzle and remove nozzle.
3. Remove shroud ventilator grille.
4. Remove screw securing ground strap to body metal and disengage electrical connectors from motor. If present remove washer hoses from motor assembly. Mark hoses to insure correct installation.
