# Feeling Groovy

## IS YOUR '65-'66 BIG-BLOCK BEING FED RIGHT?

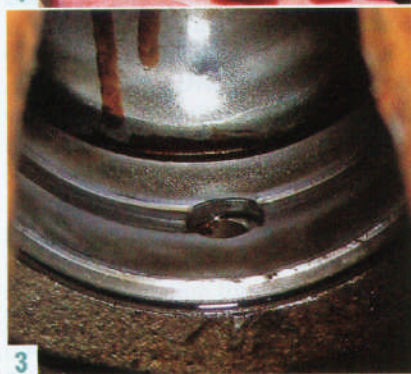
2 The matching three-hole '65-'66 rear cam bearing with the groove on the I.D. and the oil exit holes at the top to the lifter oil galleries.

of a groove in the rear cam journal and a rear cam bearing with a matching groove on its inside diameter. Oil entered the bearing through a hole at the bottom, traveled around the journal through the groove in the bearing and the journal, and exited the bearing through two holes at the top that aligned with two holes in the block; those two holes fed the oil galleries on each side that fed the lifters. Both the cam journal and the cam bearing MUST have the groove in order to provide adequate oil flow to the lifters,

and the bearing must have the two exit holes at the top.

**What This Means To You:** Your block dictates what you can use. The 1967 non-grooved cam and non-grooved one-hole rear bearing will **NOT** work in a '65-'66 block, period; you need the cam with the grooved rear journal **and** the rear cam bearing with the three holes and the groove on its I.D. The cam isn't a big problem—any competent machine shop can cut the required groove in the rear journal of the 3904359 camshaft, and all you need then is the correct rear cam bearing, which will be included with a '65-'66-only big-block cam bearing set.
