INSPECTION AND CORRECTION OF BELLHOUSING TO CRANKSHAFT ALIGNMENT

BACKGROUND

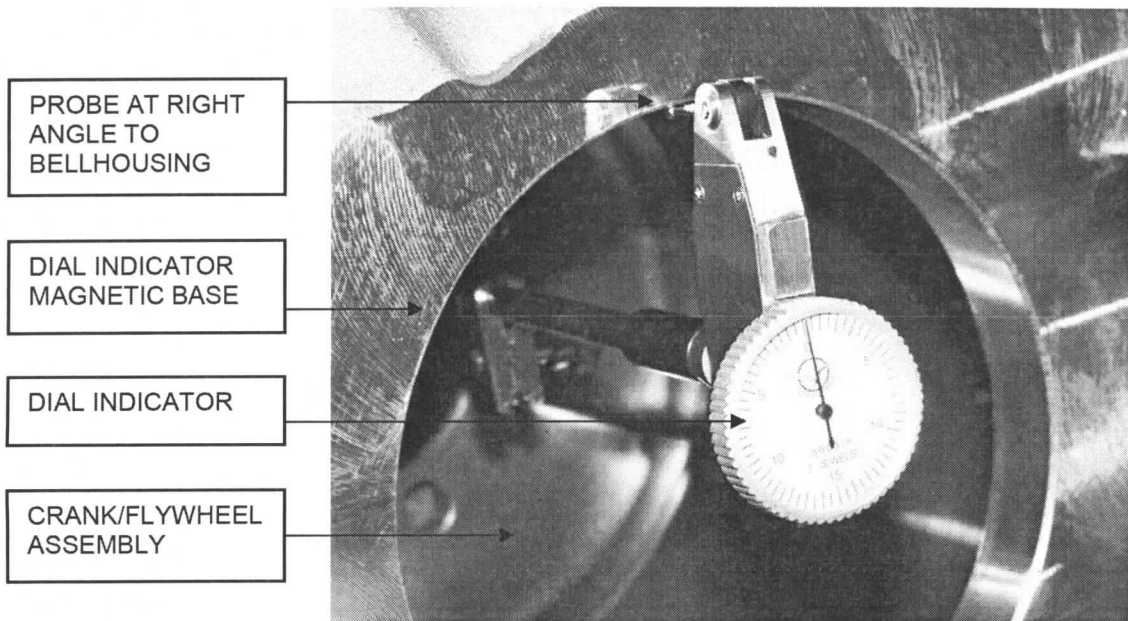
3. Position the indicator probe in contact with the smooth bore of the bellhousing that the transmission will fit into later. The **dial indicator probe** needs to be **perpendicular** to the bellhousing face to ensure accuracy.

Make sure the indicator has adequate travel in both directions and will be in constant contact with the bore register during the entire 360 degrees of rotation so that you will obtain accurate readings. It is not necessary to begin at a certain position on the bore, any point will work. Mark the point where you begin on the bellhousing with a hash mark using chalk or a marker as a reference.

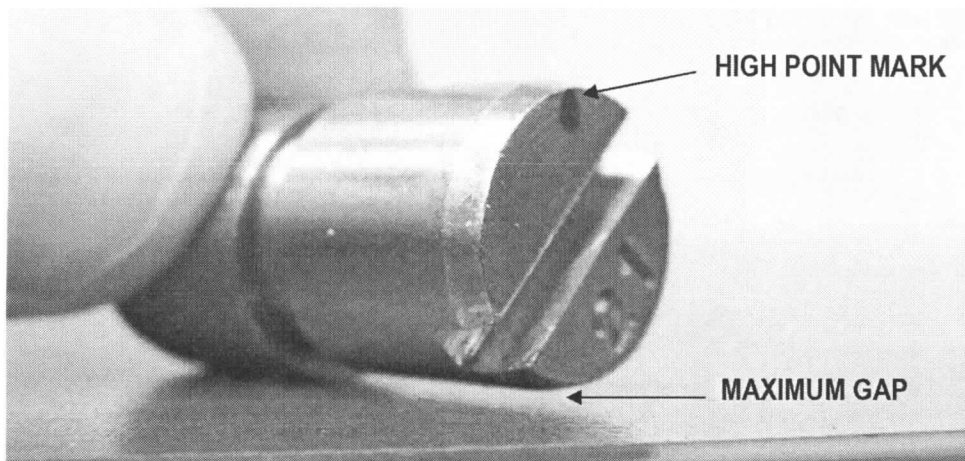
- f. Heat may help.
3. Determine where the maximum offset is on each new pin by rolling the engine side of the dowel on a hard flat surface and looking for the maximum height point as it is being rolled. Mark the high spot with a dot from a paint marker or permanent marker.

- Install the pins into the rear of your engine block with the dot on the pins (maximum offset point) oriented in the same direction as the "C" mark on the bellhousing bore. **Always orient both pins in the same direction!**

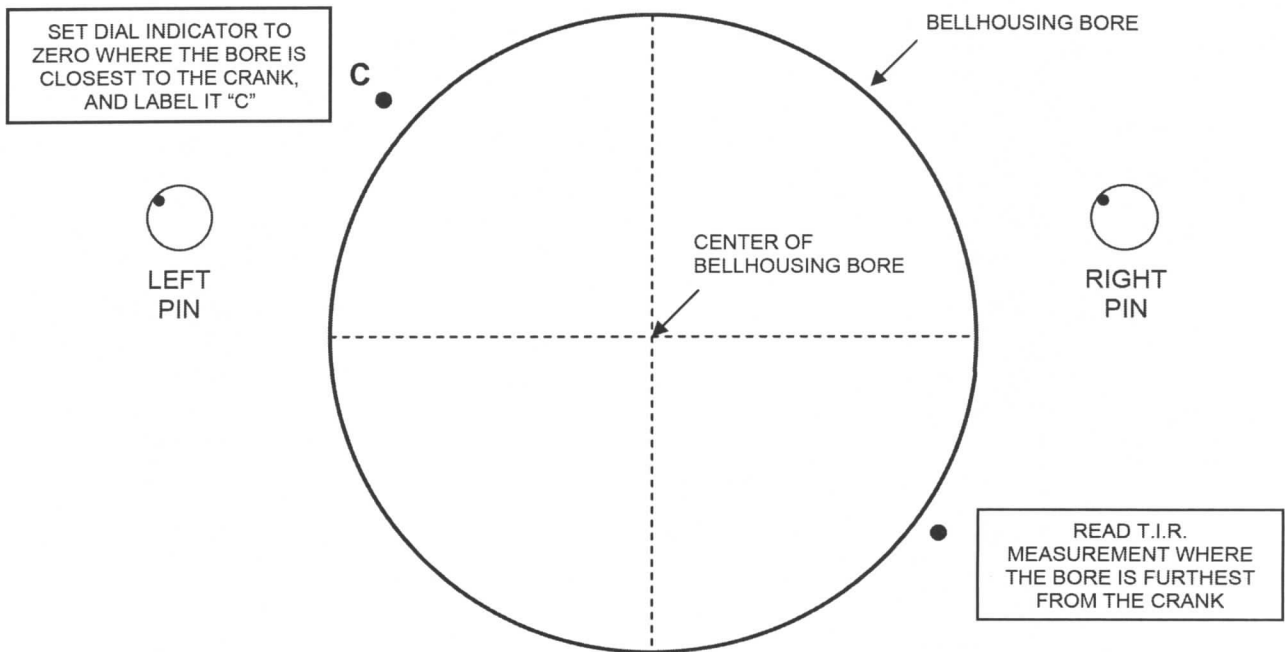
On the bellhousing below, the misalignment is such that the bore is closest to the crank at the upper left. The dial indicator would be set to zero at that point (labeled "C"). The T.I.R. would be measured where the bellhousing bore is furthest from the crank, which should be directly opposite that point. Let's assume the T.I.R. reading is 0.034". Actual misalignment would then be:

$$0.034" \div 2 = 0.017"$$

The chart on page three shows that 0.017" misalignment requires a pair of 0.014" offset pins. The pins should be oriented so that their maximum offset is in the same direction as an imaginary line drawn from bore center to point "C".
