NCRS Louisiana Chapter

ENGINE BELLHOUSING ALIGNMENT

Larry Mulder

September 2012

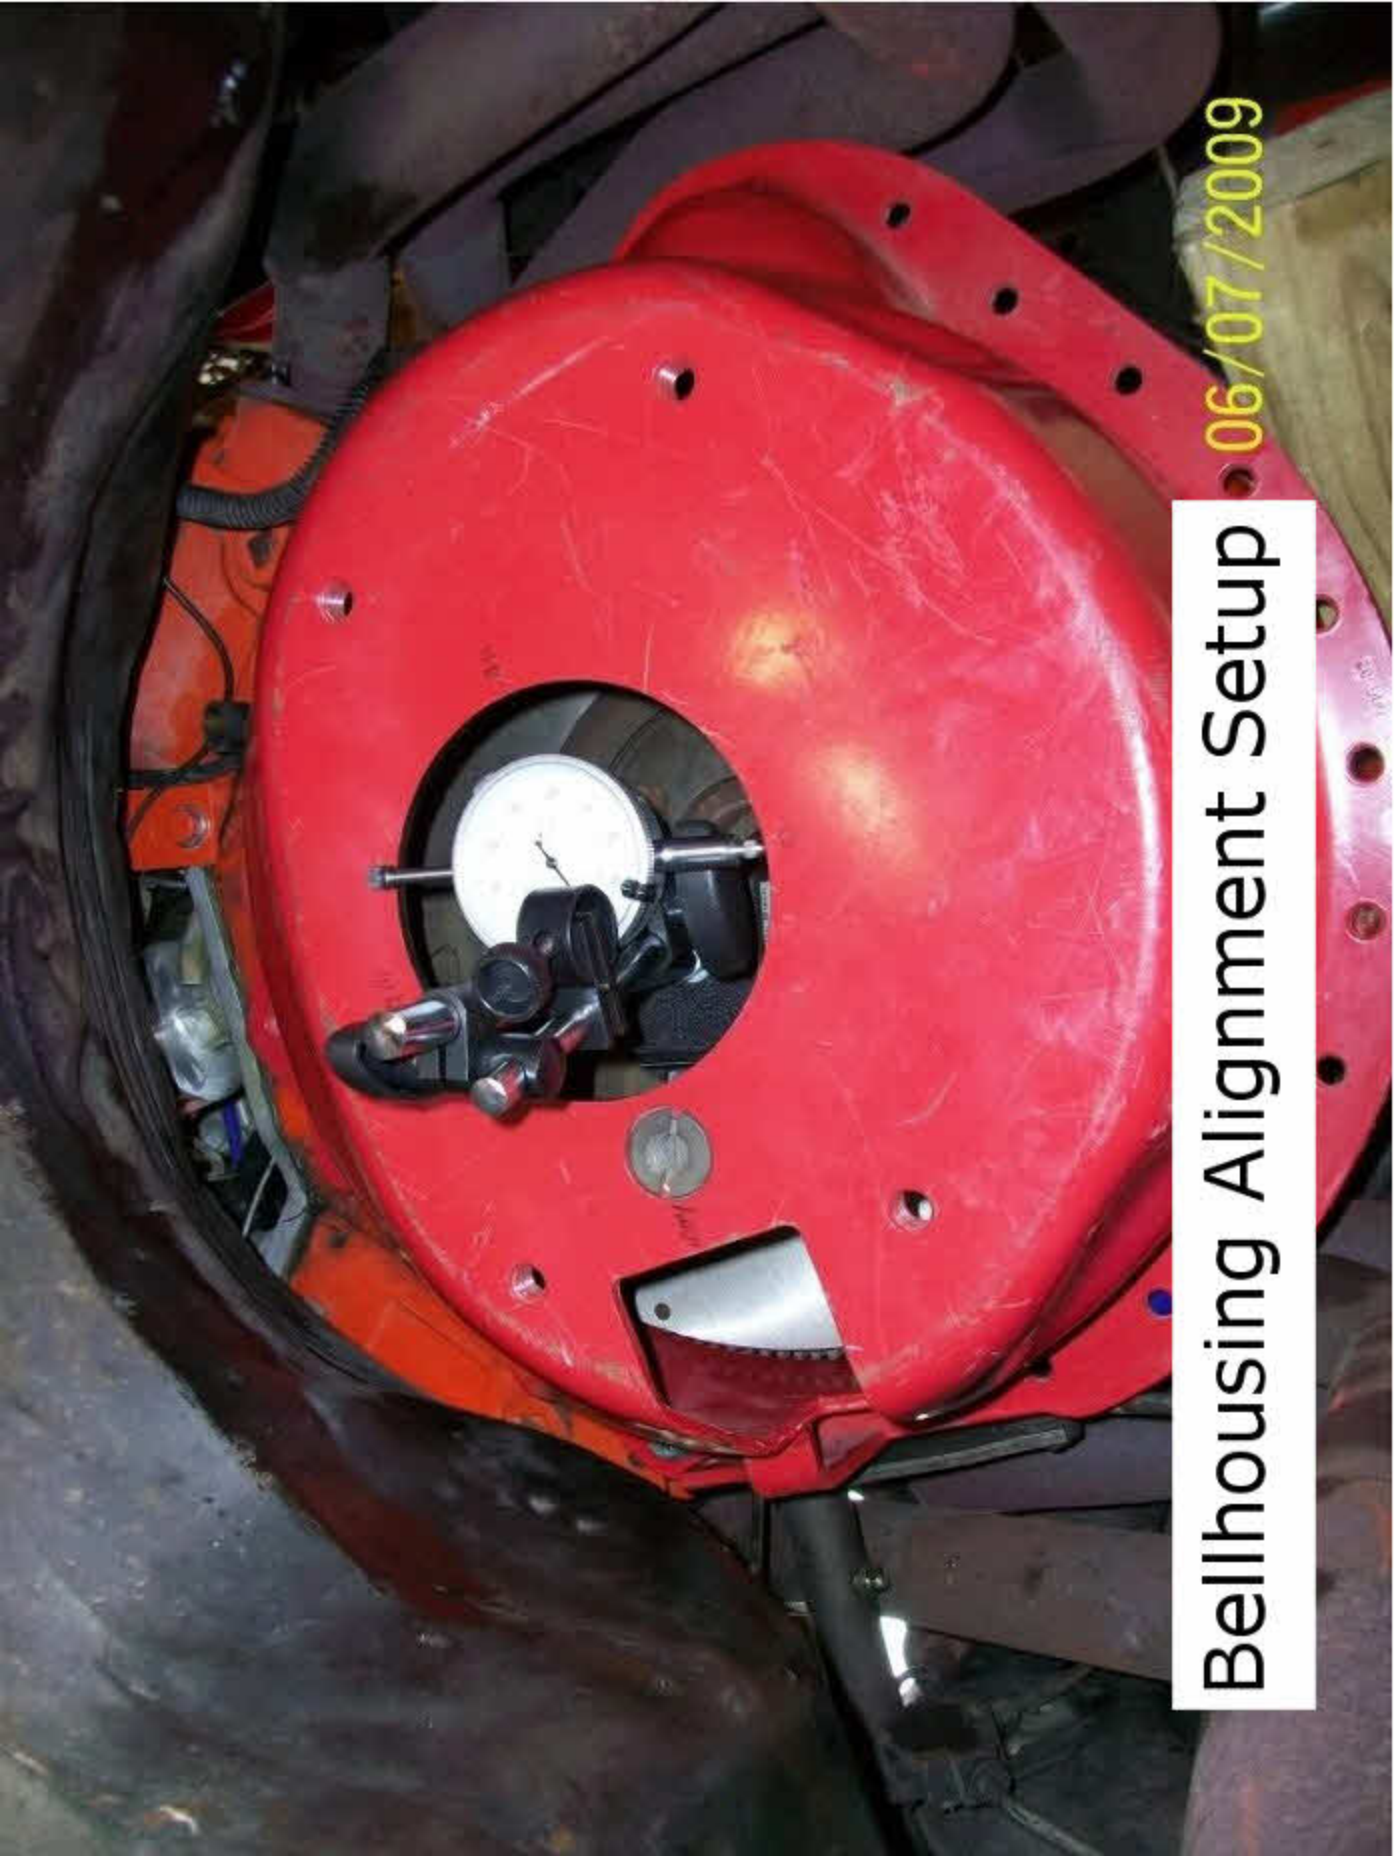
- **Make sure that the factory dowel pins, engine block and bellhousing mating surfaces, and the also the bellhousing transmission mounting pad and bore are clean and free of paint and burrs. *This is critical.* Then install the bellhousing and tighten the bellhousing bolts.**
- **Install the magnetic dial indicator base on the flywheel. Attach the dial indicator and adjust the dial plunger so that it has 0.100 inch or more of preload, and that it squarely contacts the inside edge of the transmission mounting bore of the bellhousing. See attached Bellhousing Alignment Setup picture.**

- Rotate the engine (crankshaft) so that the dial indicator plunger is at the 12 o'clock position. Move the dial indicator bezel to show zero (0) at this point.

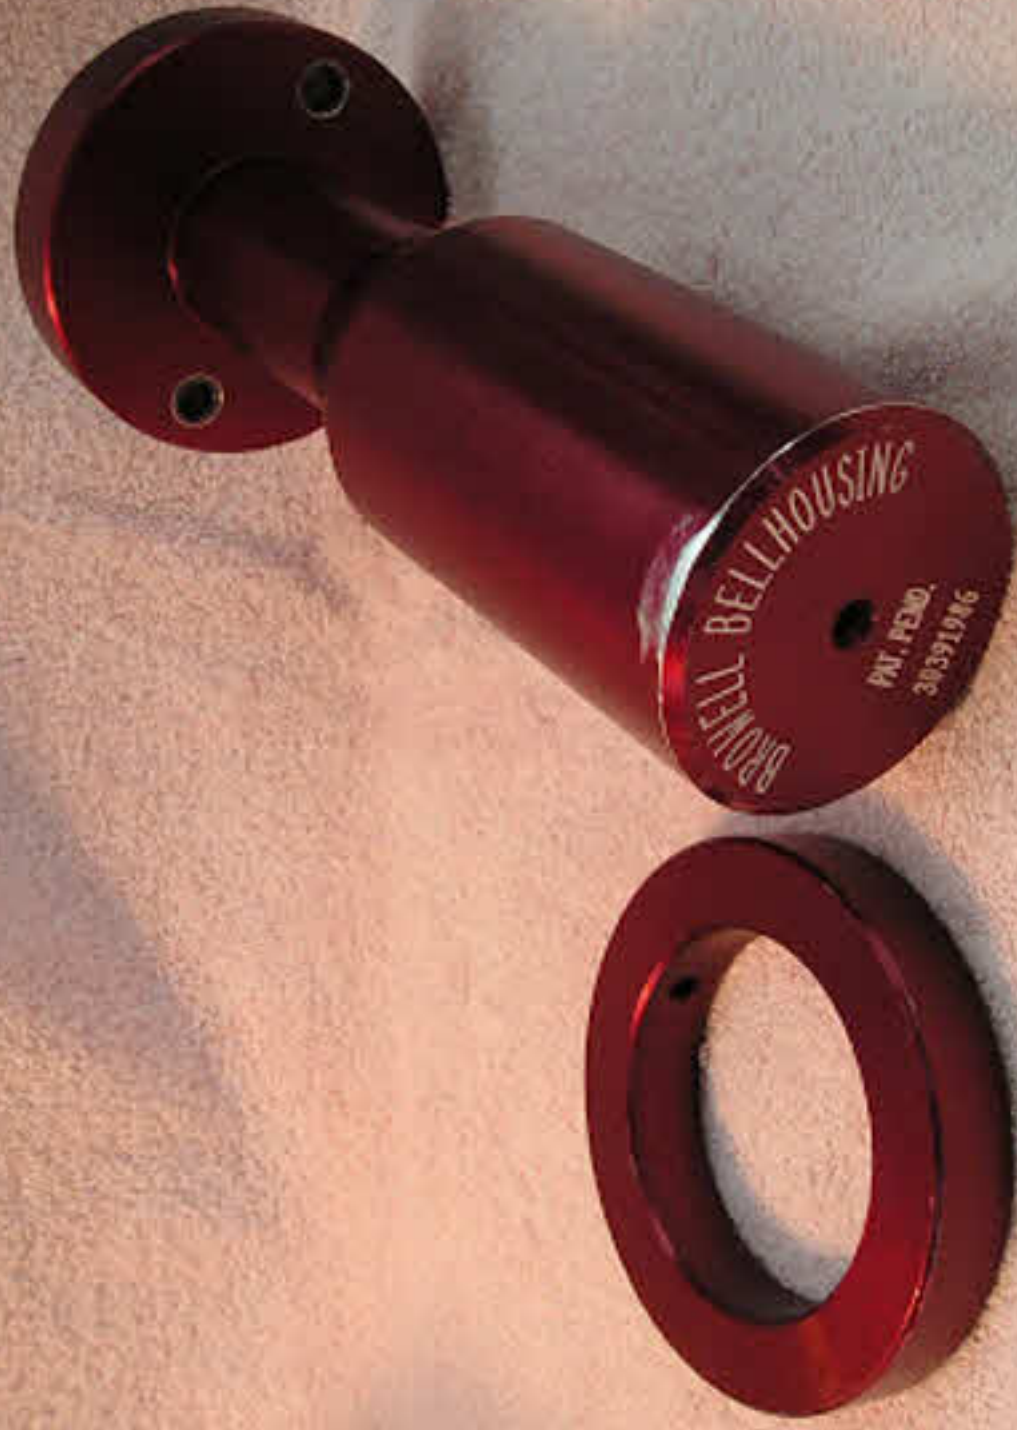
Browell Bellhousing Alignment Tool

The fit to the engine crankshaft flange is a register fit with essentially no clearance or tolerance. The ring has very close tolerances to the pin and to the bellhousing opening. The outside diameter of the ring is 4.683 inch.

- **The tool is specific to a given engine and bellhousing combination, and is not universal.**
- **If the ring can be gently pushed over the pin and through the bellhousing opening, then alignment is within acceptable specifications for proper transmission operation.**
- **If the ring cannot be gently pushed through the bellhousing opening, then the bellhousing alignment must be adjusted by using offset dowels as described earlier. (Browell Pics 1-5)**
- **The Browell tool does not measure bellhousing face parallel alignment.**
- **This tool *may not* work in every situation due to clearance stackup and limited selection of offset dowels. However, this would be rare.**
- **Tool cost new is approximately \$135. The tool can also be purchased used.**

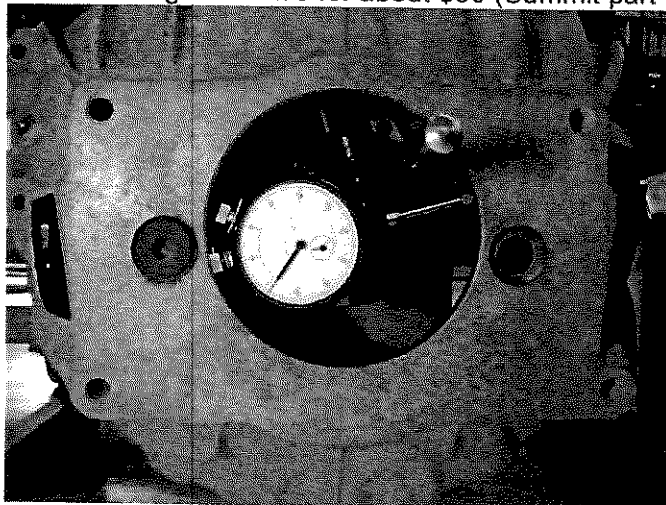
Fig. 1

2. Install magnetic dial indicator base on the flywheel/end of crankshaft and adjust the dial plunger so that it contacts the inside edge of the register bore of the bellhousing (**Fig. 1**). If you need to create space for the dial indicator base to sit flat on the flywheel, remove two of the flywheel bolts that are directly across from one another. Please note that the dial indicator base does not need to be dead-centered on the crank during this process but it must be solidly mounted. If you do not have a dial indicator, Summit Racing has an inexpensive one with a magnetic base for about \$30 (Summit part #SUM-900016-1).

8. Install bellhousing and torque bolts to specification. Re-mount the dial indicator and recheck runout by repeating step #2. Small corrections can be made by loosening the bellhousing bolts and turning the dowels with a wrench to bring the bellhousing within limits.

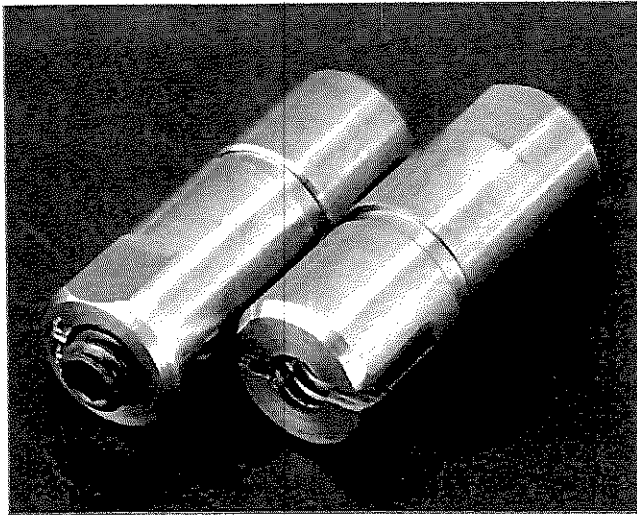
Bellhousing Alignment Dowels

Kits are \$28 Each
Each kit contains two offset dowels and two screws. Three sizes and three offsets are available.

- The recommended offset dowels to correct bellhousing misalignment are manufactured by RobbMc Performance, and are available in offsets of 0.007, 0.014, and 0.021 inch. These same dowels are also available from Lakewood. Summit, Jegs, and other speed shops sell them. Part numbers and prices are listed in the reference section at the end of this procedure.
- To select the correct offset dowels to install, divide the TIR reading you previously obtained by 2:
