HORN OPERATION DIAGNOSIS - ALL C3 CORVETTES 1969 THROUGH 1982

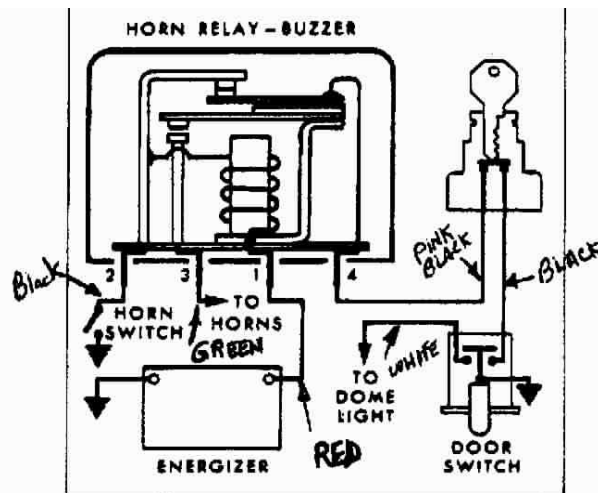
Horn Relay/Key Buzzer Schematic

- 2) **Horn Relay/Key Buzzer** – Early Corvettes have the horn relay mounted underhood, on the driver's inner fender, near the brake master cylinder. Later models have the horn relay mounted inside the car, under the dash on the instrument panel wiring harness coming out of the fuse panel.
Remove the relay from its mounting and identify the #2 and #3 terminals. Connect a jumper from the terminal marked #2 to ground. Slide a probe into the wiring harness connector to make contact if the terminals are the slip-on type. If the horns operate, check the #2 terminal wire and horn switch for defects. If the horns do not operate, leave the #2 terminal connected to ground, and connect a voltmeter from the #3 terminal to ground. If a reading is obtained, check the horn wiring and horns for defects. If no reading is obtained, replace the horn relay/buzzer.

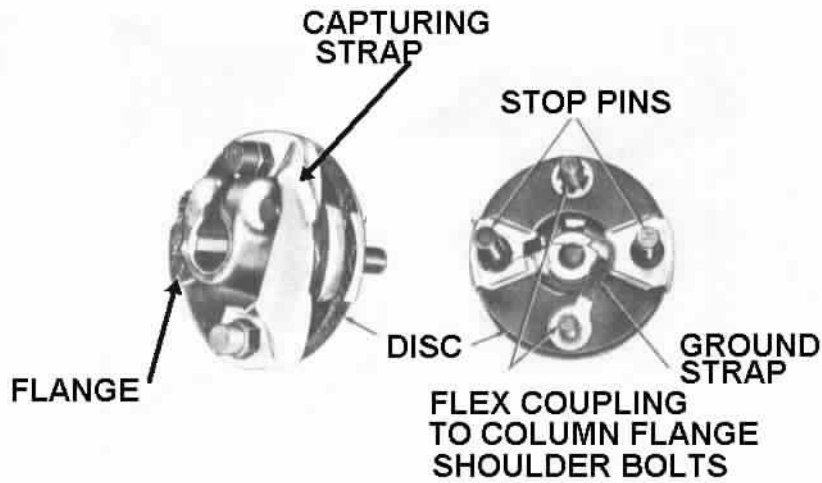
Flexible Coupling

The OEM flexible coupling has a ground wire, strap, or inlaid screen that provides a grounding path from the steering column, through the flexible coupling, to the steering gear. Some replacement units and most rebuild flex coupling “kits” do not provide a ground path. This could be the reason why your horn suddenly stops working.

Also your OEM flexible coupling has a ground wire, strap, or inlaid screen that provides a grounding path from the steering column to the steering gear. Some replacement units and most rebuild flex coupling "kits" do not provide a ground path. This could be the reason why your horn suddenly stops working.
